A DESK-BASED ASSESSMENT FOR FIRLE STABLES,
FIRLE, EAST SUSSEX.

Archaeology Services Lewes

Project number: 146-18

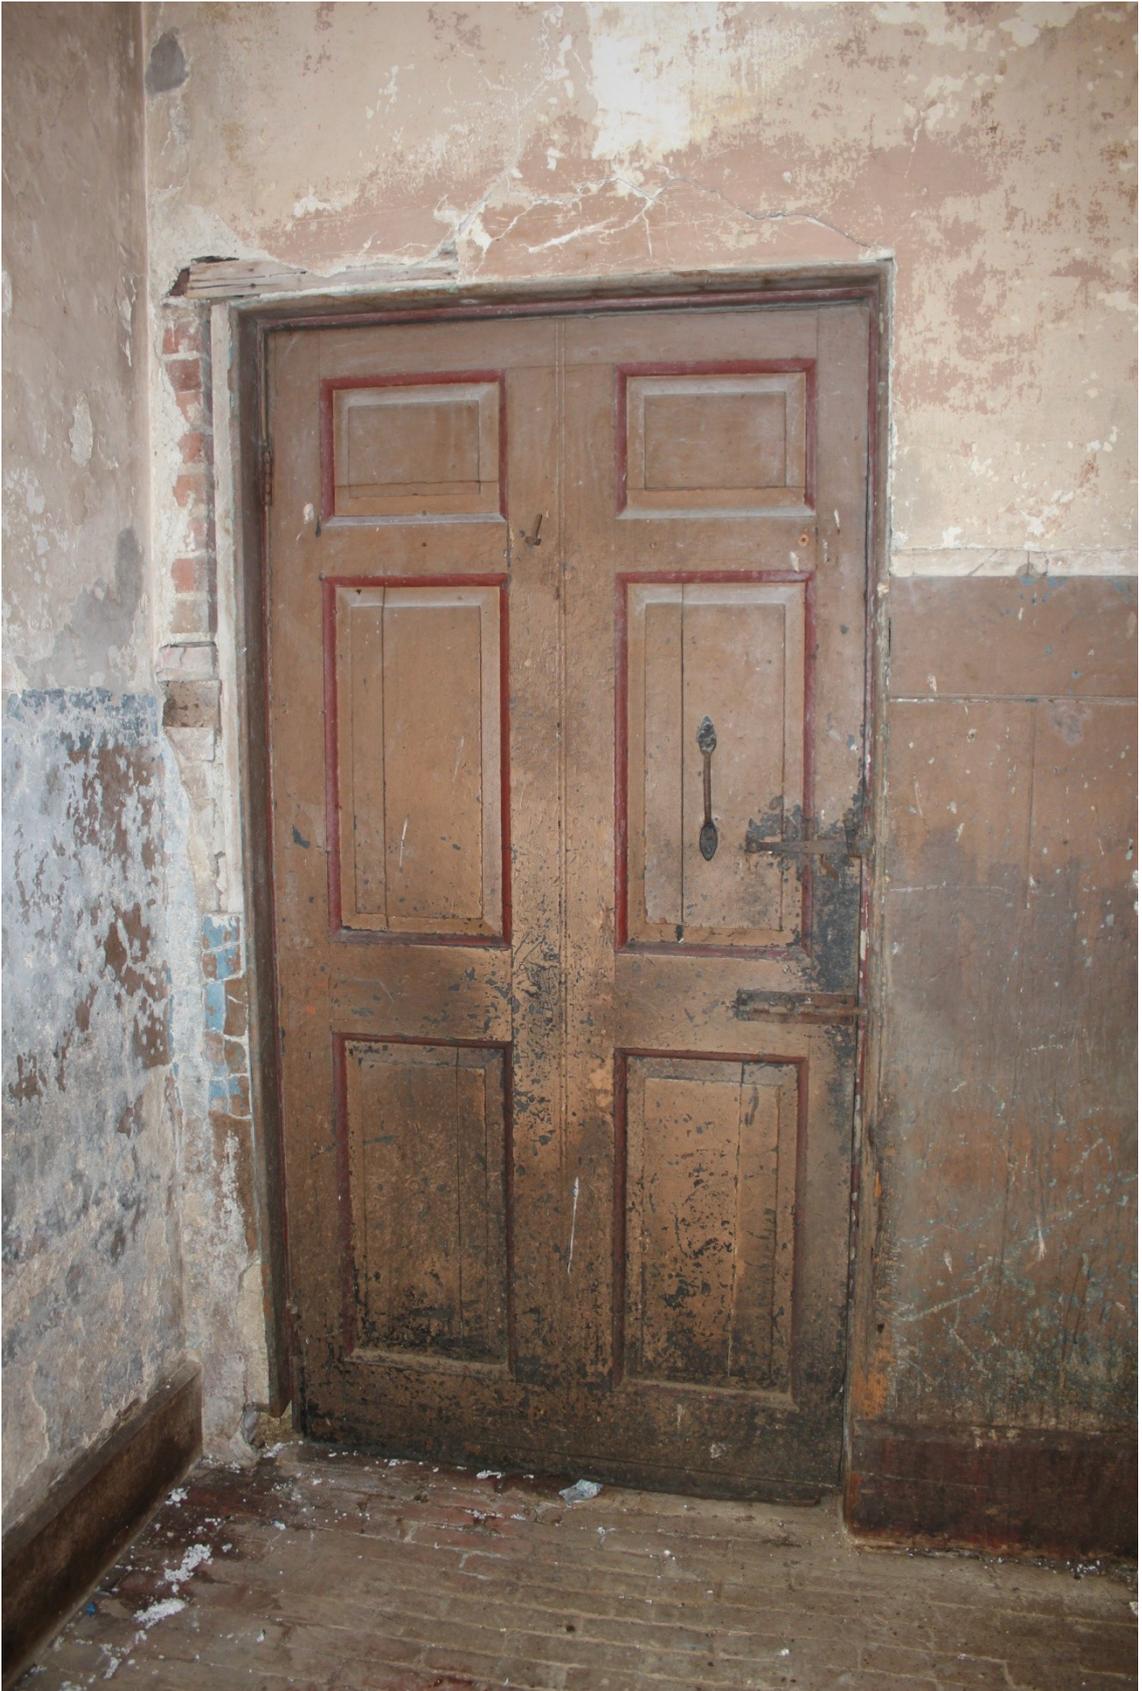
Plate 4. Original pedestrian door into the residential annexe now blocked on the reverse side.

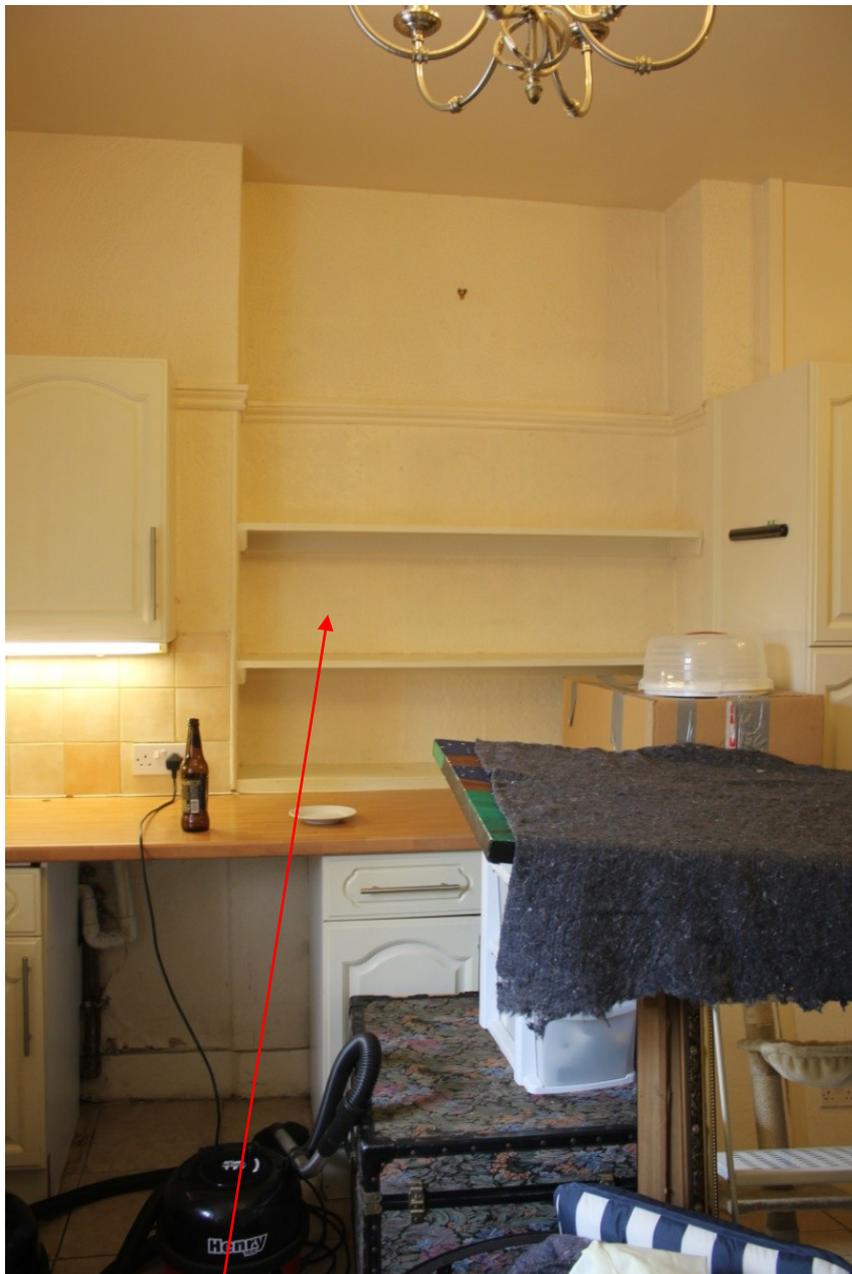
Plate 6 Blocked window which originally looked into the riding school.

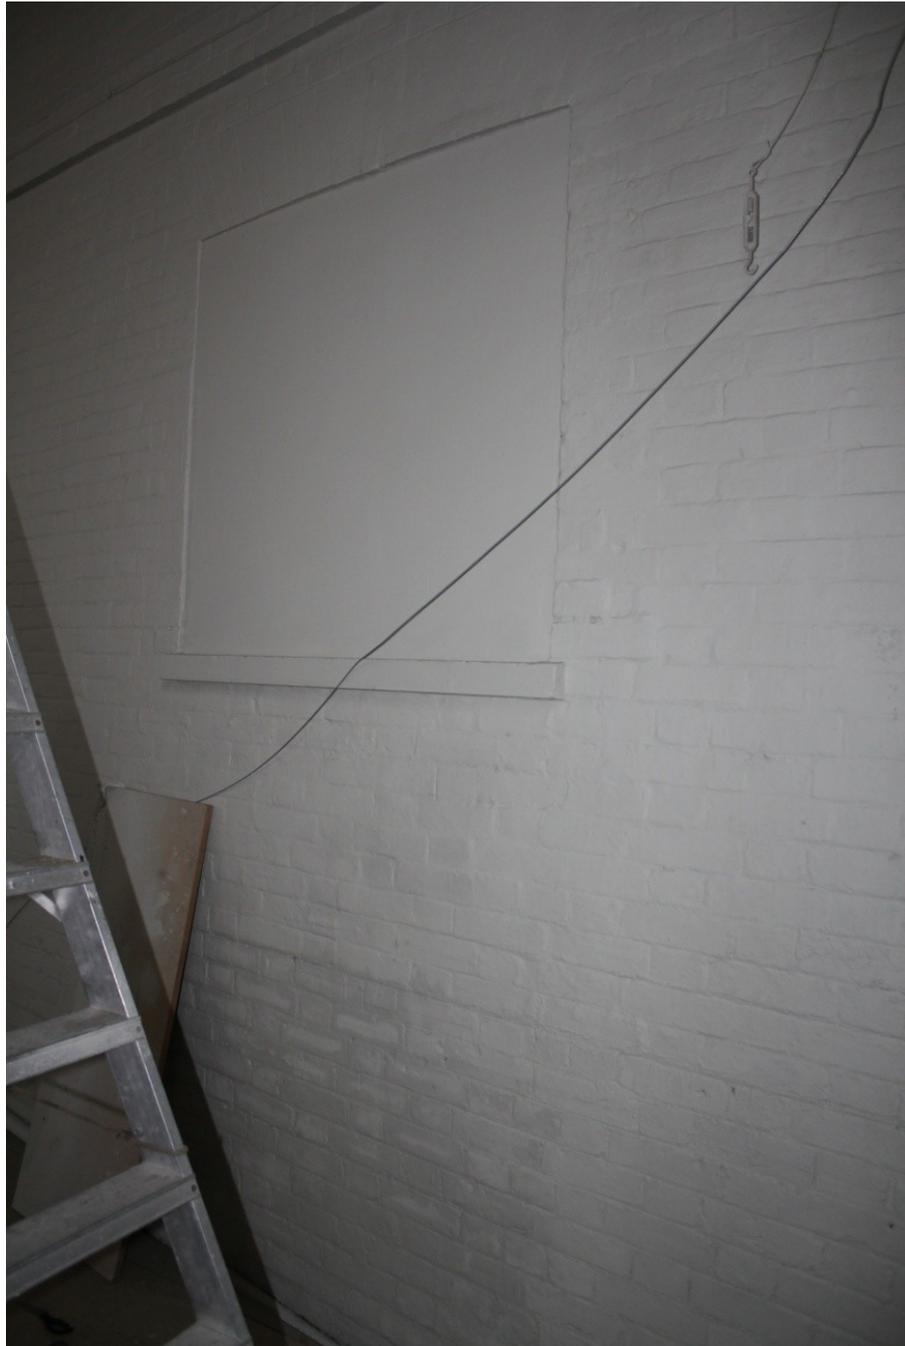
Plate 7. Blocked window within the riding school.

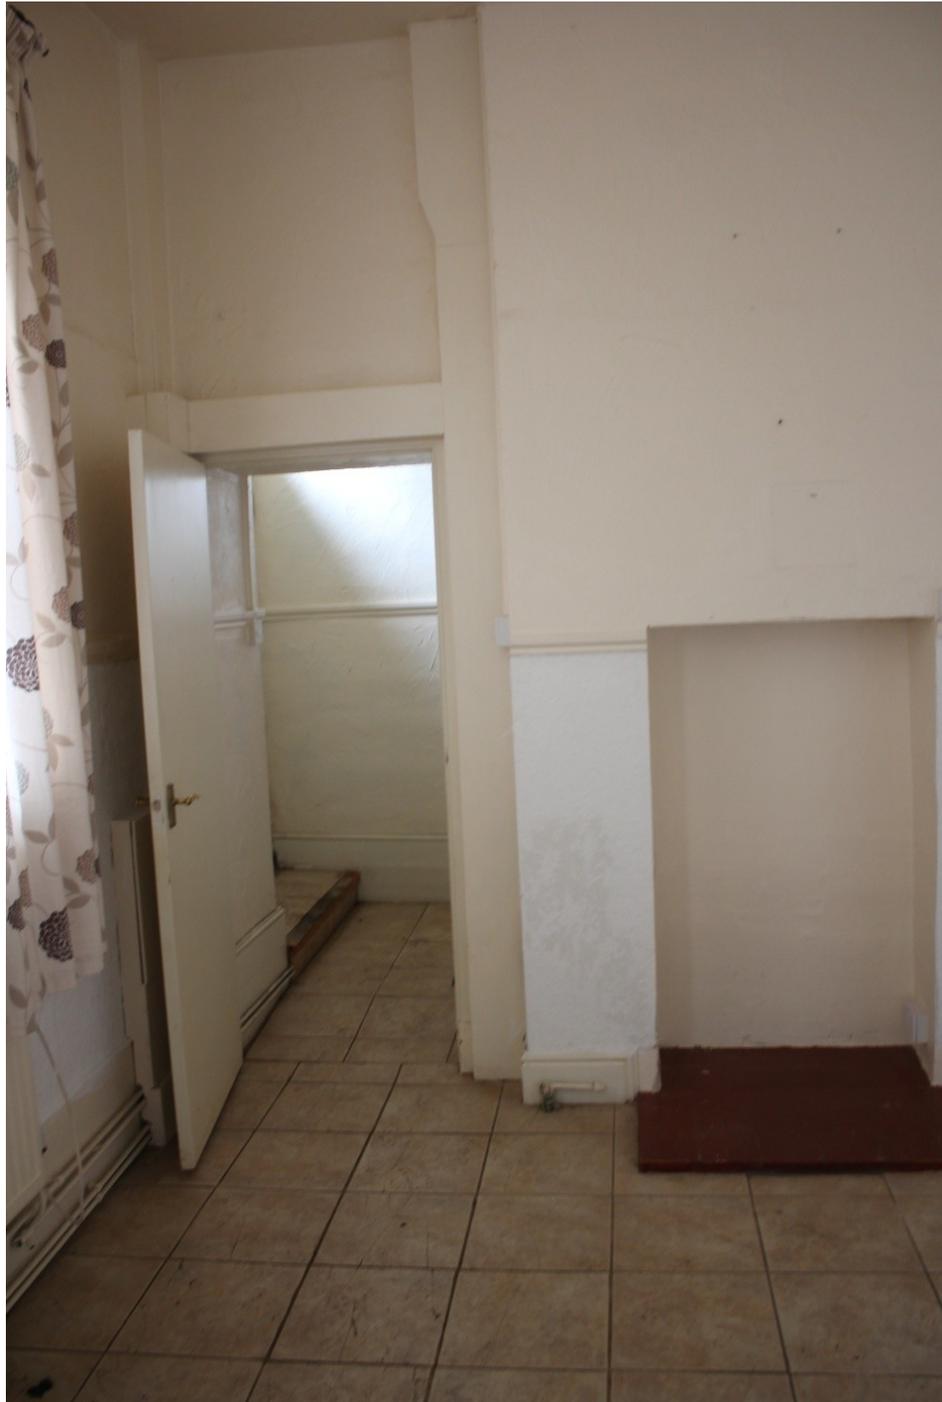
The living room at ground-floor level is entered through a modern door off the hallway and has also been renovated, with modern fittings and decoration with Artex/wallpaper-covered walls above a modern chair rail. The floor is covered with ceramic tiles, presumably laid on floorboards as evidenced by significant cracks from movement. There is patched skirting around the room and the windows are modern sashes in older frames, with one top sash on the north side being older, with horns. The wall to the north-east side is partitioned to the hallway and has a blocked doorway evident here. There is also a chimney breast apparent which has been blocked up in the north-west side of the room (Plate 8).

Plate 8. Blocked fireplace in the ground floor living room.

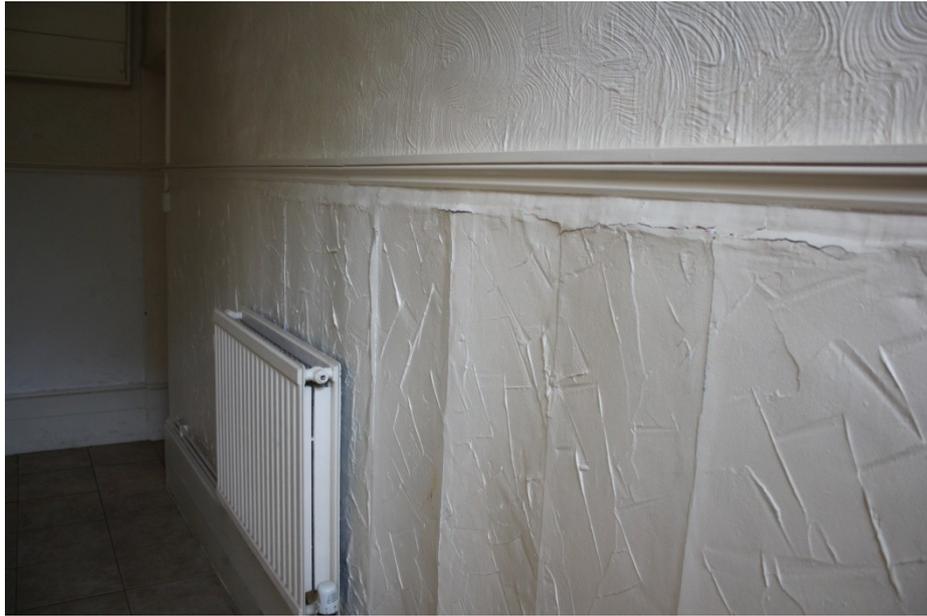
The L-shaped hallway has a step down from the rear door, with ceramic tiled flooring and a cornicing around the perimeter of the ceiling which appears truncated at the blocked doorway into the stable on the north-east side. There is high skirting board at 0.34m around the perimeter which leads into the living room but continues over the blocked doorway into the kitchen. There is a chair rail at a height of 1.44m on the south-east side, with vertical tongue and groove wooden panelling below which has been plastered over (Plate 9).

Plate 9. Plastered wall panelling in the hallway.

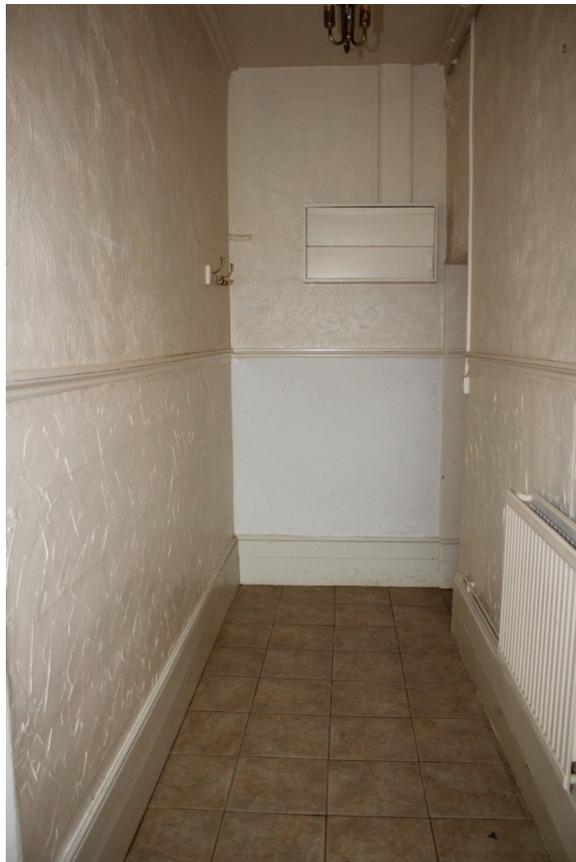
The north-west wall also has plastered panelling, but here it appears horizontally fixed (Plate 10). The architrave into the existing kitchen doorway is probably early 20th century (Plate 11).

Plate 10. Horizontal panelling plastered over in the hallway.

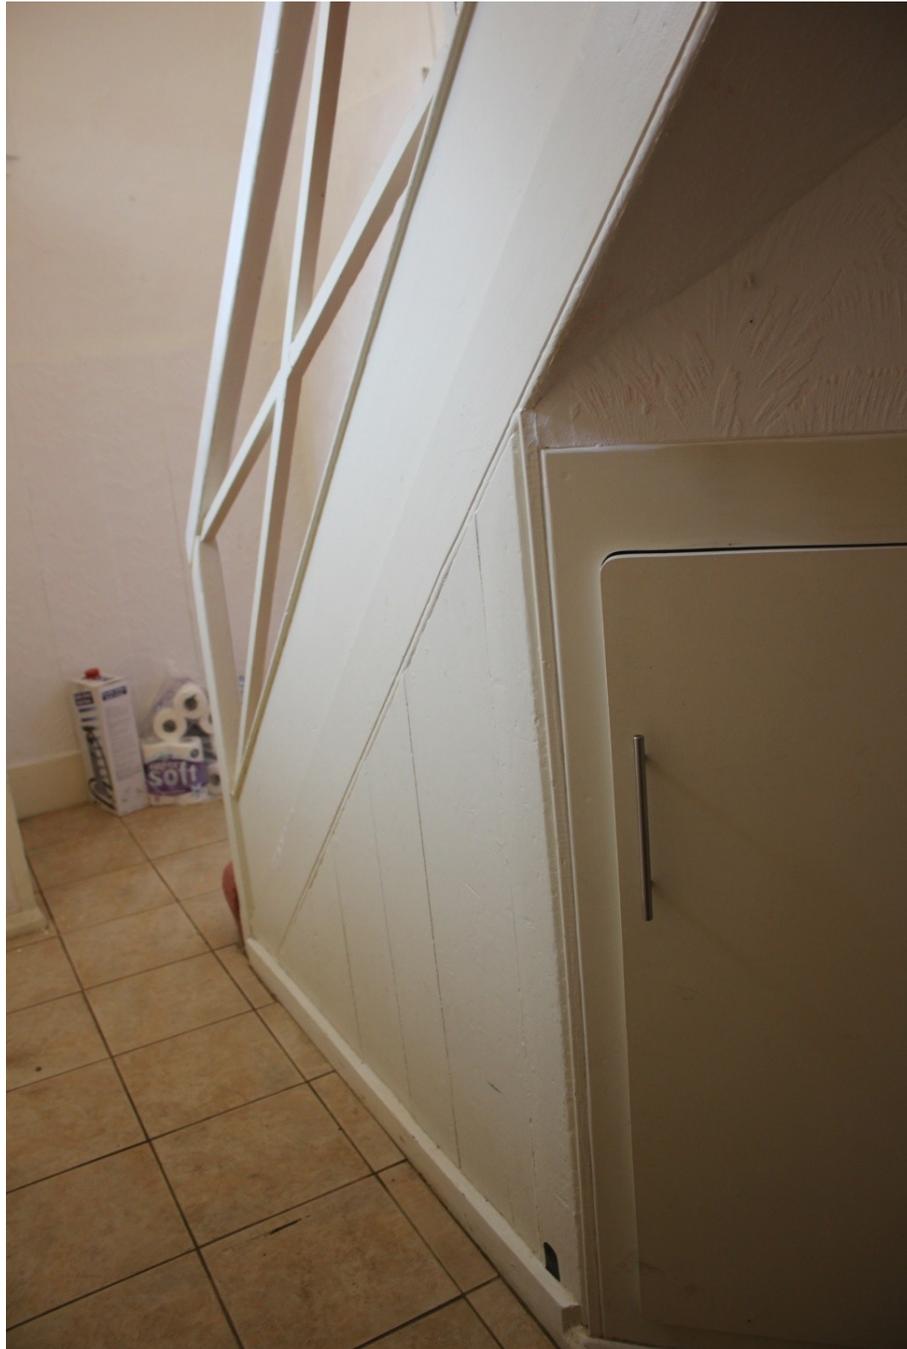
Plate 14. The 20th-century stairs, probably replacing earlier ones.

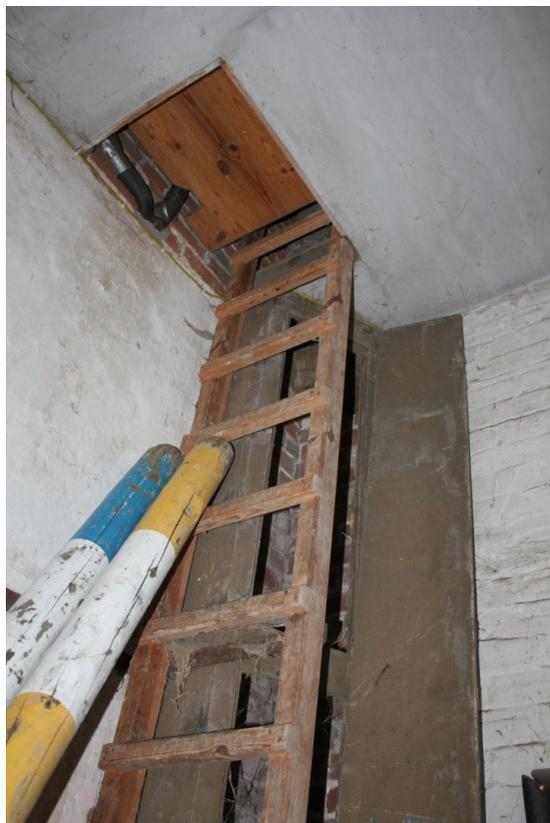
There are two triangular apertures in the ceiling (Plate 16) on the south and north corners, which form panelled access routes for the weights of the clock above, which would have moved down through the apertures when the clock was working.

Plate 16. Triangular apertures for the clock weights with access ladder to re-set these.

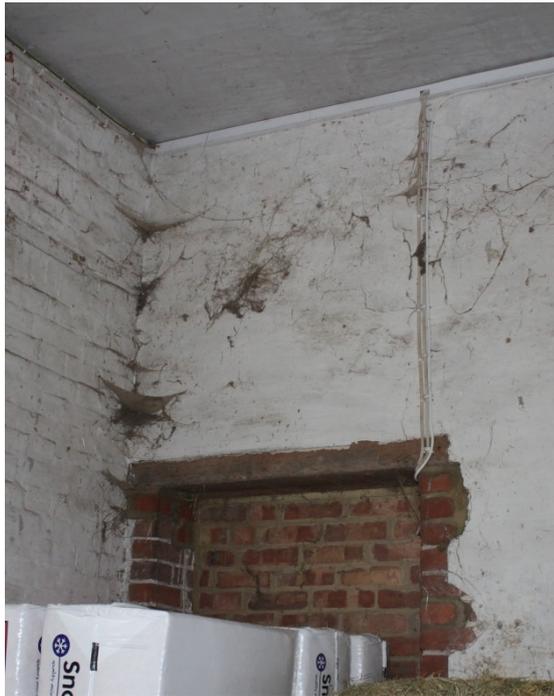
Plate 17. Blocked doorway into Flat 2 in the south-east wall.

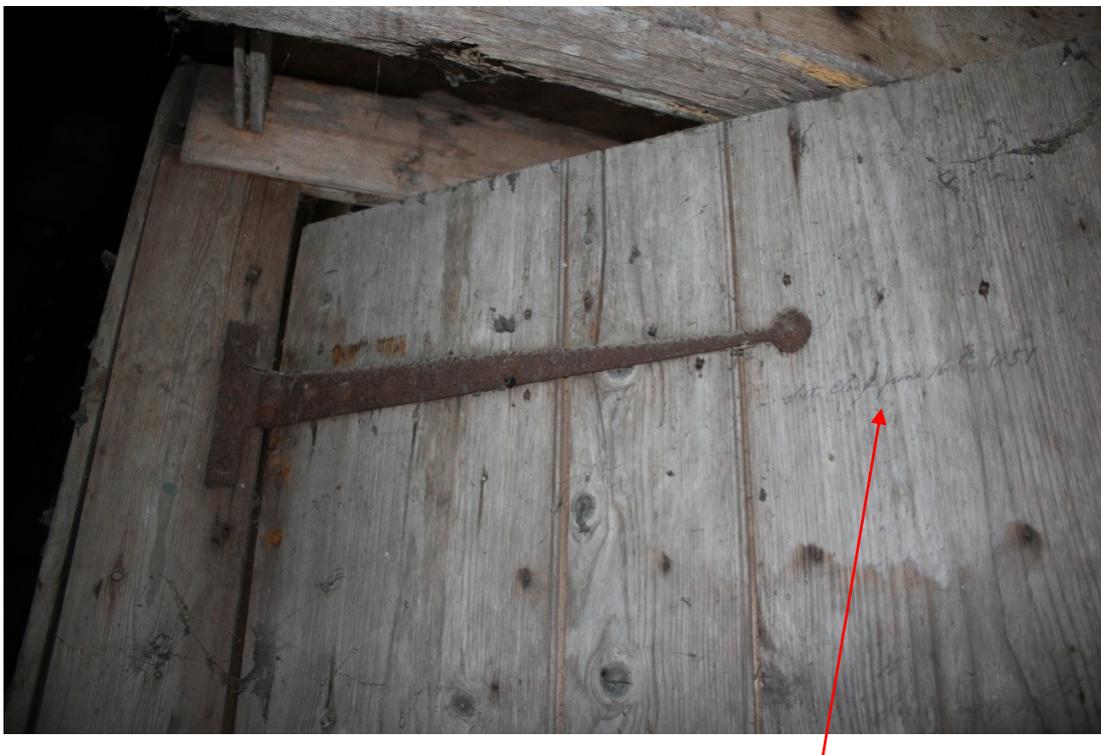
The door in the south-east side is a 19th-century ledge and plank door with iron strap hinges and various pencilled re-setting dates and information relating to the clock (Plate 26).

Plate 26 Ledge and plank door with re-setting notations.

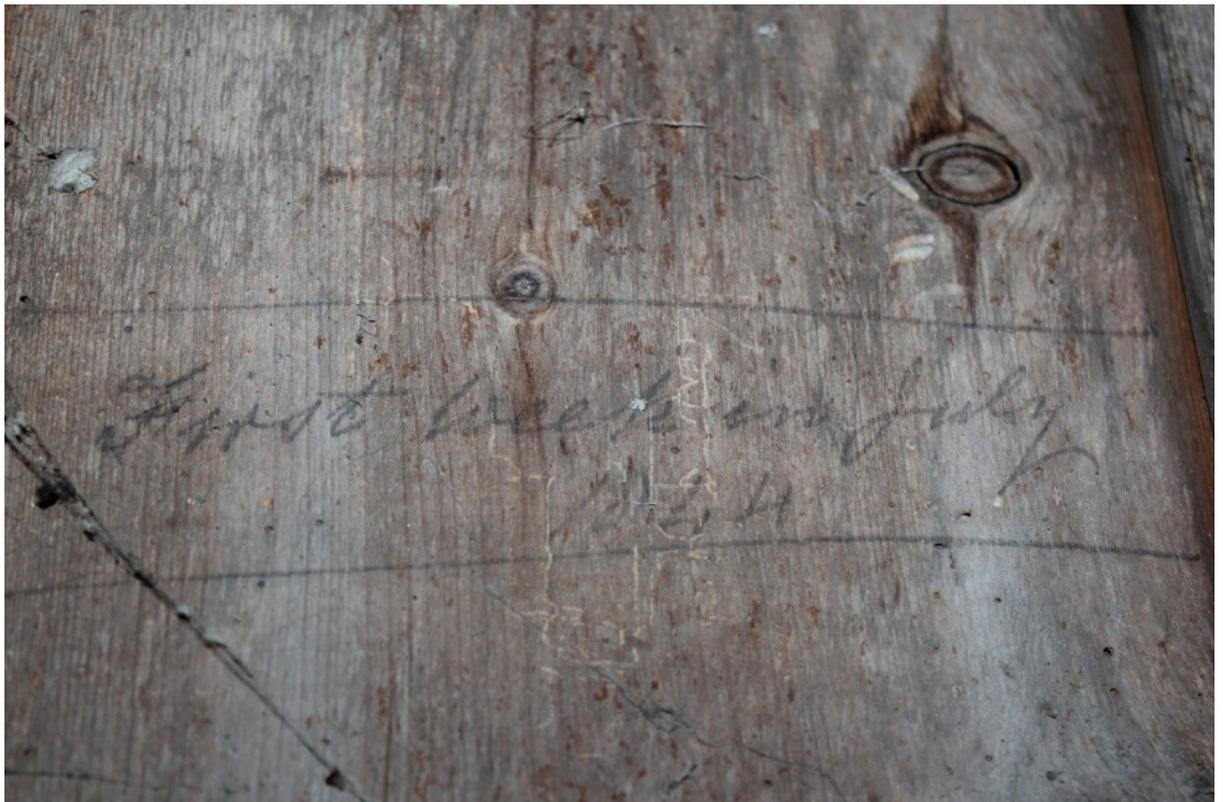
'Pulley rusts after O this side 11-3-1982 R.W. Holford'

'New wire this side 2-9-93'.

Plate 27. Pencilled dates on the rear partition wall of the clock room.

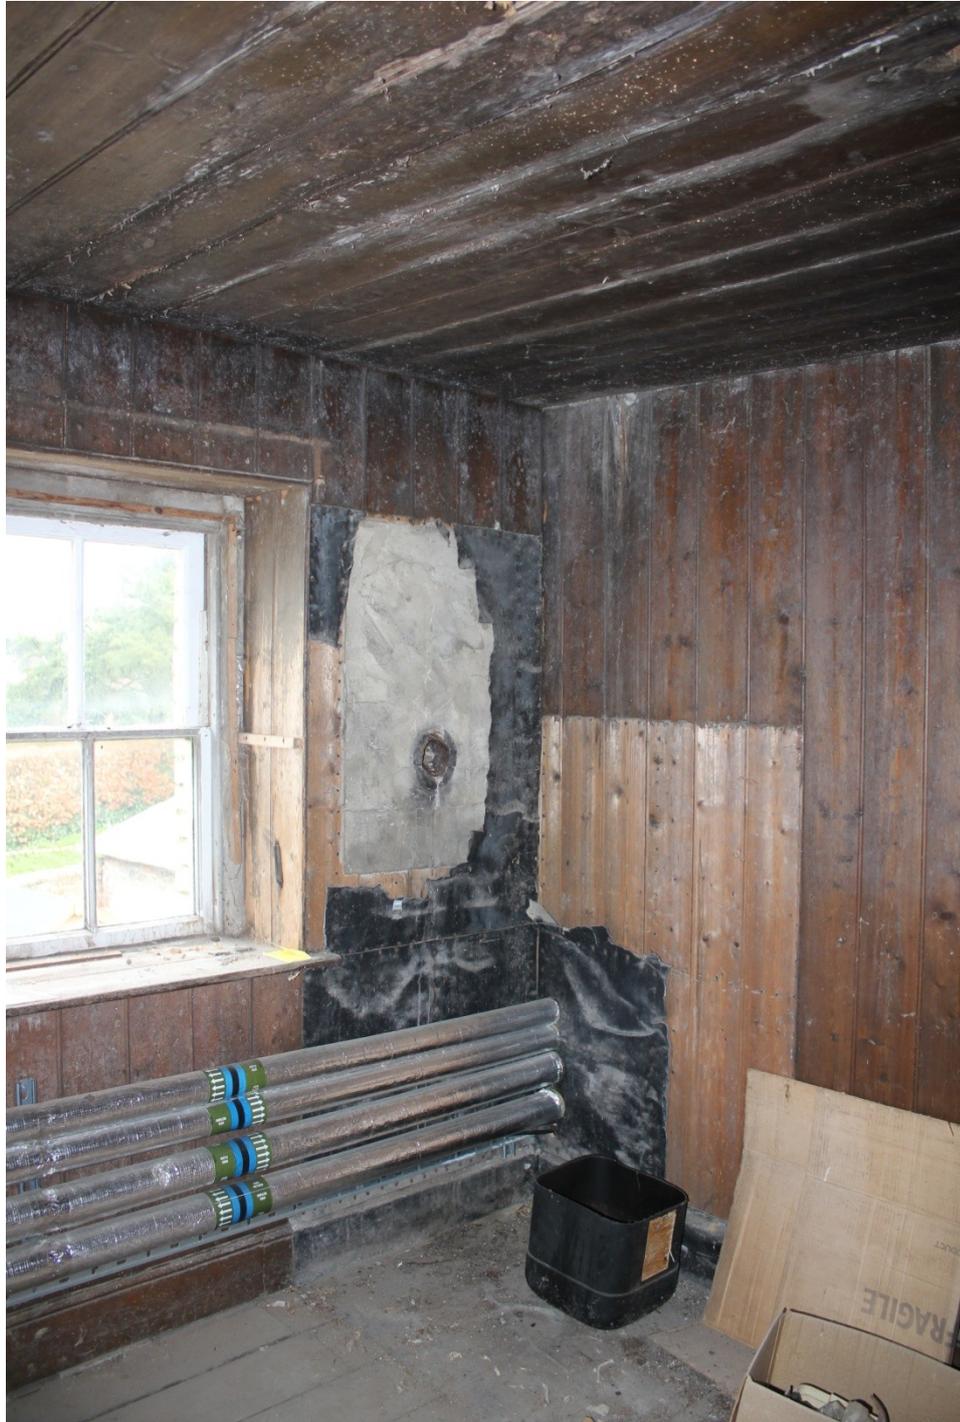
Beyond this, to the rear, is a small room which would have provided accommodation at one point, as it once contained a small fireplace which stood on a metal plate in the south-west corner of the room, with a flue which protruded through the wall, lined with lead flashing (Plate 30). It is likely that this room was created here in the early 20th century.

Plate 30. Small accommodation room with former fireplace in corner.

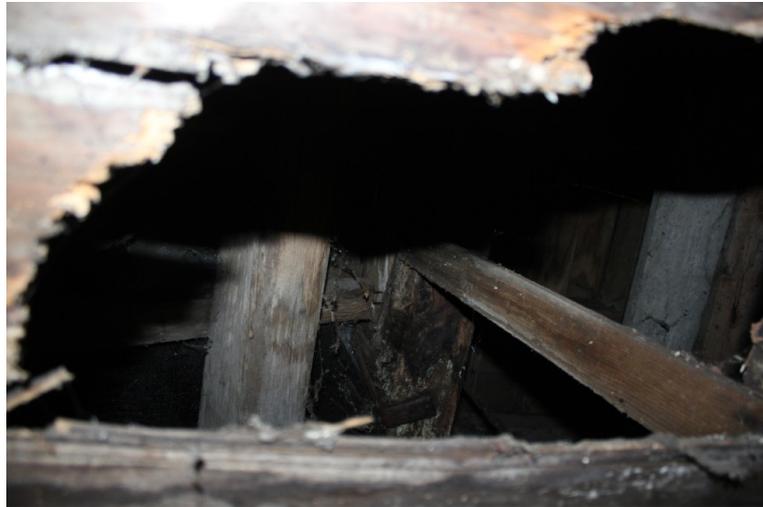
There has been significant water ingress in the roof here (Plate 31) which has brought the ceiling down in places and is progressing through the floor, which are softwood boards, 0.17m wide. The walls and ceiling are constructed with softwood

Plate 31. Water ingress in the roof has rotted the ceiling boards.

- 10.5 It is recommended that the water leak from the new pipes is stemmed as a matter of urgency, along with the leak in the roof, before more historic fabric is impacted.

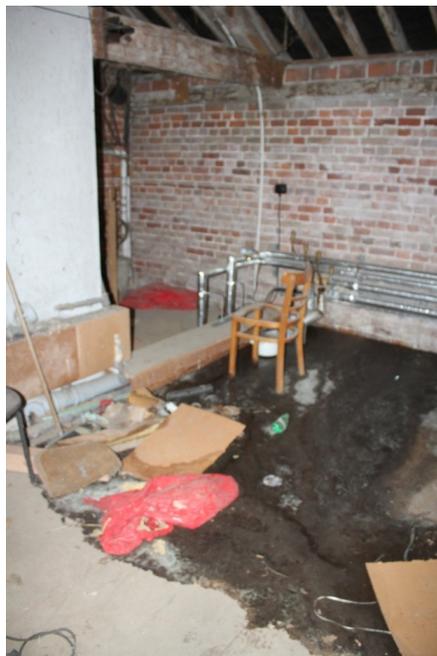
The third area provides storage space and has significant water ingress from the modern pipes situated within (Plate 32). The floor is covered with hardboard here, and there is a small, partition space in the south-east corner which is not accessible, but which contains a water tank above, so probably houses a boiler for the second flat below. The second clock weight is housed in the south-west corner of this area (Plate 33).

Plate 32. Area 3 with modern pipes and water leak seeping into the floor.

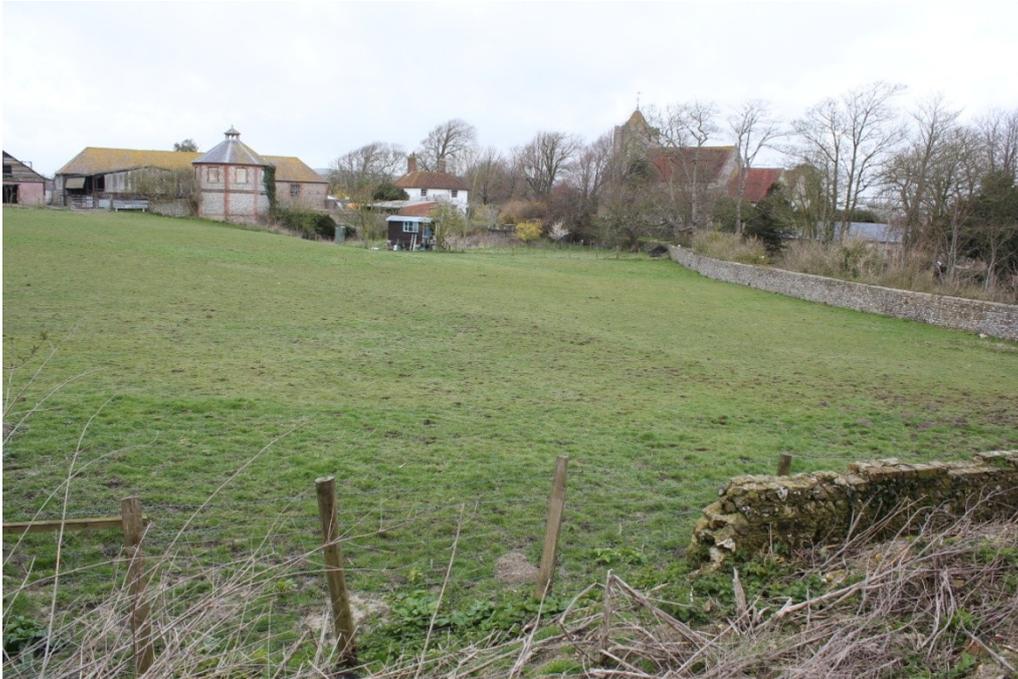
Plate 38. Earthwork running across the field where the proposed car park is to be situated.

An earthwork is visible in this field, running in an east-to west orientation across the field (Plate 38). It is not known what this feature is.
