HERITAGE IMPACT ASSESSMENT FOR LEIGHWOOD  
HOUSE BARN, NORTH CHAILEY.  
ARCHAEOLOGY SERVICES LEWES  
Report number: ASL 50-15  
January 2015

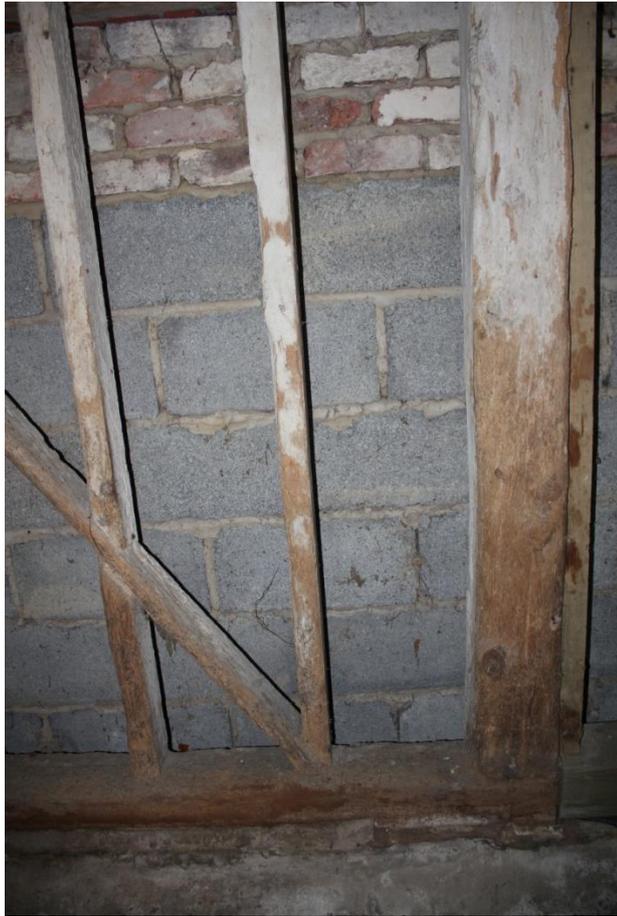
Plate 2. Worn whitewashed beams in truss A-A

- 4.2.2 The west bay has evidence of wear on the face of the timbers, due to the action of animals (plate 2 and 3). This bay has been whitewashed at some point in its history and this has evidently been worn away in places. The whitewash only extended as far as the side girt (see also plate 5).

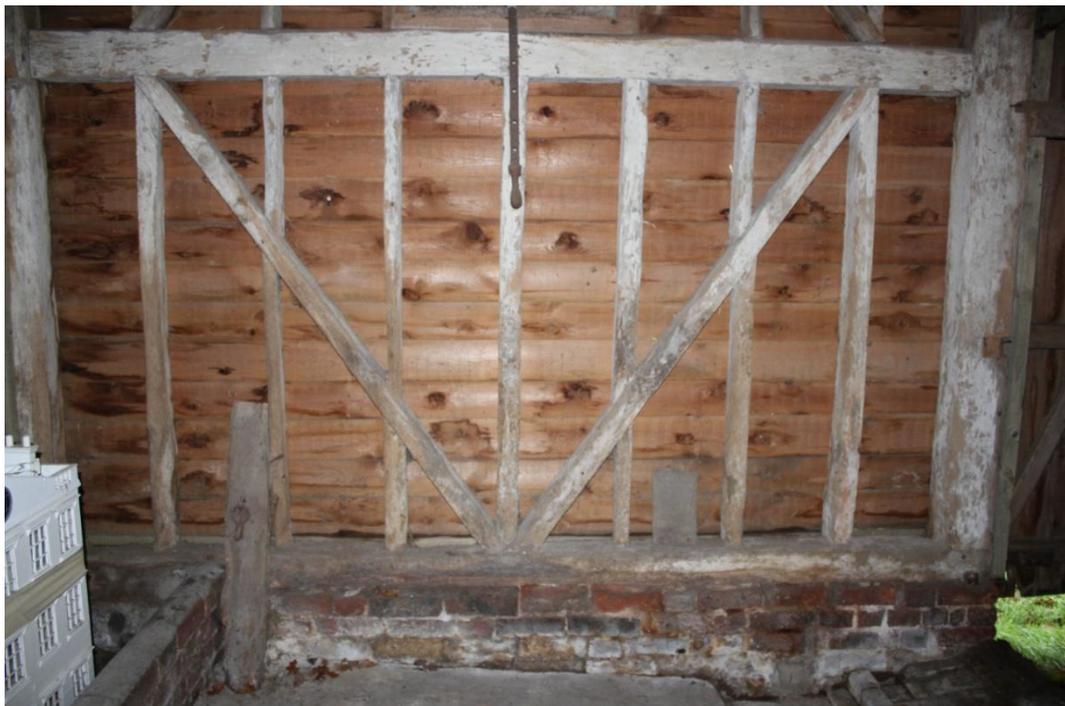
Plate 3 Worn white washed beams in north elevation between truss A and B

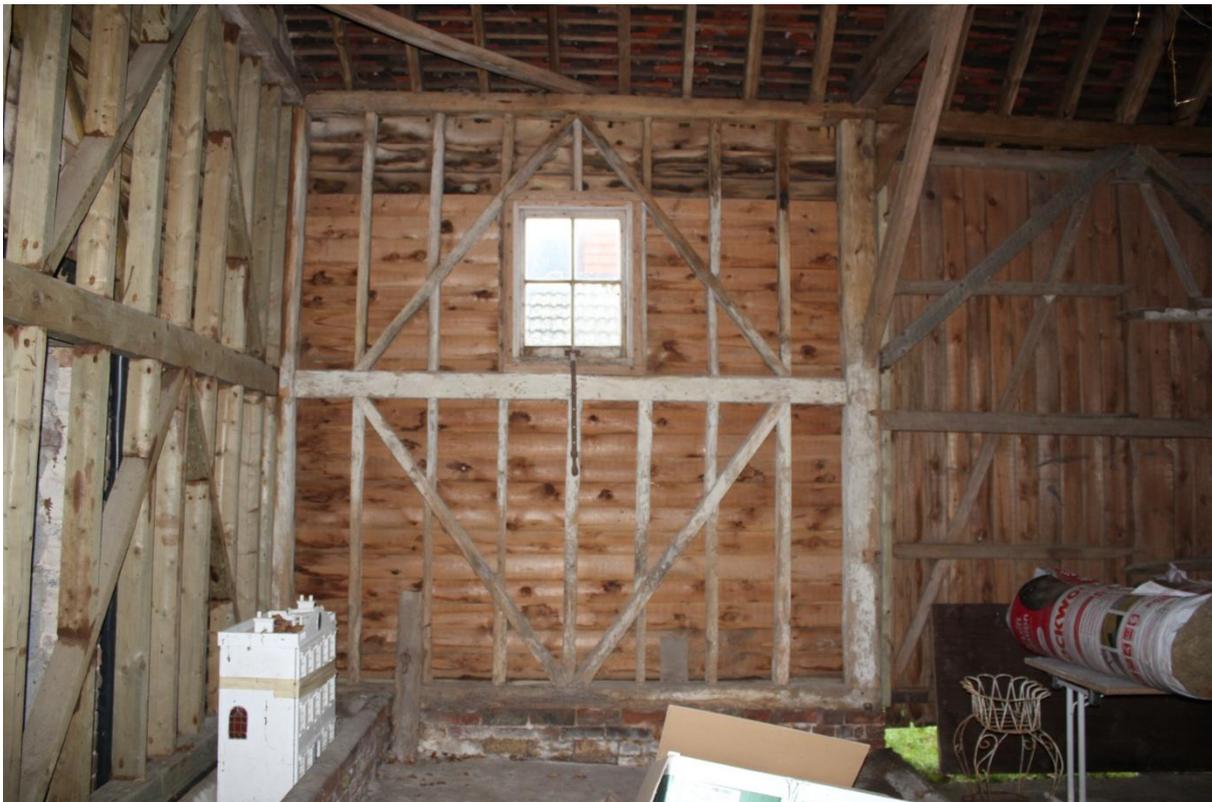
Plate 5 North elevation between truss A and B

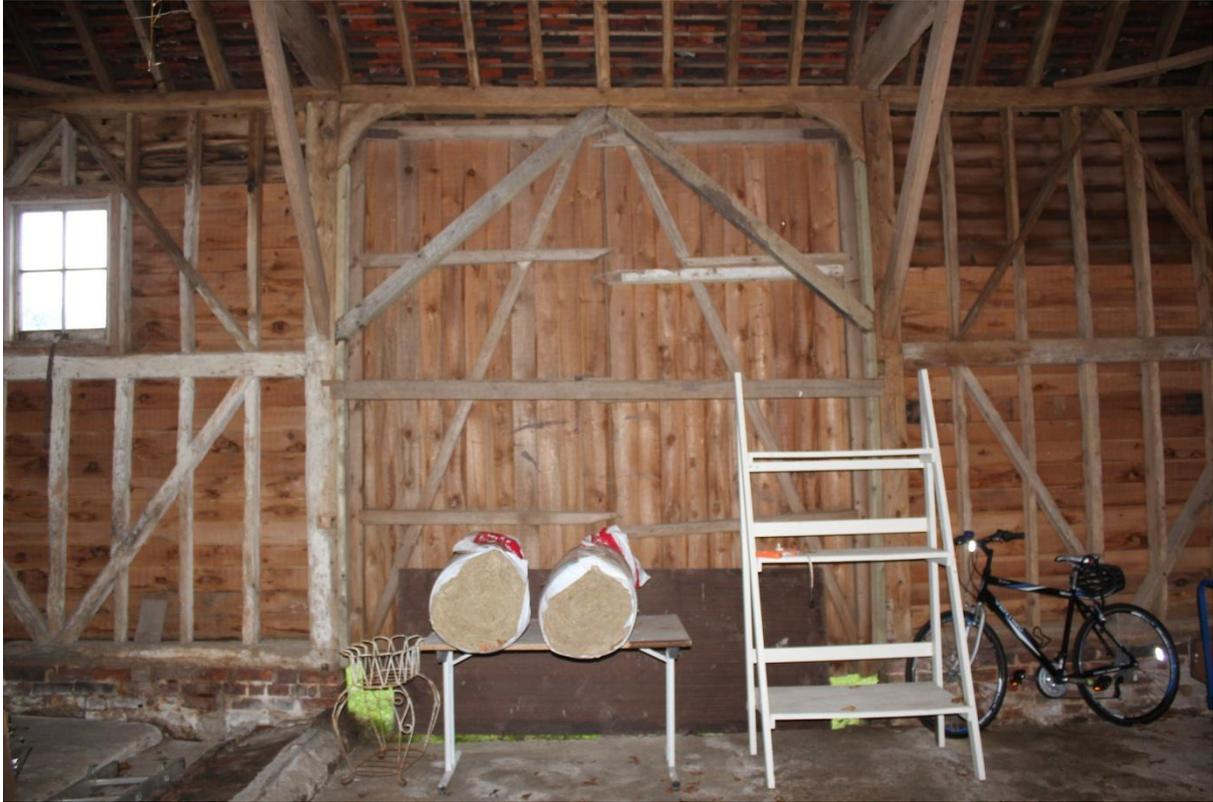
Plate 6 Full height door in north elevation between truss B and C

The full height entrance to the south has now been partially blocked off by the insertion of a stud wall, side girt and brick built plinth. The full height doors in the north elevation are still in place but are likely to be replacements (plate 6).

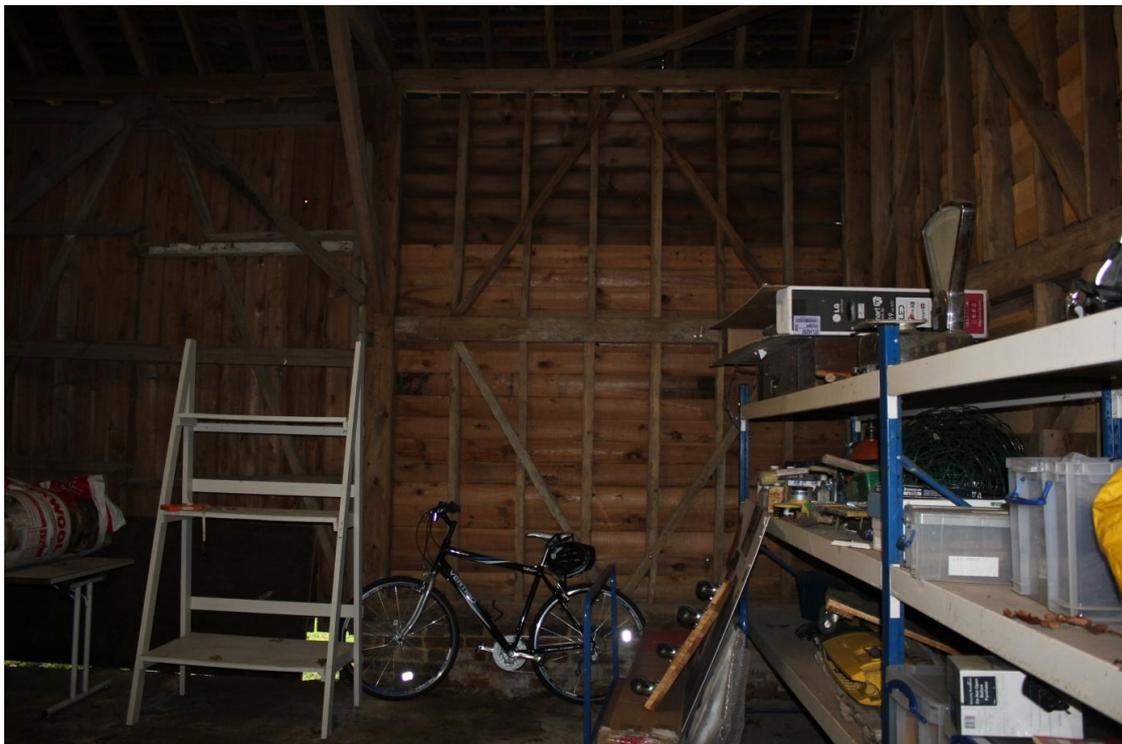
Plate 7 North elevation between truss C and D

- 4.2.3 The east bay between truss C and D (plate 7) has no evidence of animal husbandry, the beams are not whitewashed or worn and there is no brick flooring for stalls evident. It is likely that this bay was used for crop storage but there is no evidence for older mortices cut into principal posts or side/end girts and therefore no evidence for an inserted floor.

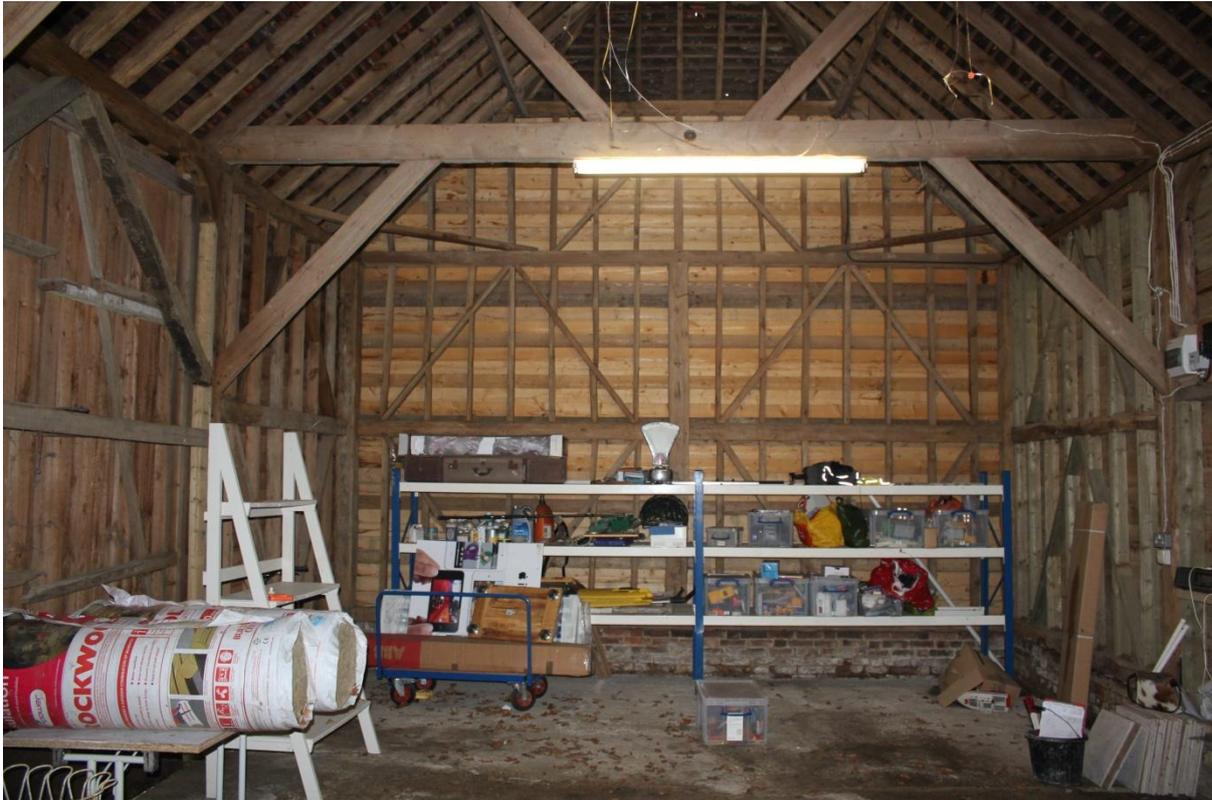
Plate 8 The east elevation in truss D-D

- 5.4 The nature of the impact within the barn includes the proposed removal of the rear (eastern) wall which will facilitate the width of the new extension. In order to do this it is proposed that truss D-D is removed entirely. As this wall is entirely original it may be prudent to consider whether it is possible that this design can be reviewed, along with the removal of trusses B and C, which is necessary in order to create enough head height at first floor level. However, as full specifications for this have not been available yet it is difficult to comment further or give alternative compromises. In the very least, clearer details of this

need to be submitted. This truss has been subject to a full archaeological survey and fully recorded (see plates 8 and 15 and cross section in figure 10).

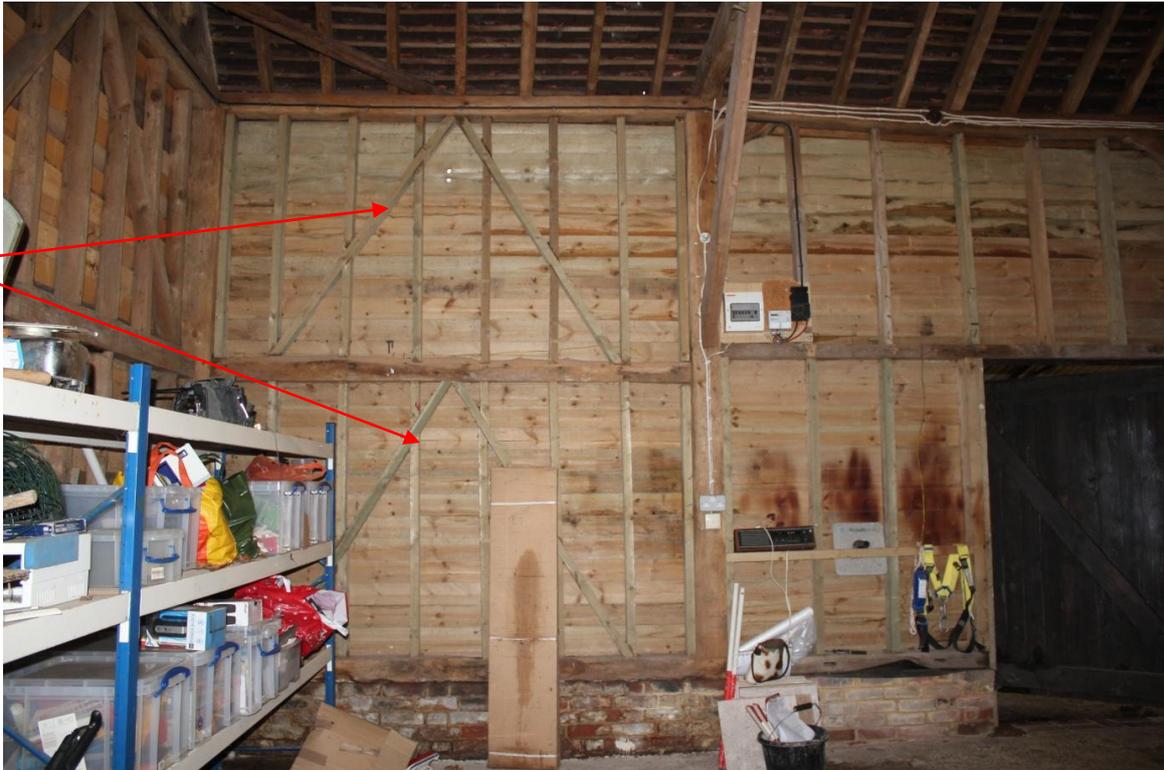
Replaced  
studs  
and  
struts

Plate 9 The south elevation between truss D and C with partially blocked door between truss C and B

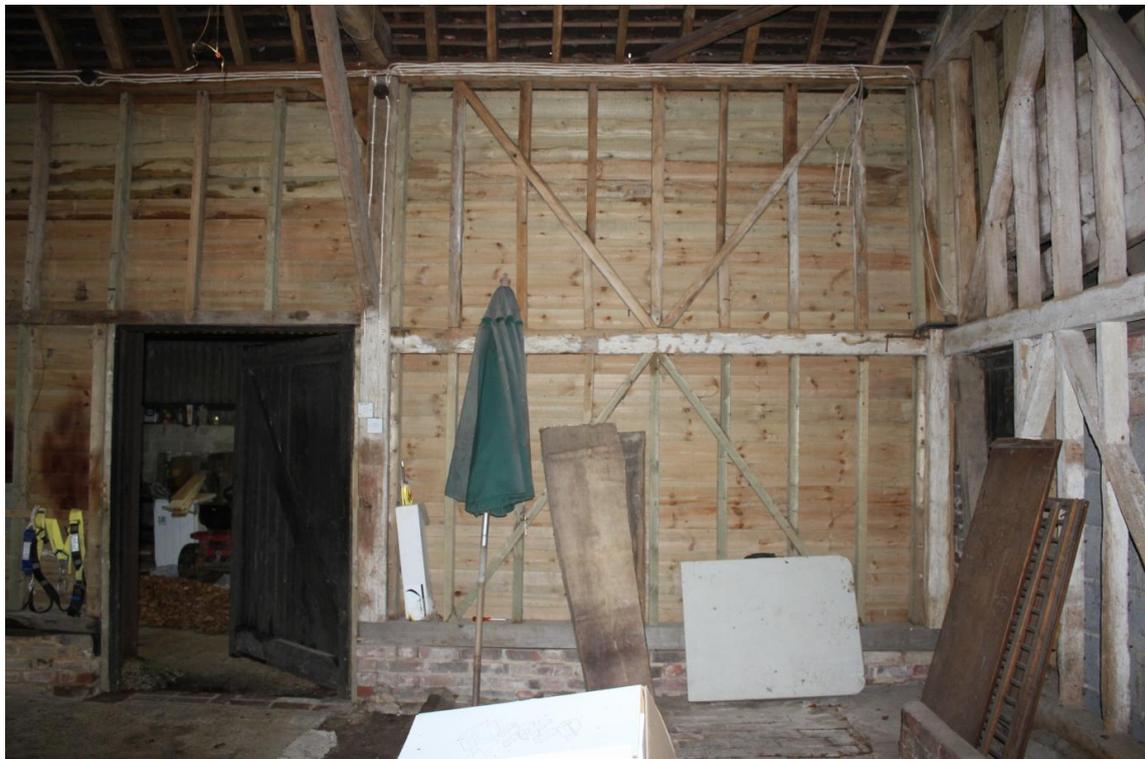
Plate 10 The south elevation with replaced lower studs, struts, sole plate and plinth

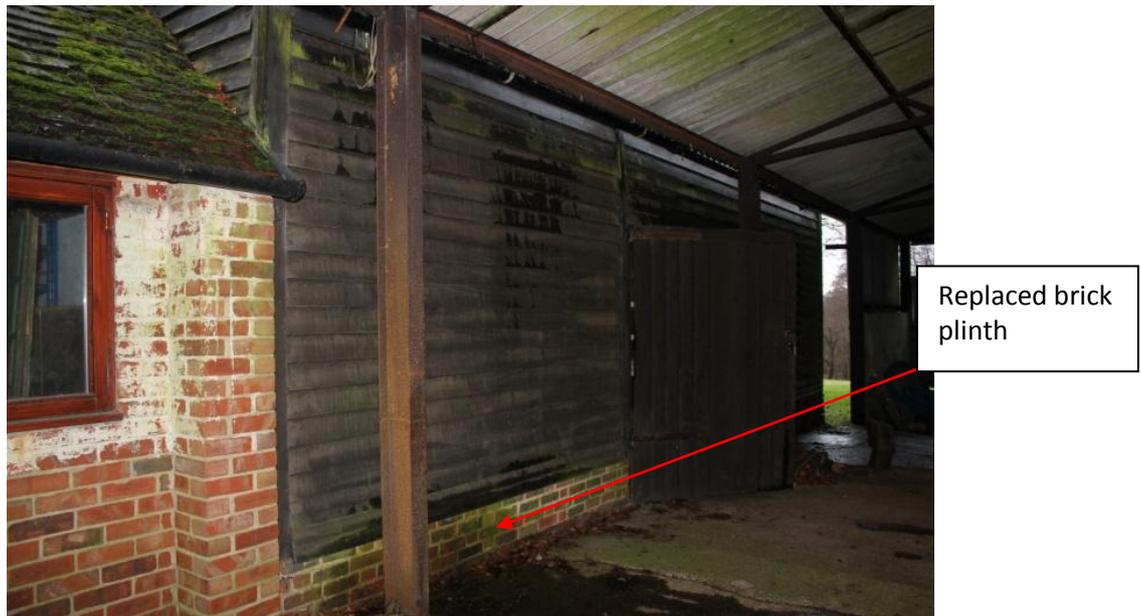
further foundation of bricks offset from the main plinth at right angles. The plinth between truss A and B have been replaced on the south elevation and the door between truss B and C was also infilled at the same time by a new brick built plinth and sole plate.

Plate 11 The exterior of the south elevation with re-built plinth between truss A and B

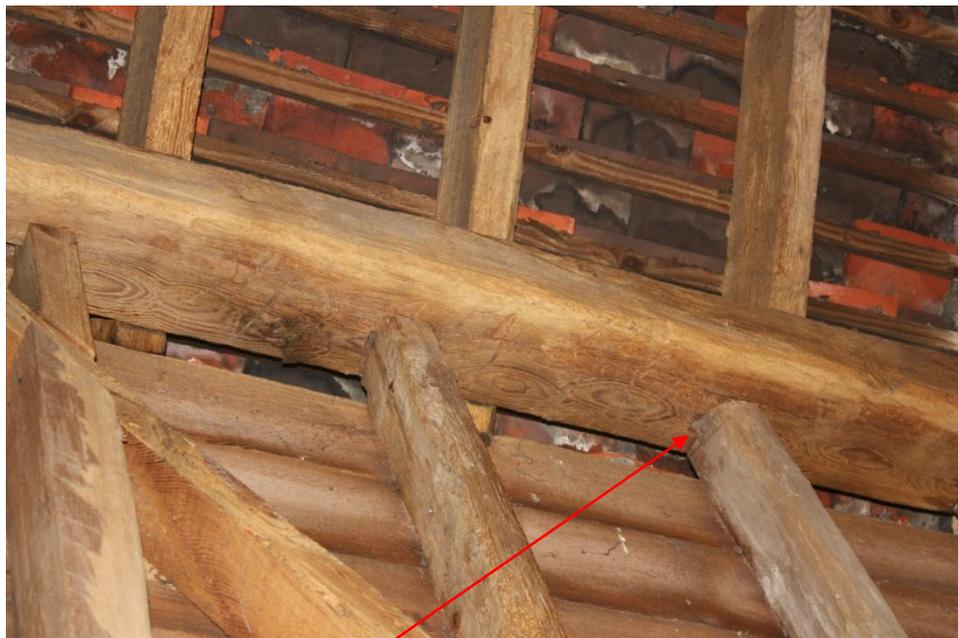
- 4.2.6 The studs are morticed into the side girts and the soffit of the wall plates as well as the sole plates but not pegged.

Plate 12 Morticed studs in soffit between truss C and D

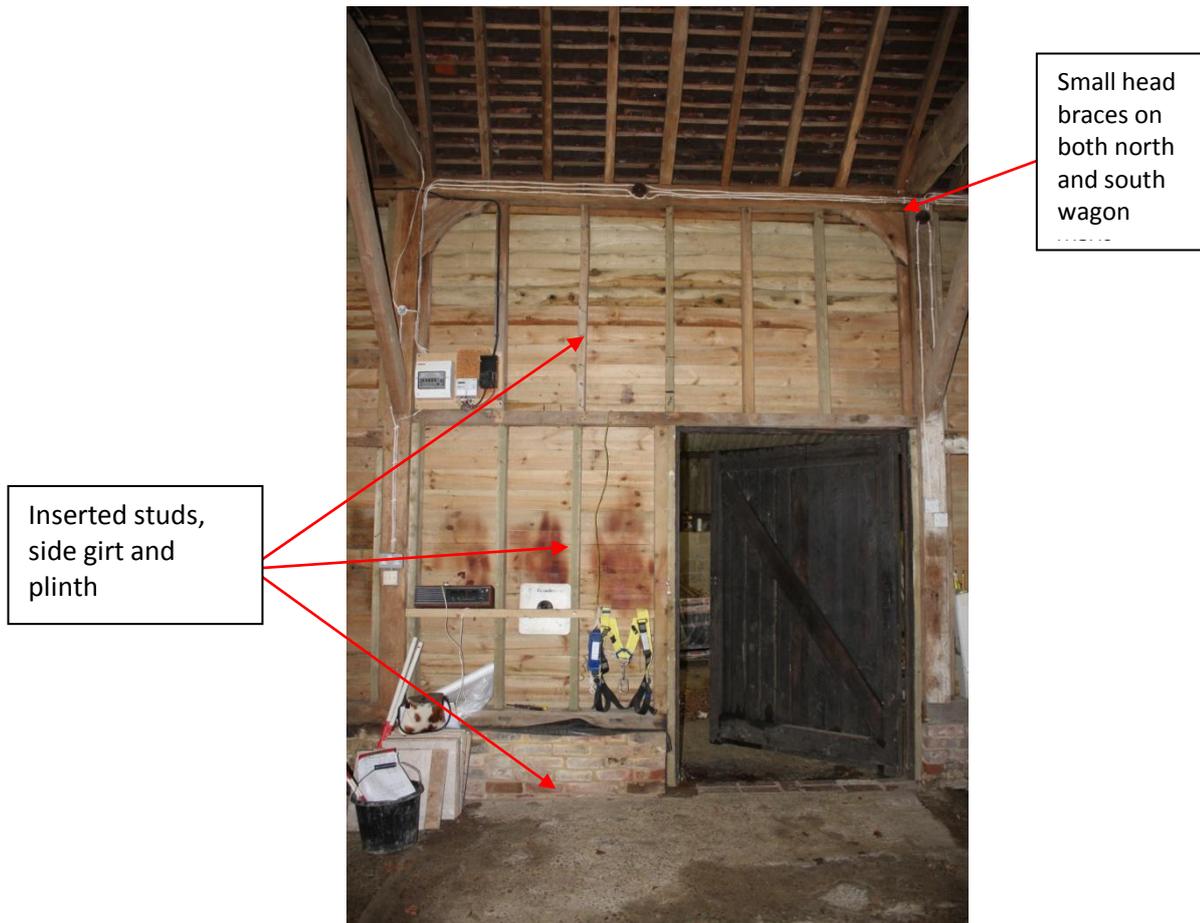
Plate 13 The partially filled in wagon way in the south elevation

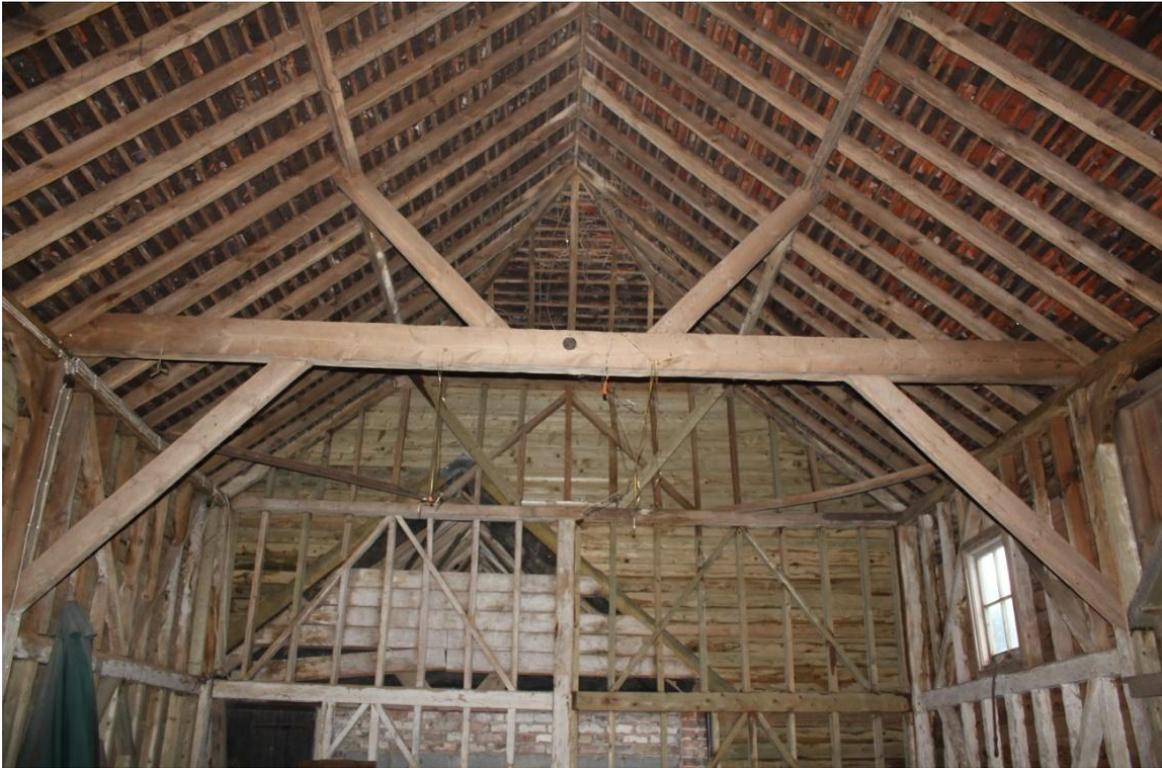
- 4.2.7 The tie beams at open trusses B and C have straight bracing to both sides (plate 14).

Plate 14 The roof looking west

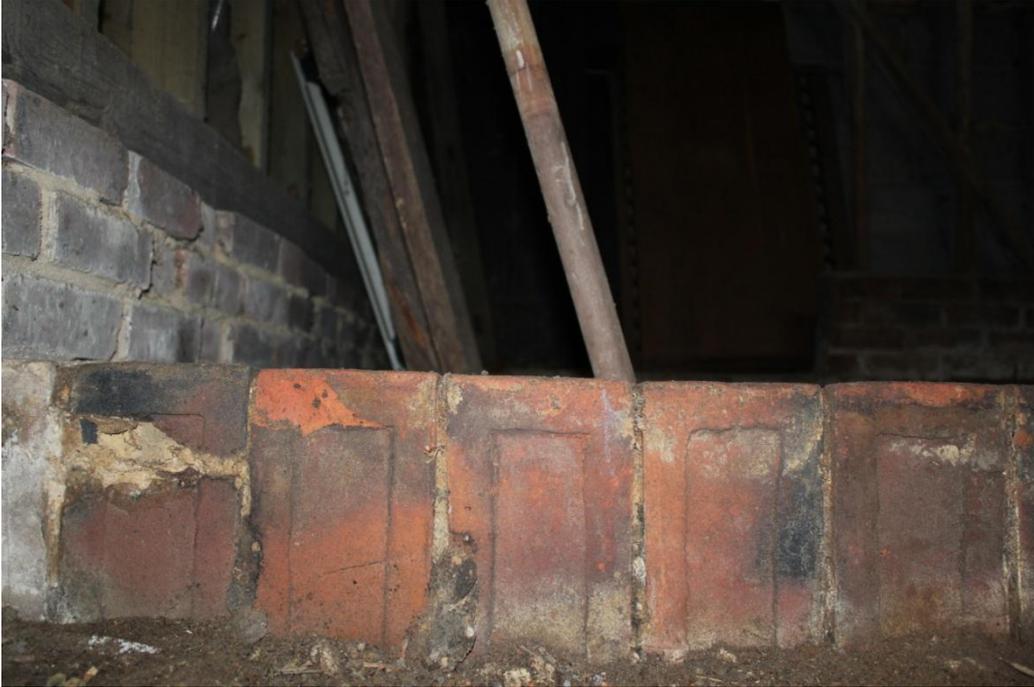
Plate 16 The purpose built brick floor, raised within the at the western bay

- 5.13 The conversion of this building to a modern living space will include the removal of the flooring of the original animal stalls. This area has been photographed and measured for posterity and included in this impact assessment so it is of my opinion that no further action is necessary.

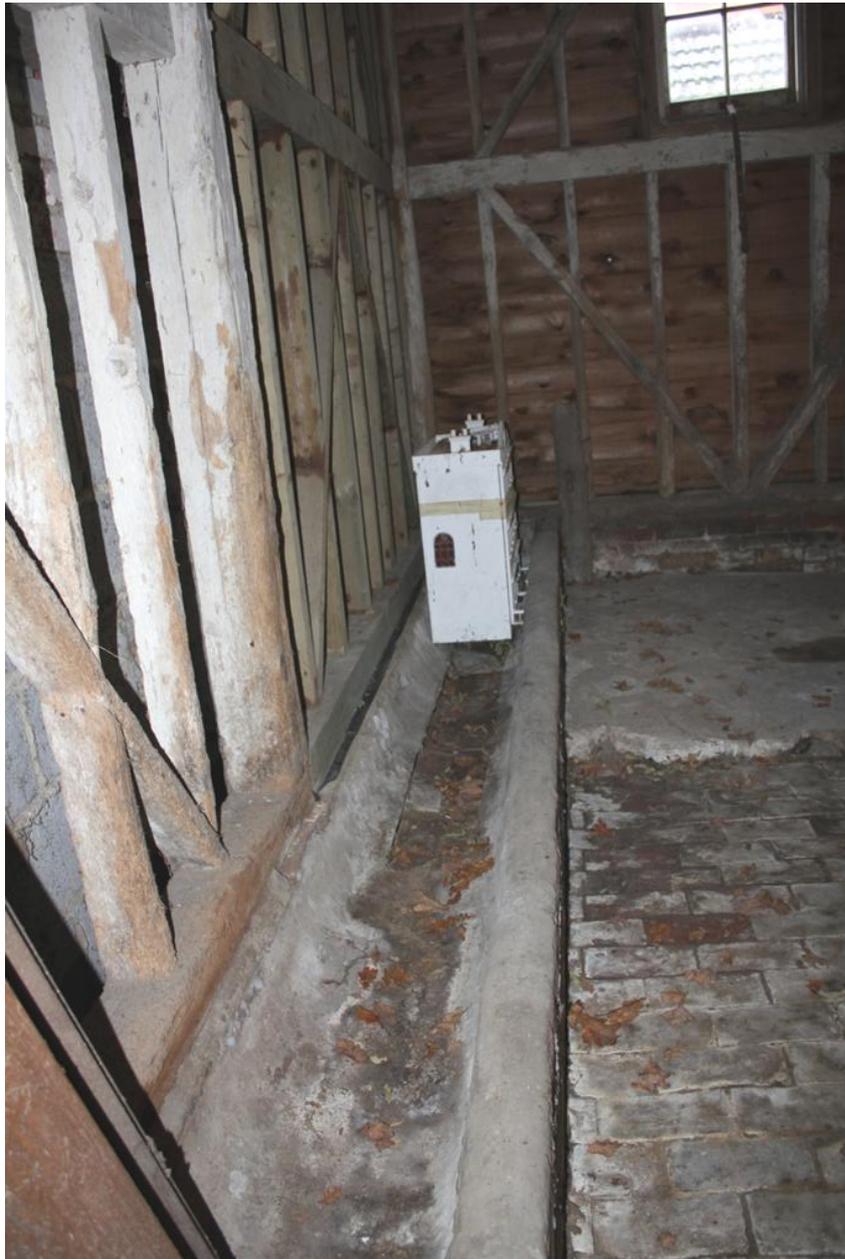
Plate 19 The brick built feeding trough (now capped with cement) looking north

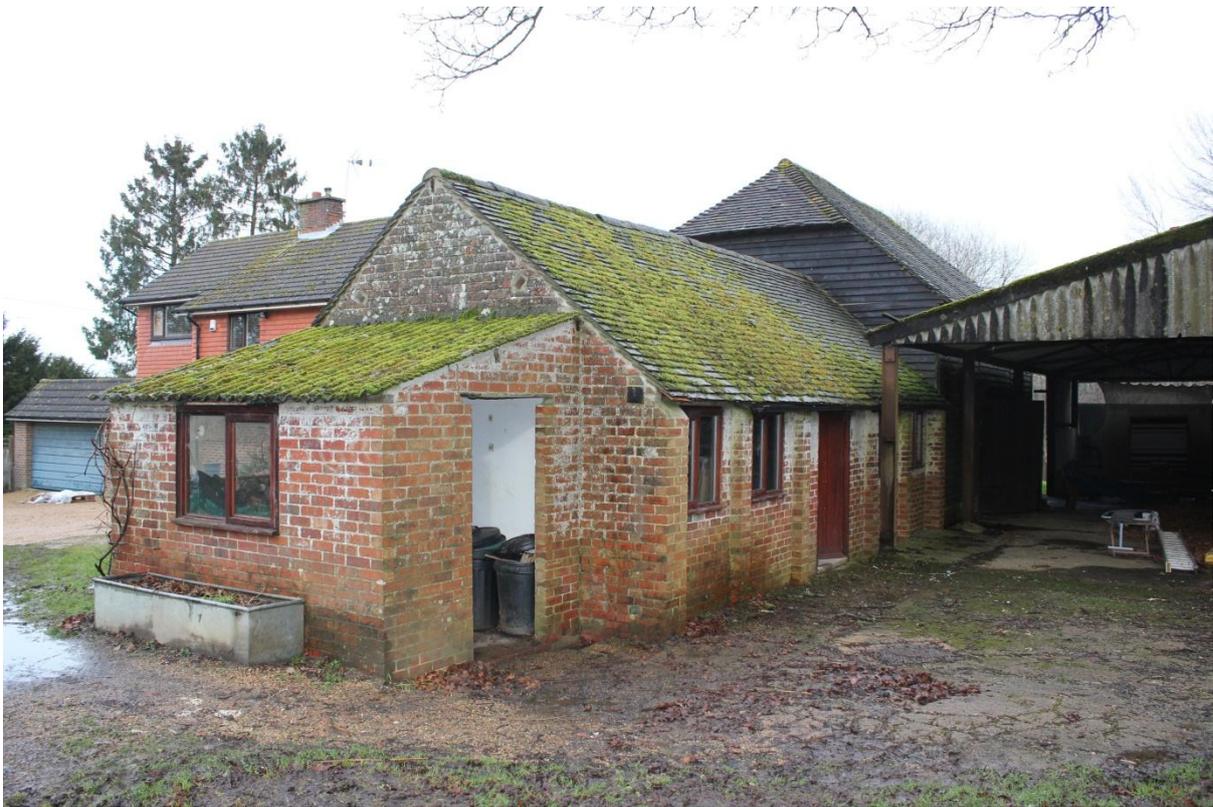
Plate 24 The later brick outshot, likely re-built and re-roofed within the last twenty years or so

- 5.9 The later brick built outshot extension discussed in 2.3 above has not been included in this impact assessment and in my opinion is not viewed as highly significant due to the construction materials and later date of this addition in relation to the age and archaeological significance of the rest of the barn. Therefore, this area is not included below in the mitigation guidance and any additions to this structure should be relatively free from development conditions.

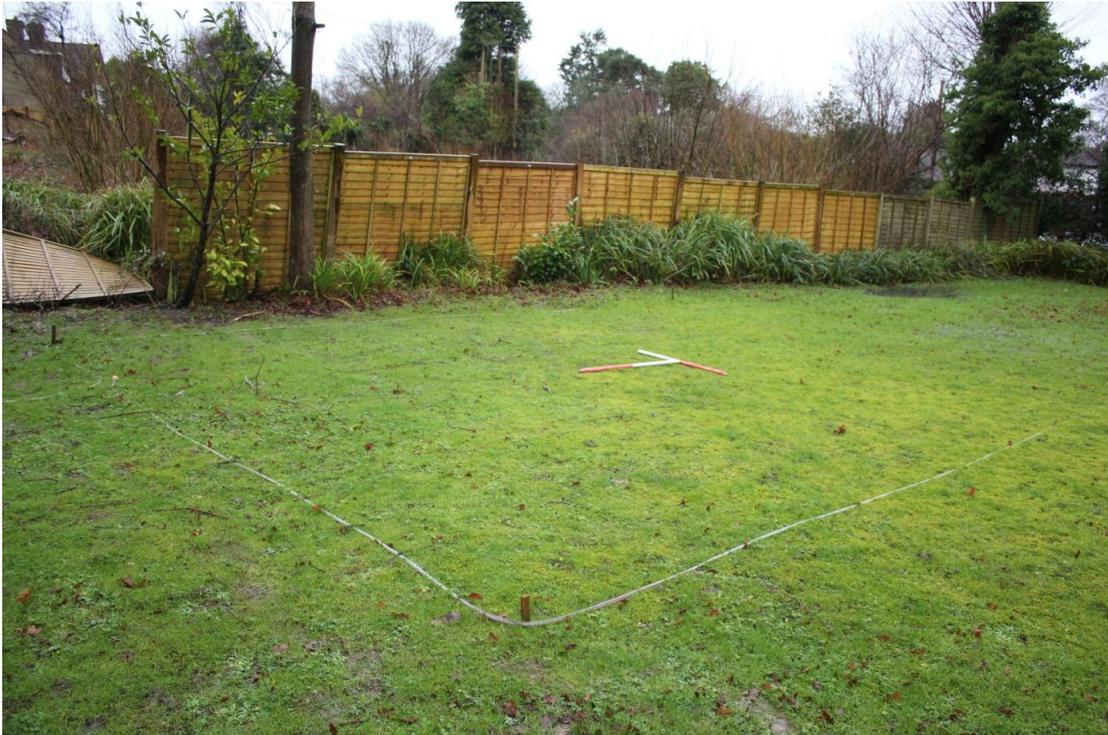
Plate 26 The proposed location of the two-bay garage (scales 1m)

- 5.10 In addition to alterations within the barn, a separate two bay garage is proposed within the grounds. This potentially impacts the site of the farm pond which would have given access to water for the animals housed in the barn when it was in use. As such, this is potentially of archaeological interest and was highlighted on the HER as being of some archaeological value. However, having visited the property to look at the potential impact of this, it became evident that the greater proportion of the pond once existed in the neighbouring property, as evidenced by water-loving plant species still growing in the ground beyond the boundary fence and high levels of water retention in this area. The current owner has informed me that the pond was filled in several years ago (likely to be after 1950) and any likely remains of this will have already been impacted. It is possible that the silted remnants of the base of this pond may be evident with possible artefacts present, but given the 'young' age of the barn and the accompanying range of buildings the proposed construction of a garage would, in my opinion, not impact greatly.
