HISTORIC BUILDING RECORD FOR THE SMALL HOUSE, 40A SUSSEX SQUARE, BRIGHTON.

Archaeology Services, Lewes.

Report number: ASL 134-17

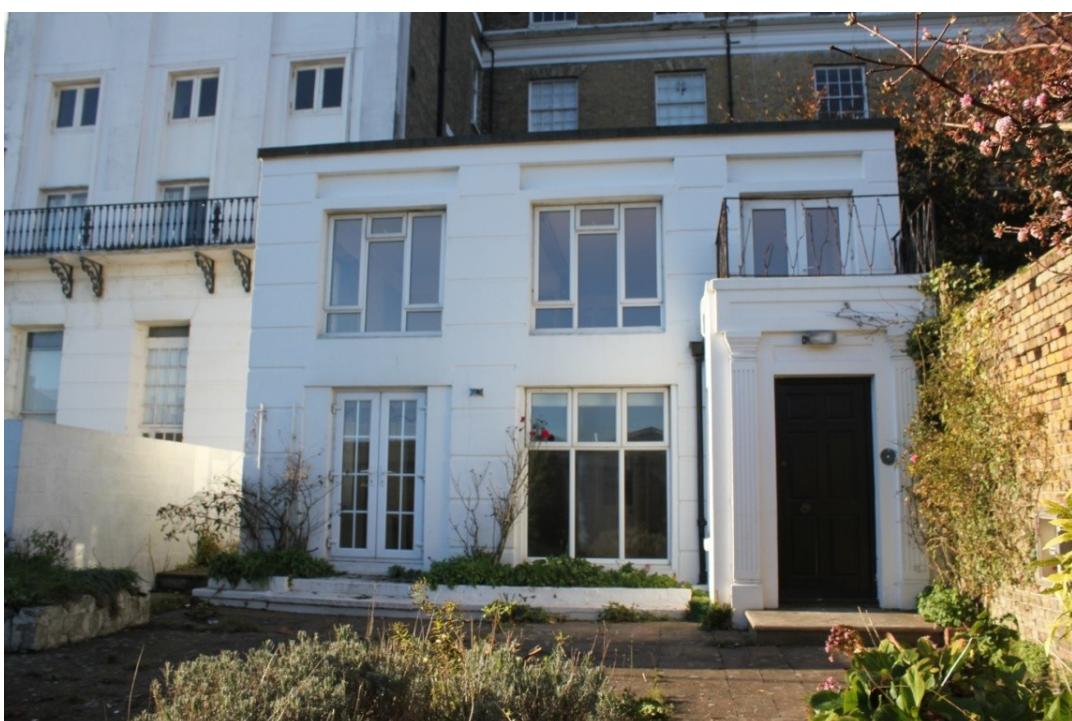
Plate 3. The front elevation of The Small House.

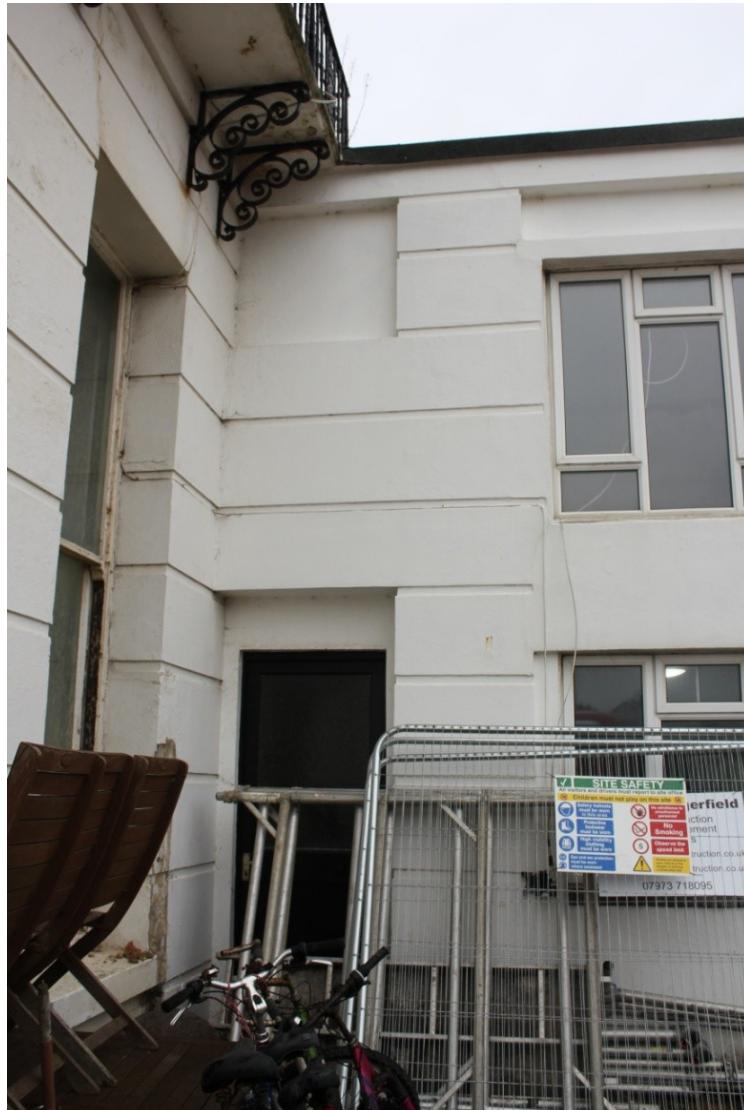
Plate 4. The south elevation of The Small House, attached to 40, Sussex Square.

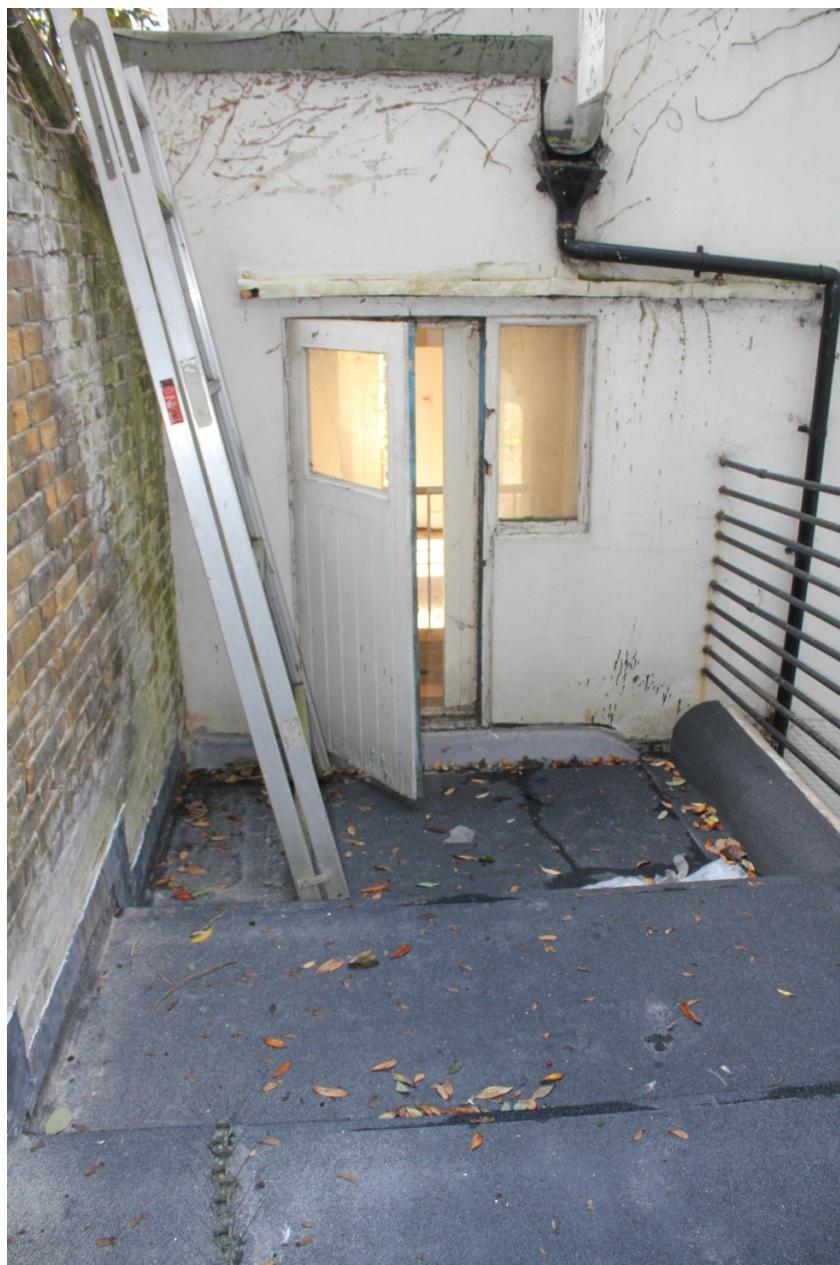
Plate 5. Rear door and steps leading from The Small House up to the rear of 39 Sussex Square.

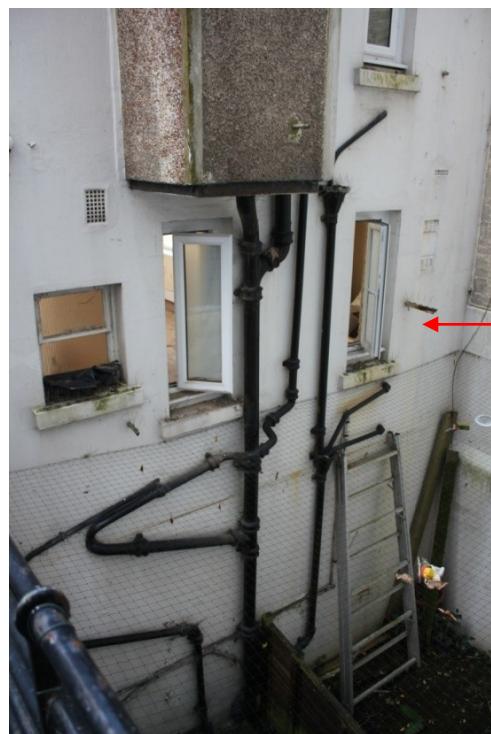
Some of the render has been removed in recent years to reveal badly wedged, clamp-fired bricks which measure, on average, 230 x 107 x 63mm on the west side and 230 x 107 x 67mm on the east. The rear wall is very thick, at 0.38m wide. Presumably this is because it forms a higher retaining wall, with the lower light well for the basement level of number 39 behind it (see Plate 13), and this thickness is noted on Lutyens' drawings (in imperial, at 1'2" thick).

Plate 13. The light well between the rear of number 39 and The Small House, with thicker wall.

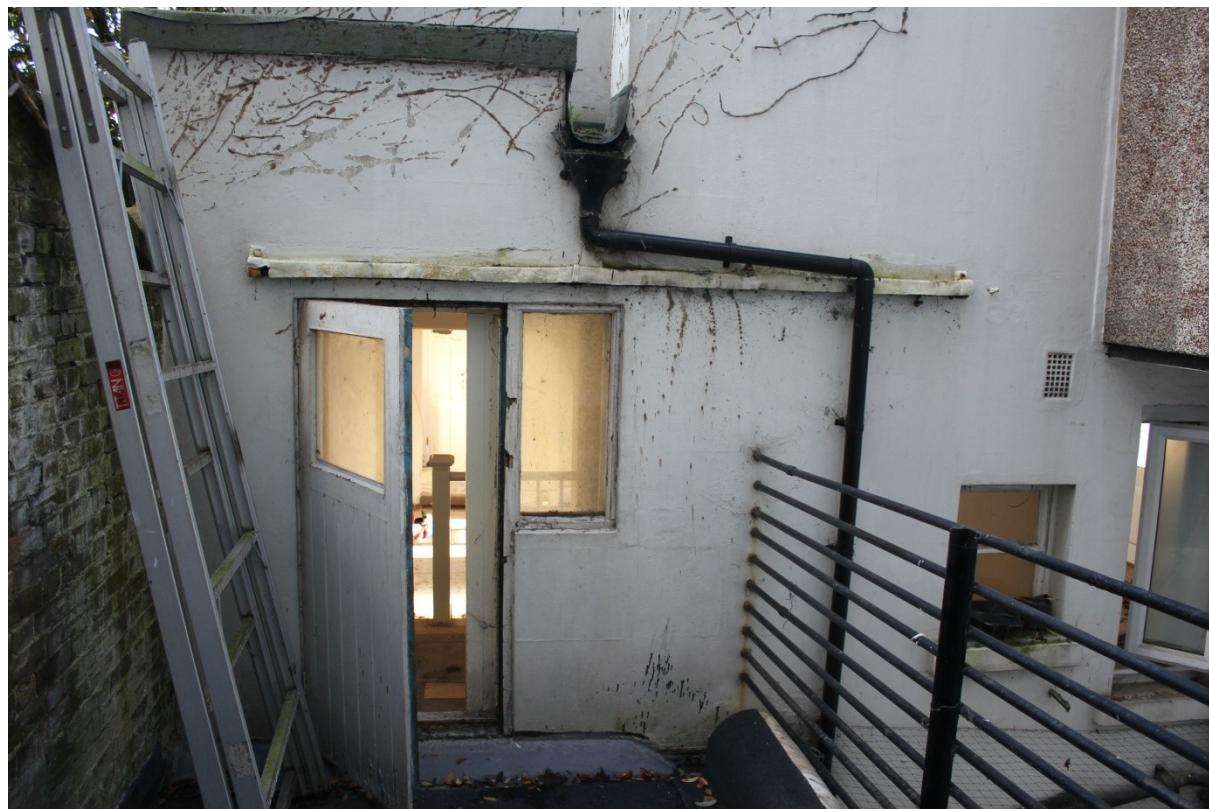
No doorways from this period exist and if the 'window' apertures were open, then doorways would never have been needed, except for the rear doorway. This has since been replaced in **Period B**, but an original, double-width, sliding door runner exists on the external face of the rear wall (see Plate 14).

Plate 14. Runner above former sliding door to the rear.

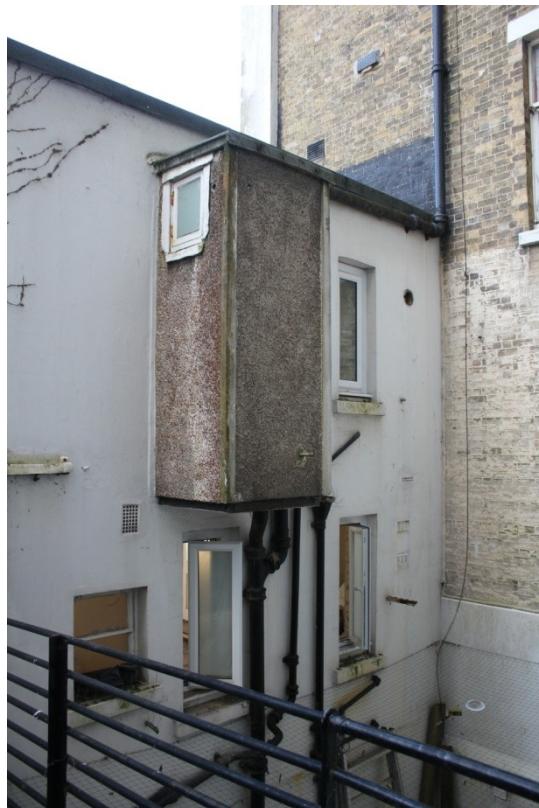
During this period the building was significantly remodelled and converted for use as a dwelling. This included inserting windows, replacing the roof and inserting a first floor. A new kitchen and ground-floor toilet room was added, facilitated by blockwork walls. A newspaper dating to 1931 was found amongst the inserted plumbing pipes in the kitchen area and a new ventilation aperture was punched through the rear wall to create a larder cupboard (see Plate 16). Upstairs, a new bathroom and cantilevered toilet room were added (see Plate 17).

Plate 17. First-floor cantilevered toilet.

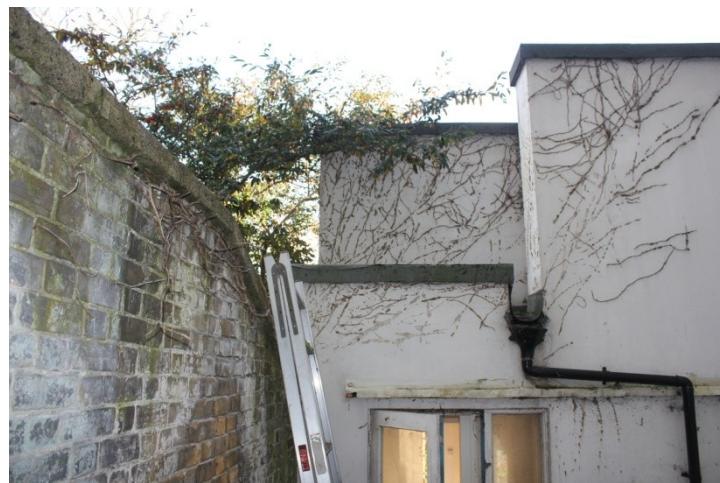
has a small section of parapet added above the rise in height (see Plate 19). It was during this period that the external walls were probably stuccoed.

Plate 19. Small section of parapet added to the rear.

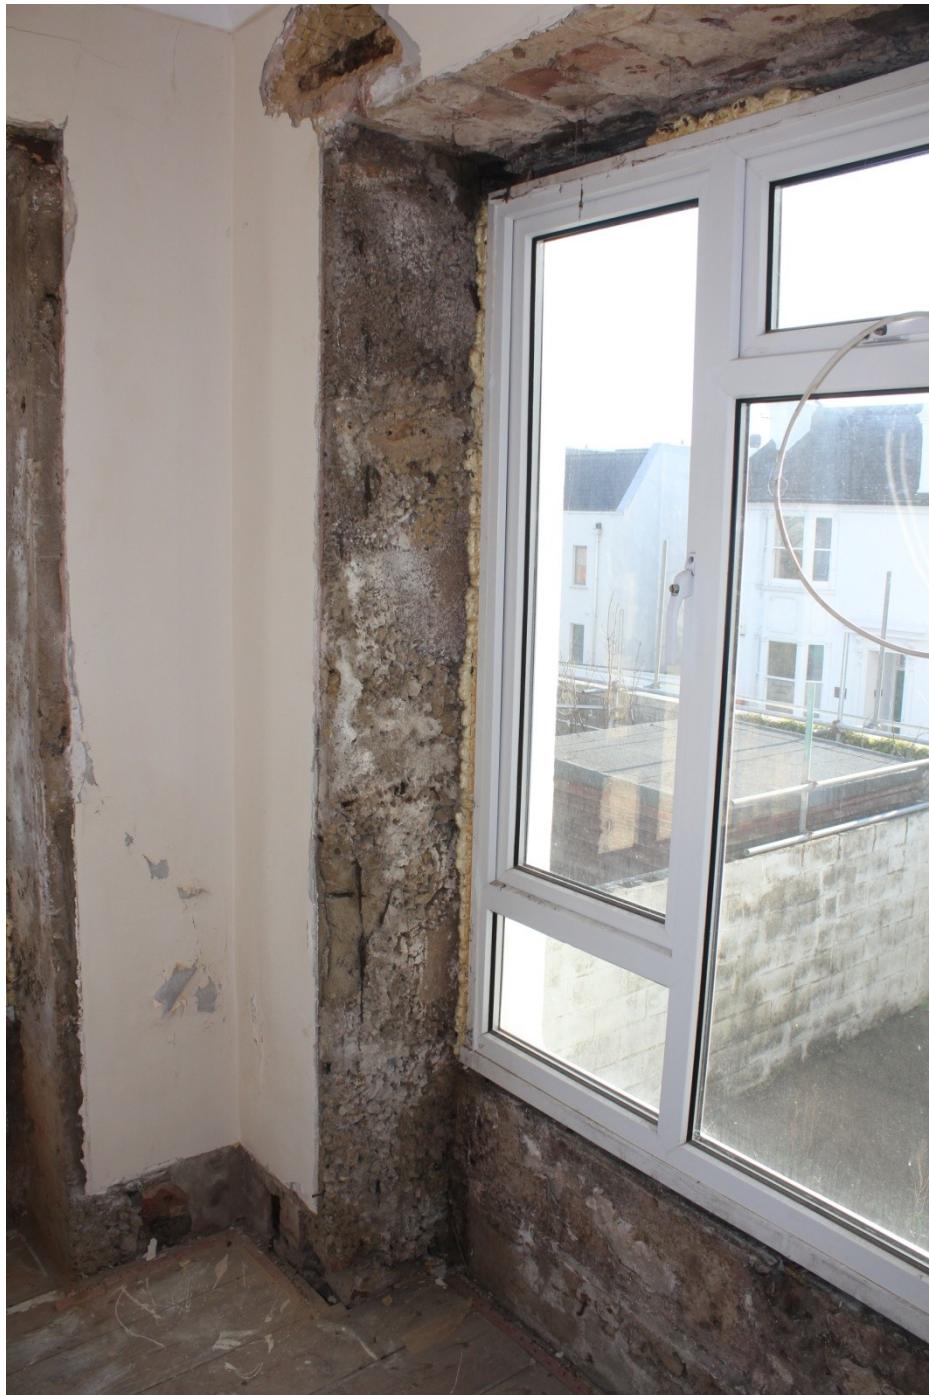
Windows were first inserted into the open apertures in the front elevation during this period but have since been replaced. Two new apertures were created at first-floor level in the north wall which have surviving *Crittall* windows *in situ*, with another, opaque, version in the west wall of the ground-floor toilet. The former open apertures between the columns in the front elevation were strengthened with concrete shuttering (see Plate 20). New lintels were also inserted to divide the tall apertures, consisting of a mixture of concrete, brick and

Plate 20. Lintels and concrete shuttering reducing the former open apertures.

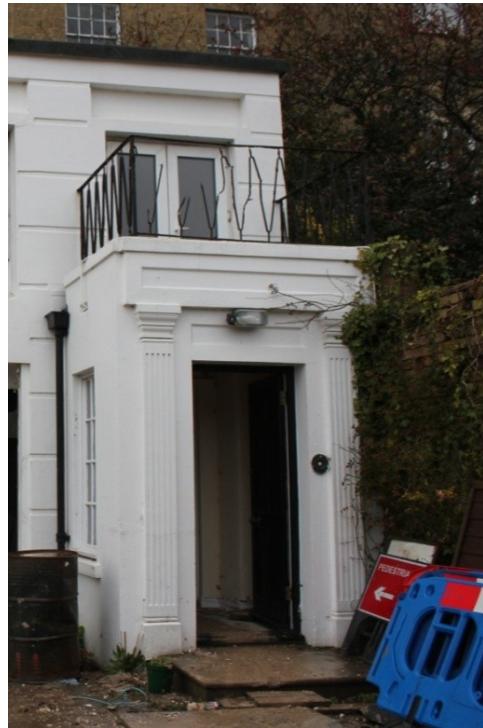
A new front entrance porch with doorway was added on the north side of the front elevation, with a balcony over (see Plate 21). Additionally, the south-west door into number 40 was blocked off and a new door and window was inserted into the rear doorway.

Plate 21. New porch and balcony added.

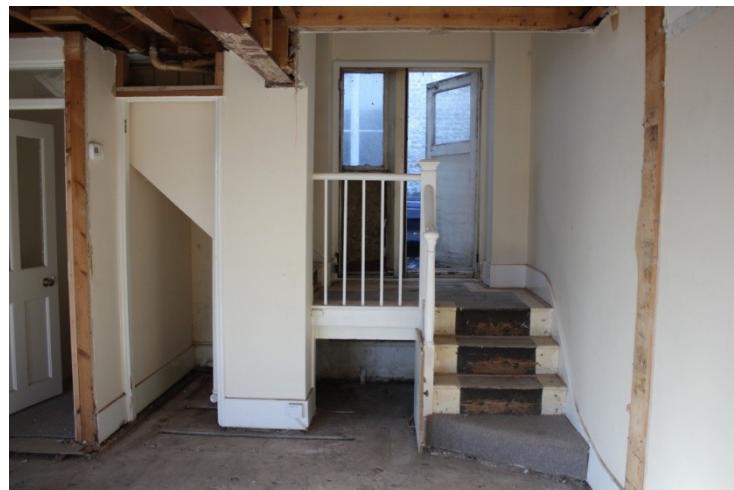
The inserted stairs from this period include a small section of reused posts and banister rails which appear to date from the early 19th century (see Plate 22).

Plate 22. New stairs within The Small House.

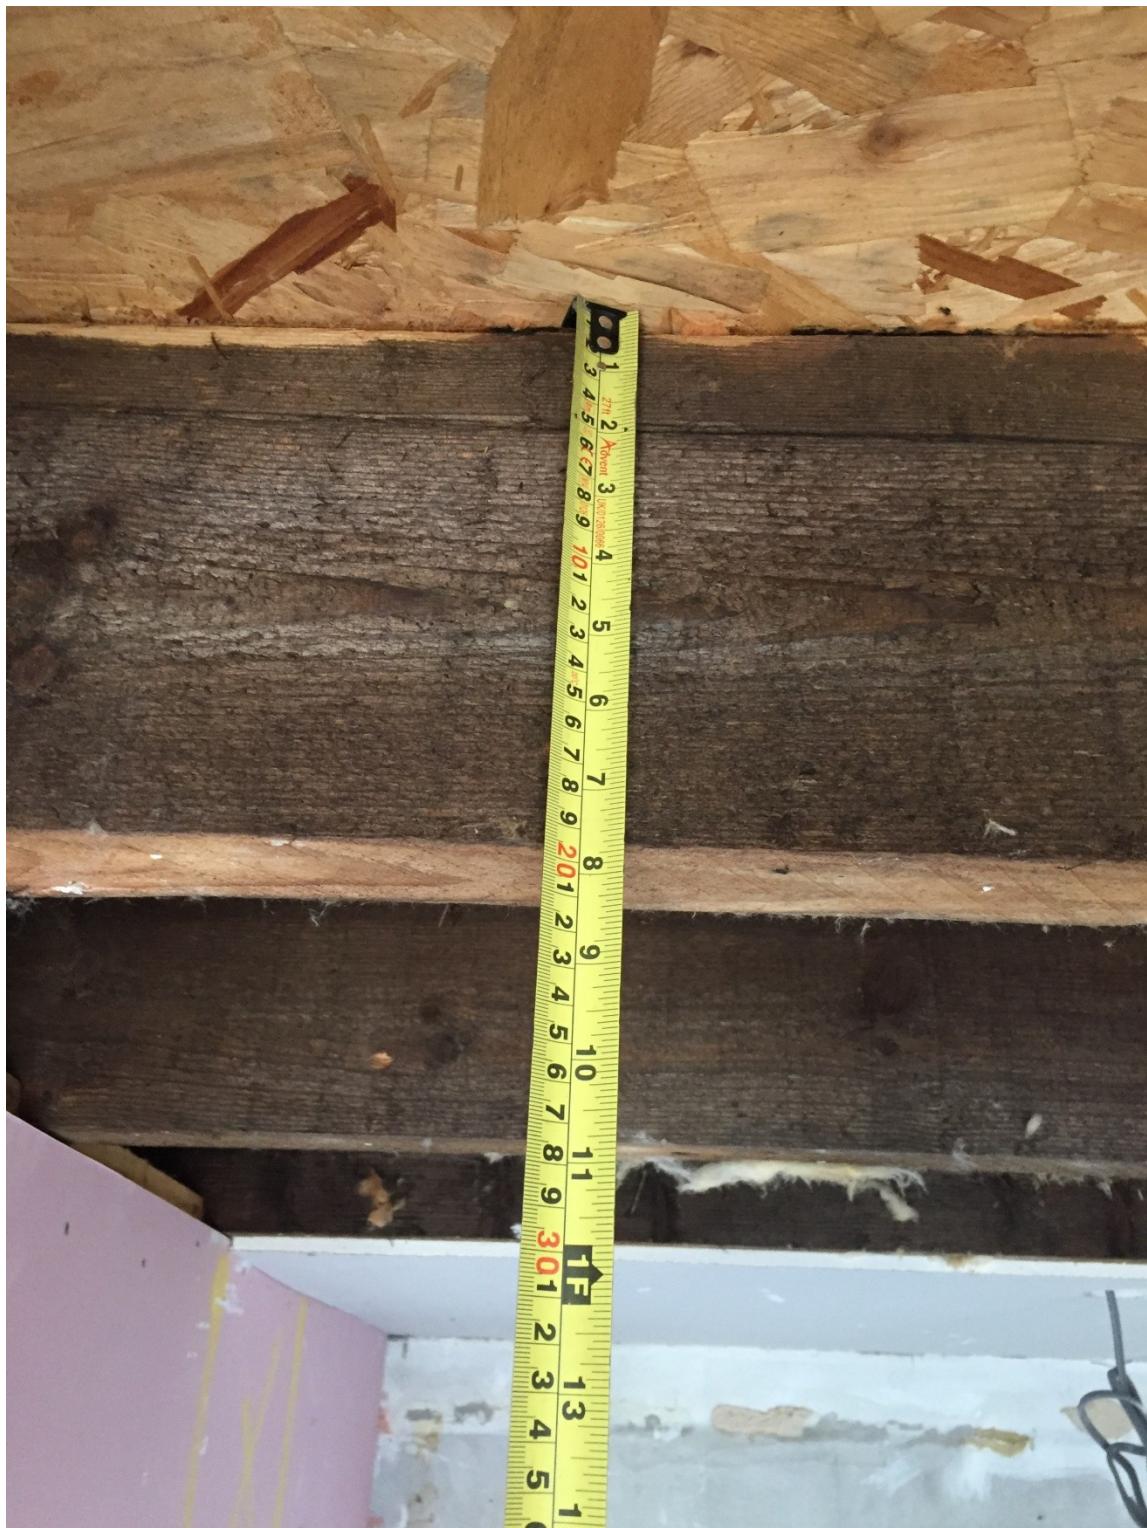
External access was not possible, but it is assumed that the roof has been covered with roofing felt externally. During development the underside of the roof was partly exposed and did not reveal any surviving evidence for the **Period A** roof. The roof is constructed from OSB (oriented strand board) above 190mm-deep softwood joists (see Plate 23).

Plate 23. The exposed first-floor ceiling / underside of the flat roof.

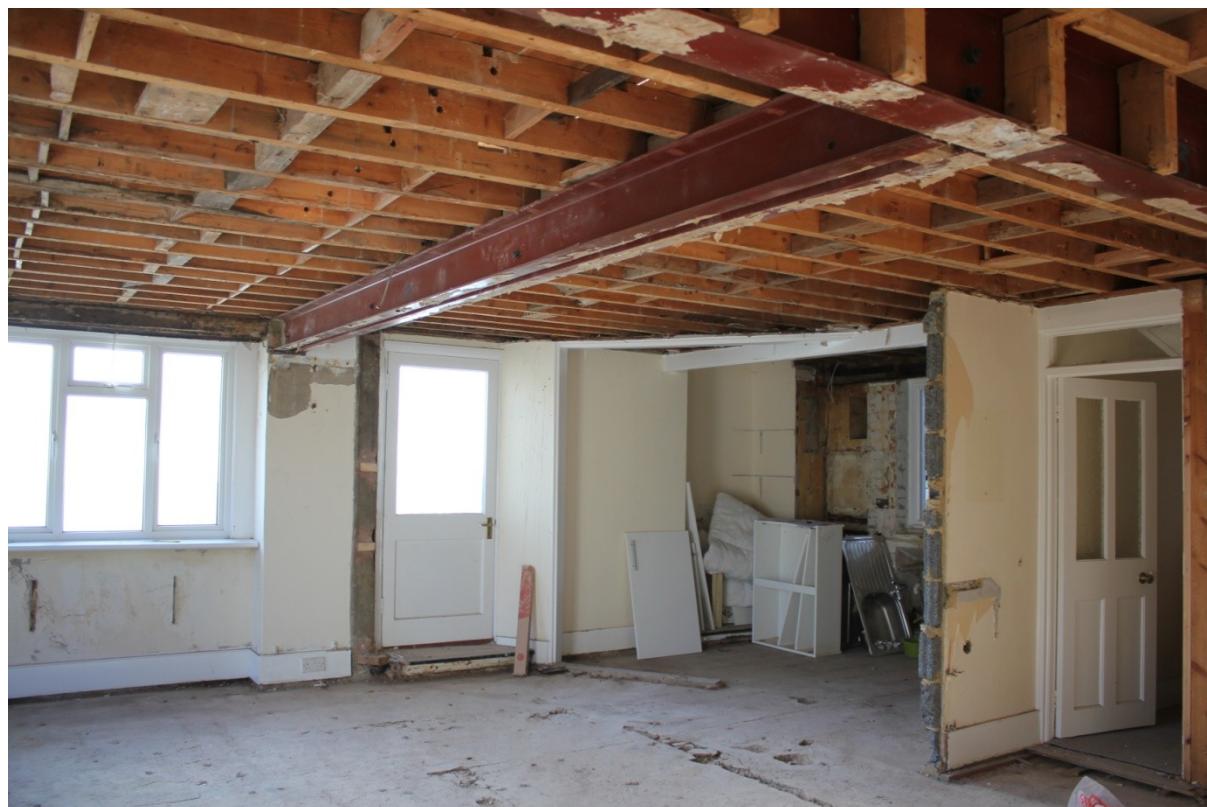
- 6.1 Small changes were made to the building during the late 20th century. These include the removal of some of the **Period B** windows and their replacement with UPVC, double-glazed units (dated 1991) in the front and south elevations. Prior to insertion, the apertures were reinforced, as discussed above. Windows in the west elevation were also replaced in the kitchen, toilet and bathroom areas.
- 6.2 A new doorway was inserted more centrally in the south elevation for access into the garden.
- 6.3 Two new steel girders were inserted within the ceiling, below the joists, for added strength (see Plate 24).

Plate 24. New steel girders in ceiling.

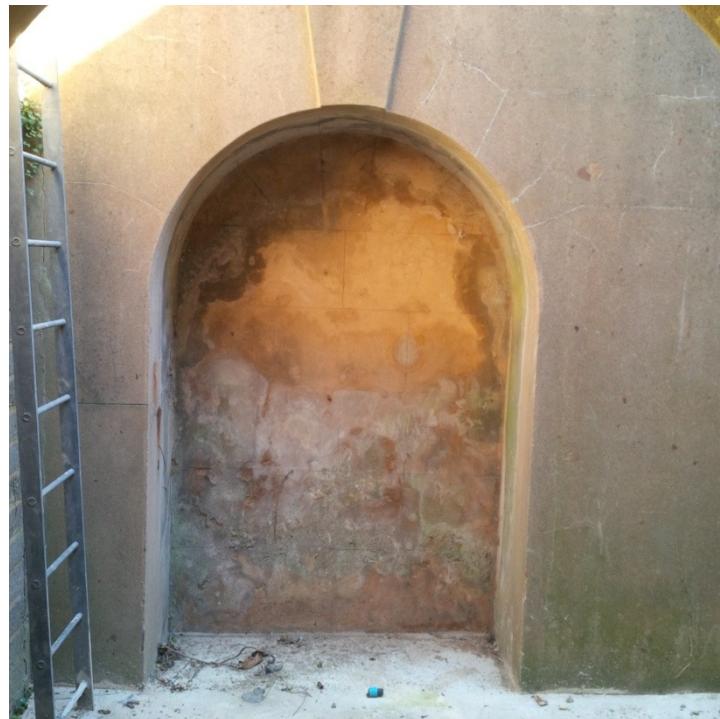
- 7.1 The vaulted basement area (see Fig. 17) was also designed by Edward Lutyens. The blueprint plans (see Fig. 18) show the designs, but it appears that they were never completely built or that part of the design has been replaced by the construction of a modern electricity substation and later concrete steps. It is unlikely that this can be resolved.
- 7.2 The basement was originally designed to lead from the rear of 40 Sussex Square, proceeding underground in an easterly direction before exiting into a light well. This light well faced a tunnel which is believed to extend under the road to the rear of numbers 39–40 (see Fig. 13), entered through an arch which is still visible (see Plate 25).

Plate 25. The blocked-up entrance to a tunnel which may extend under Bristol Gardens to the east.

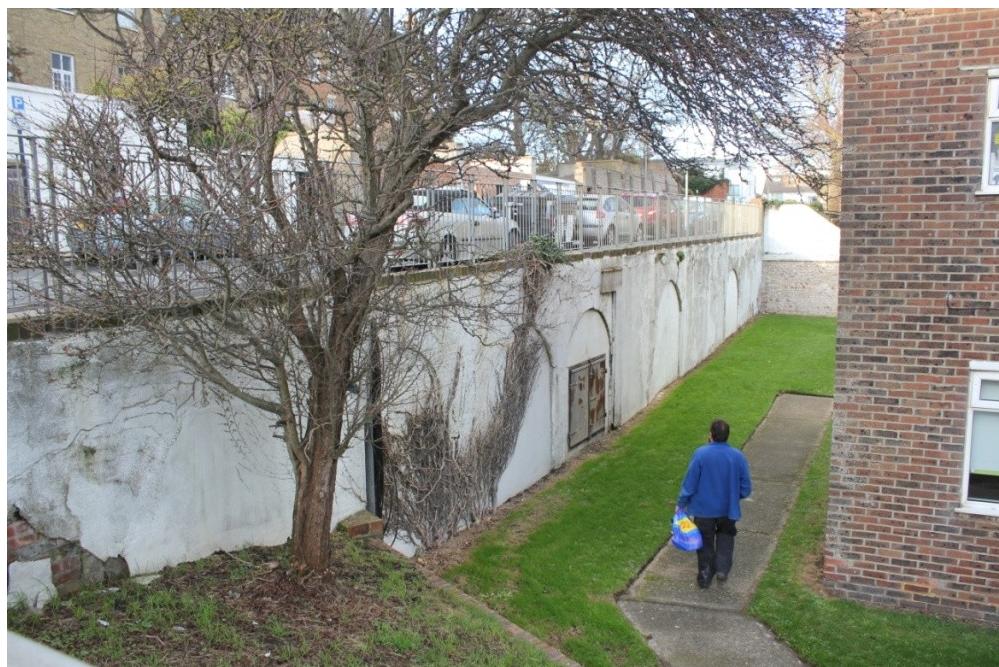
However, there is some doubt regarding the tunnel. Lutyens' designs included a grand plan for a sunken garden in Bristol Gardens, beyond the tunnel. It would appear that this was never built, although it is difficult to say for certain, as the site has since been redeveloped and a modern block of flats now occupies the space. To make interpretation more difficult, the tunnel has been bricked up on both sides. However, beyond Bristol Gardens the tunnel appears partly open where a modern electricity sub-station is situated. There are four further blocked arches here which do not appear to have any depth and may have been built purely for show (see Fig. 14).

Plate 26. The central tunnel beyond Bristol Gardens. The other arches appear to be false.

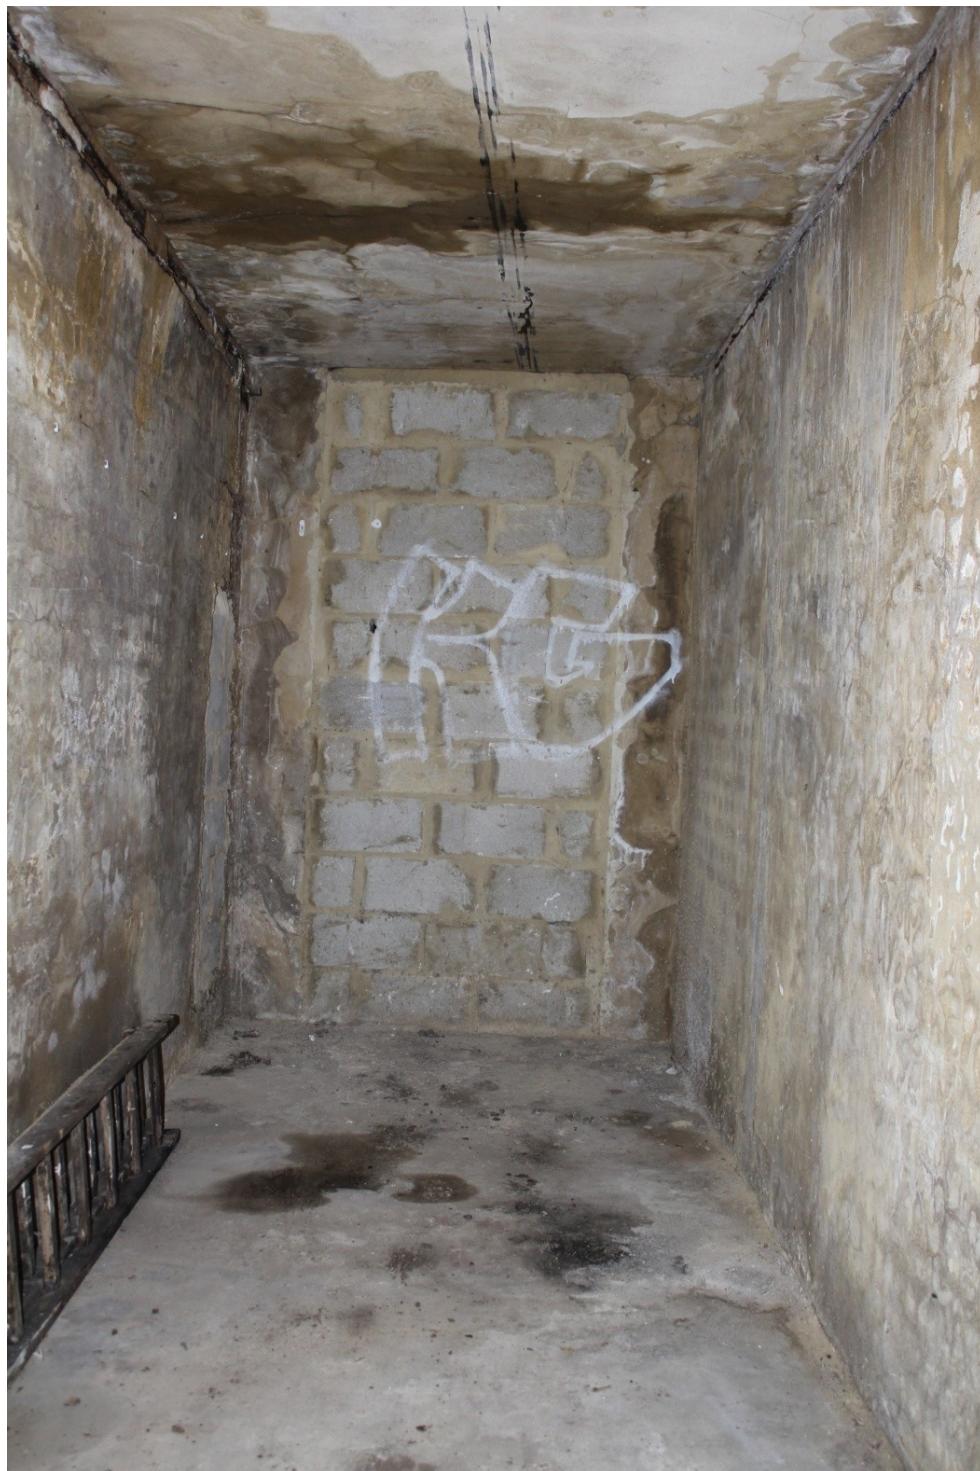
- 7.3 In plan, the basement consists of a central east–west corridor leading to two side rooms and a light well beyond. The west side of the corridor begins in the basement of number 40, although the entrance from the house into the basement is now blocked (see Plate 27). Access to the side rooms is through open arches on either side of the corridor. The floors are concrete, and the roof consists of a solid slab of concrete, known as a ‘top hat’, which is reinforced with steel ‘H’ beams. The roof is as drawn on the structural engineer’s plan of 1920 (see Fig. 18), although the window drawn in the north room never existed and nor did the bowed wall in the south room.

Plate 27. The west side of the corridor with in-filled doorway into 40 Sussex Square.

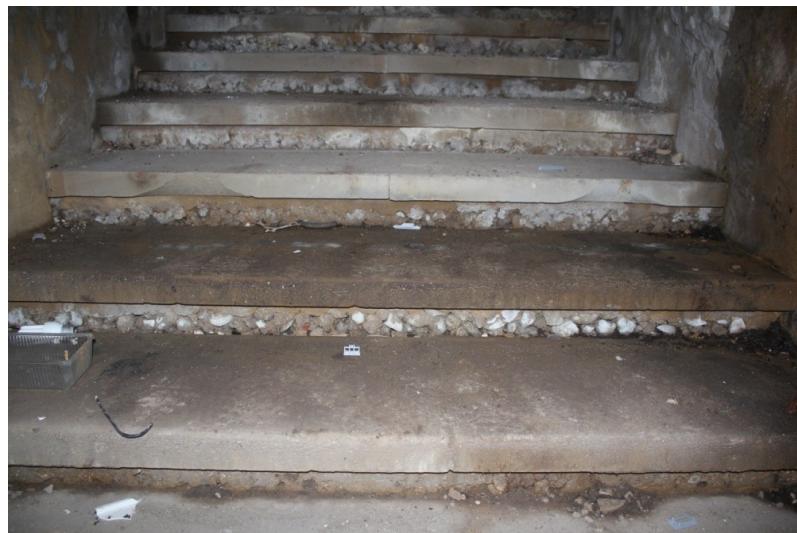
- 7.4 The corridor is constructed entirely from brick, which varies in places. At the far western end the brickwork is mainly rendered, but where it is exposed the bricks are clamp-fired and bonded with sandy mortar. Towards the middle of the corridor the floor steps down in height by seven steps. The brickwork here is fully exposed and laid in Flemish bond, with a light-coloured, sandy mortar. The steps are stone, with concrete and water-worn pebble/hardcore layers beneath (see Plate 28).

Plate 28. The steps in the middle of the basement corridor.

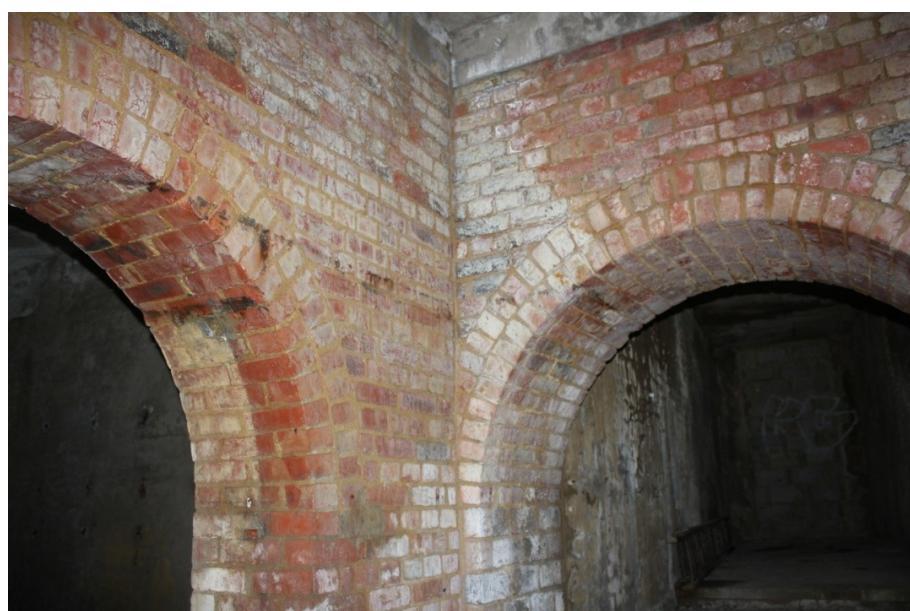
There is an arch above the steps (see Plate 29), where the ceiling also reduces in height, constructed with clamp-fired bricks, mixed with some which are fairfaced (with flush, smooth surfaces). Electricity cables run the length of the corridor: two runs on the south side with two light switches and a single return cable on the north side. The archway at the eastern end of the corridor is rendered brickwork, which had been partly infilled with modern, fairfaced brick (see Plate 30). This had been removed by the time the next monitoring visit was made, which enabled the blocked tunnel arch to be clearly recorded (as seen in Plate 25).

Plate 29. The arch above the steps on the right and the arch into the southern room on the left.

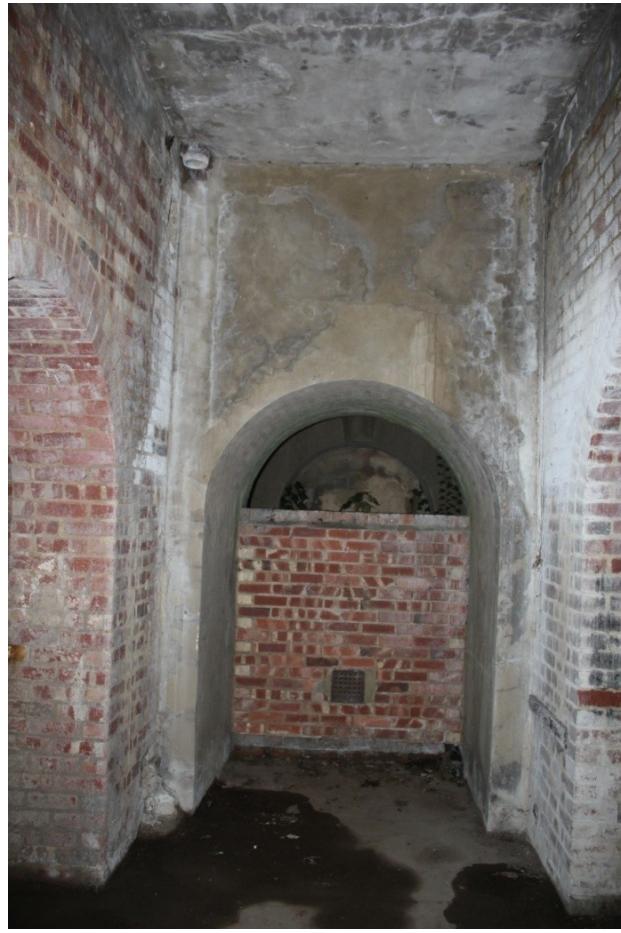
Plate 30. The partly blocked east end of the corridor with the light well beyond.

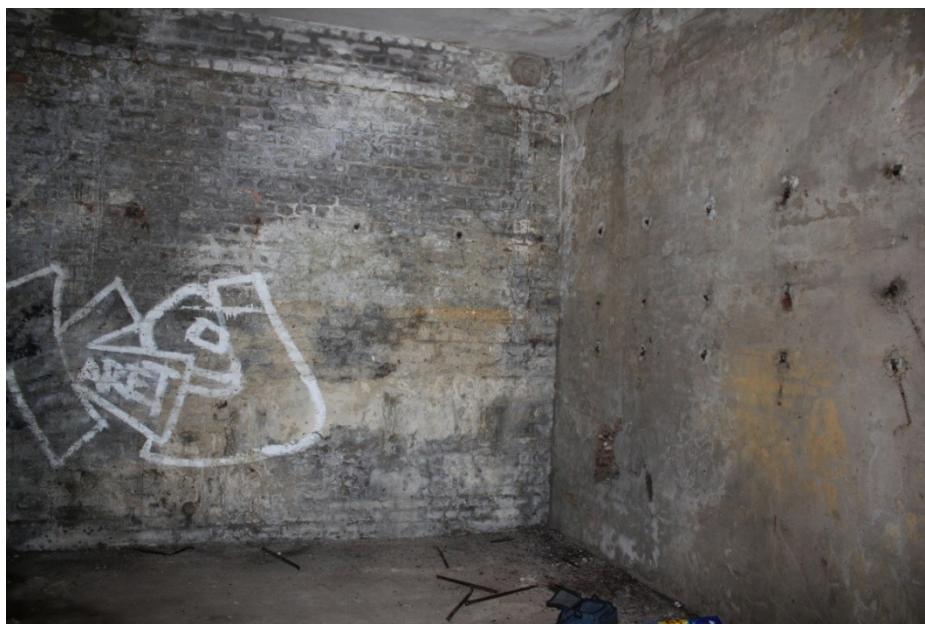
- 7.5 The southern room off the corridor is constructed with a variety of brickwork, with clamp-fired bricks on the south wall (where exposed), bonded with yellow, sandy mortar. In general, most of this wall is painted (*see Plate 31*).

Plate 31. The south-west corner of the southern room, with rendered west wall and corroded pins.

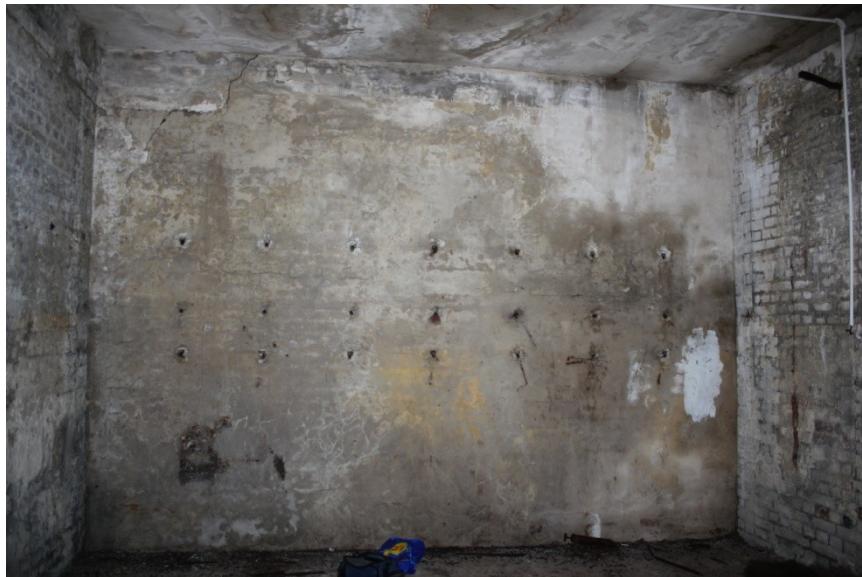
The west wall of the southern room is also rendered, but some patched repairs show it is constructed with clamp-fired bricks. Around the walls of the room, particularly in the west wall, are what are presumed to have been iron shelf brackets with hand-forged 'eyes' (see Plate 32) at the terminals. Most of these have corroded and broken off at the wall surface.

Plate 32. The west wall of the southern room.

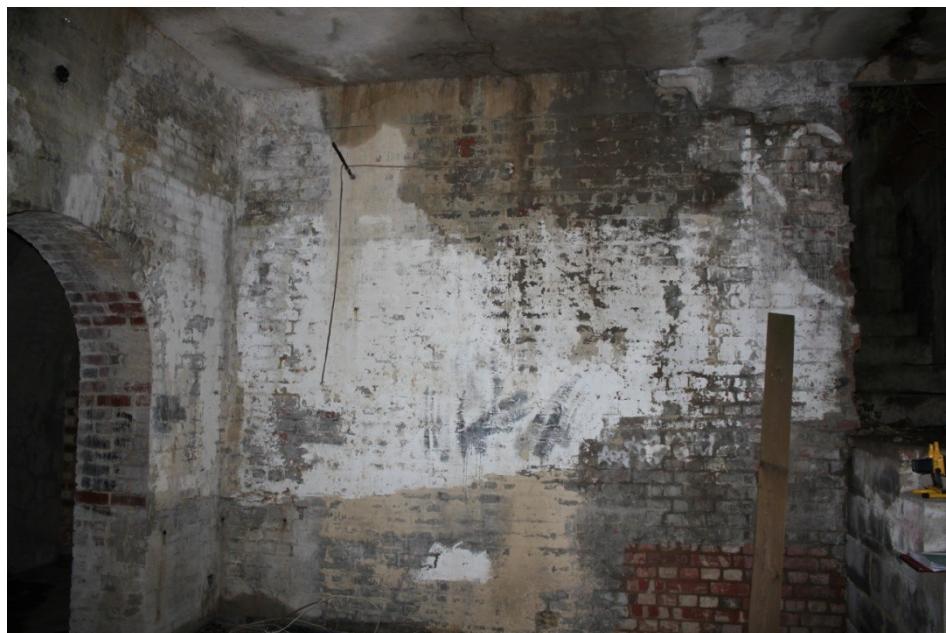
The bricks on the east wall are fairfaced where exposed (see Plate 33). This wall is mainly rendered but has been subjected to modern interventions where a pedestrian access in the south-east corner of the room has been knocked through to give access into the basement from the garden. Concrete steps were added externally. The original sketches for this wall show a significant bow, with an alcove on the external face. There is no evidence for a completely bowed wall, but a shallow alcove does exist externally and can be seen when looking down into the light well outside the room (see Plate 34).

Plate 33. The east wall of the southern room.

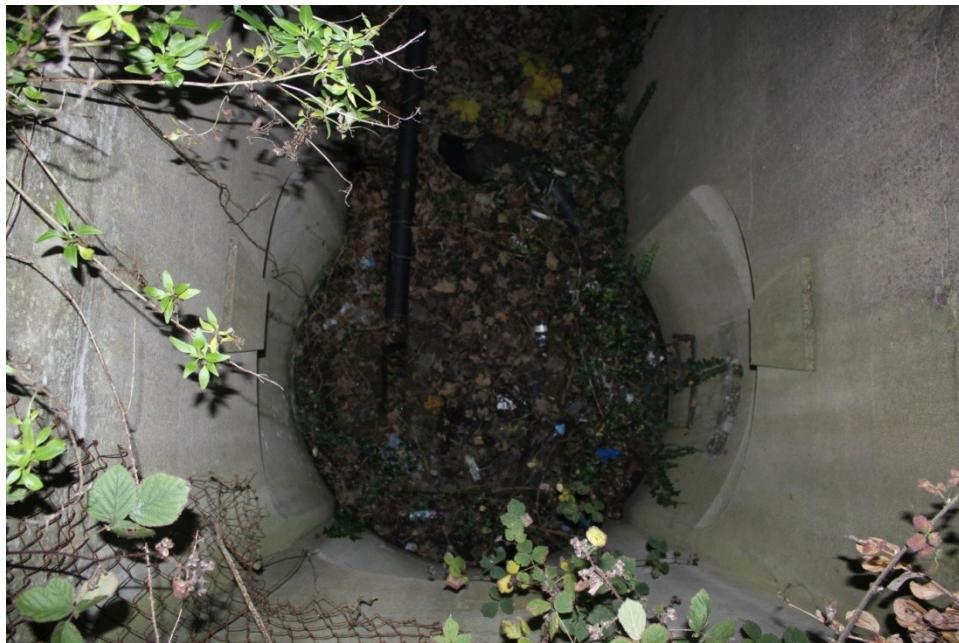
Plate 34. The alcoves in the basement light well beyond the east wall of the southern room on the left.

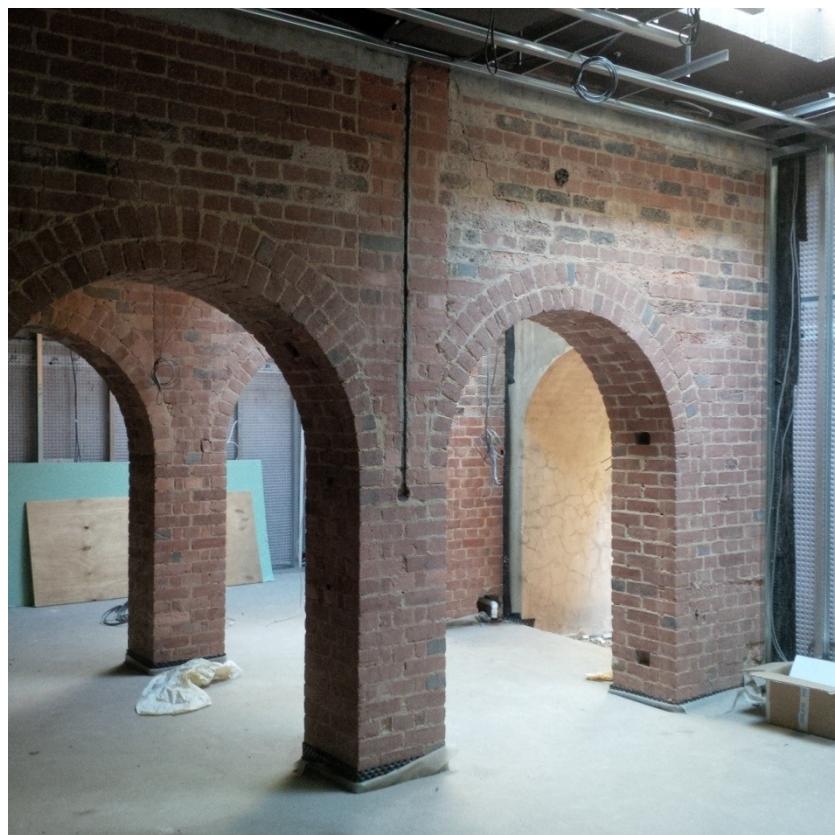
There are two arches in the north wall giving access into the corridor. This wall is a mixture of fairfaced brick and clamp-fired brick, with butt joints suggesting that the arches are a later addition (see Plate 35). This is reflected in the engineer's blueprint (see Fig. 18), which indicates three, open, brick piers in this location, rather than walls.

Plate 35. The arches in the north wall of the southern room after cleaning.

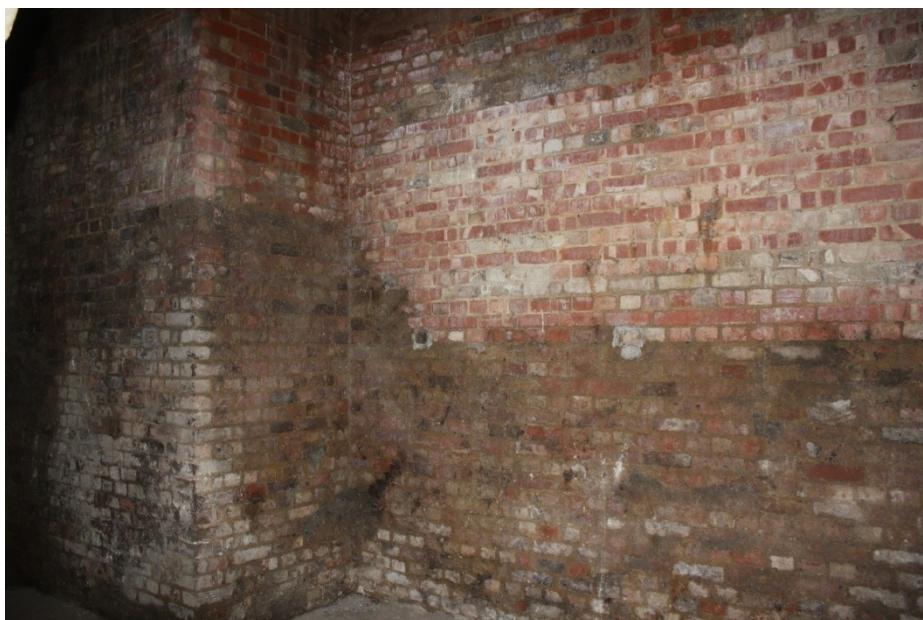
- 7.6 The north room varies in plan, with a dog-leg in the north wall. It is apparent here that there are two phases, with two types of brick used. The lower half of the wall is constructed with clamp-fired bricks which appear to form wide steps, rising in height towards the west side of the room. This is of interest, as they would appear to reflect a series of steps as drawn by Lutyens in his original sketch. This could be tantalising evidence that some of the original designs were carried out and have since been built up. The bricks above the 'steps' are fairfaced (see Plate 36).

Plate 36. The north wall of the basement's north room with different brickwork evident.

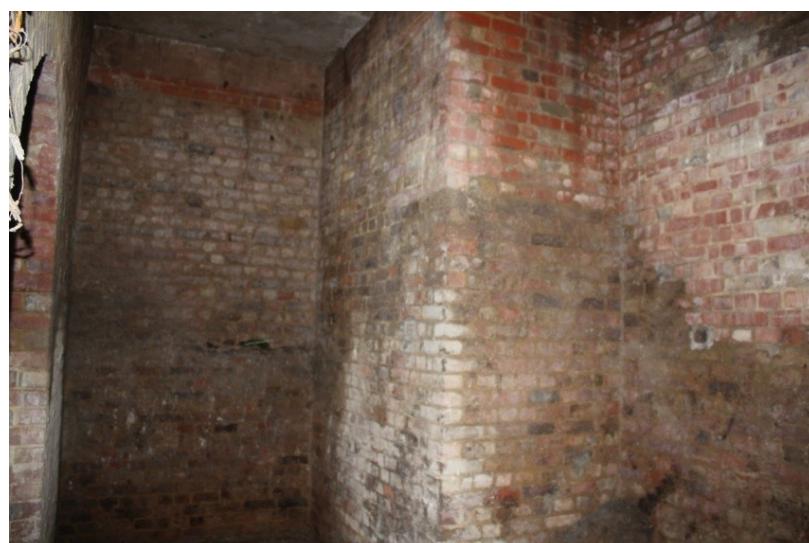
- 7.7 The west wall of the north room is built from-clamp fired bricks, apart from the two top courses which are fairfaced bricks with yellow, sandy mortar (see Plate 37).

Plate 37. The west wall of the north room (looking west).

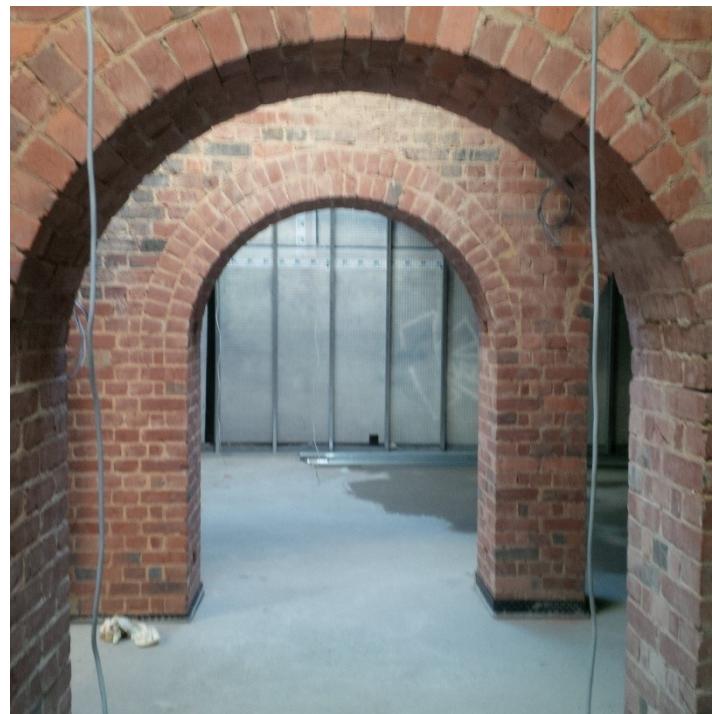
- 7.8 There are two matching arches in the south side of the north room which are identical to those in the south room (see Plate 38). These are built with fairfaced bricks and yellow, sandy mortar.

Plate 38. The cleaned arch in the north room seen from the south room (looking north cross the corridor).

An *in situ*, 1930s light switch is on this side. It has clearly been added at a later date as the brick has been channelled to receive the cloth-covered cable, with the intention of rendering the wall. This was never carried out.

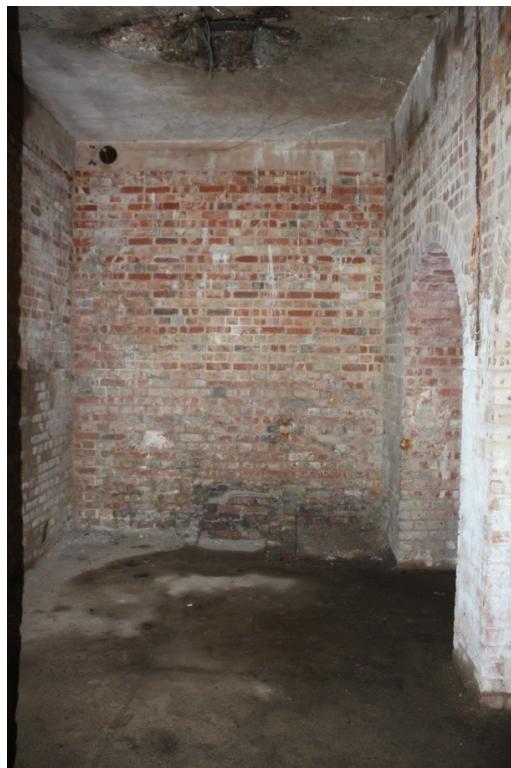
Plate 39. The east wall of the north room (looking east).

- 7.9 The east wall of the north room is built with fairfaced brick. There is no evidence for the window which was drawn on the original plans. In this corner is what could be loosely described as a brick-built bunker, perhaps for storing coal (*see* Plate 39).

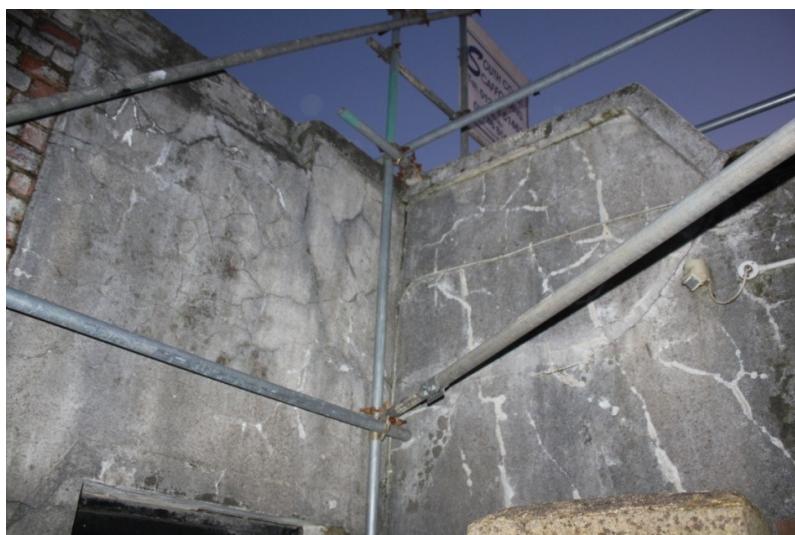
- 8.1 The development application included the demolition of the southern boundary wall of the garden. This was due to high levels of structural movement. The wall was recorded both prior to and during demolition (*see* Plates 40–42 and 43–45). It appears that the wall might be a later rebuild, as evidenced by the scar of a different wall in Plate 45, which shows the stuccoed south elevation of the house sealed by the demolished garden wall.

Plate 40. The south-east corner of the boundary wall from inside the garden.

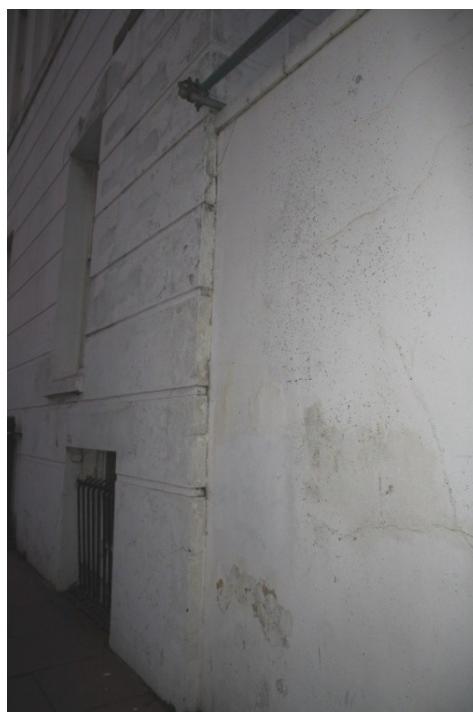
Plate 41. The juncture between the South elevation of number 40 and the garden wall.
