HISTORIC BUILDING RECORD FOR THE SMALL HOUSE, 40A SUSSEX SQUARE, BRIGHTON.

Archaeology Services, Lewes.

Report number: ASL 134-17

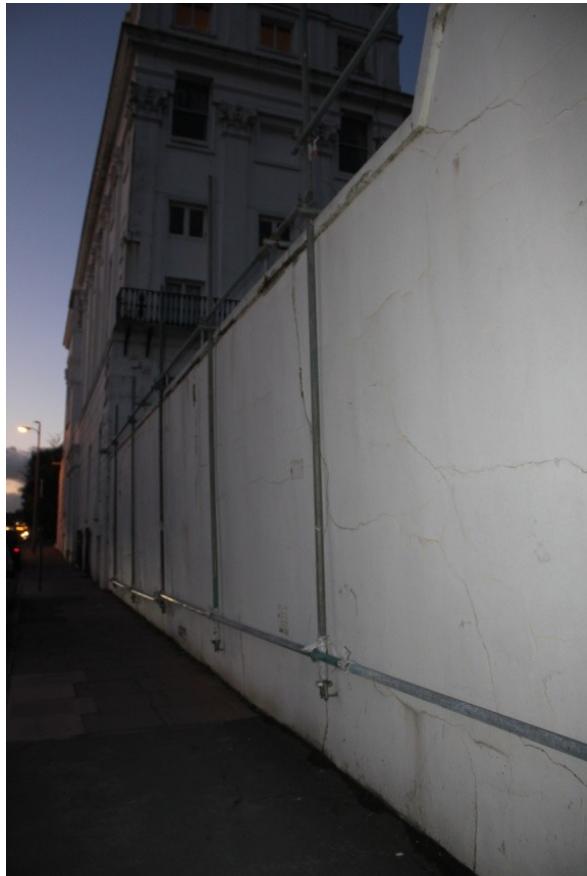
Plate 42. The south facing elevation of the garden wall.

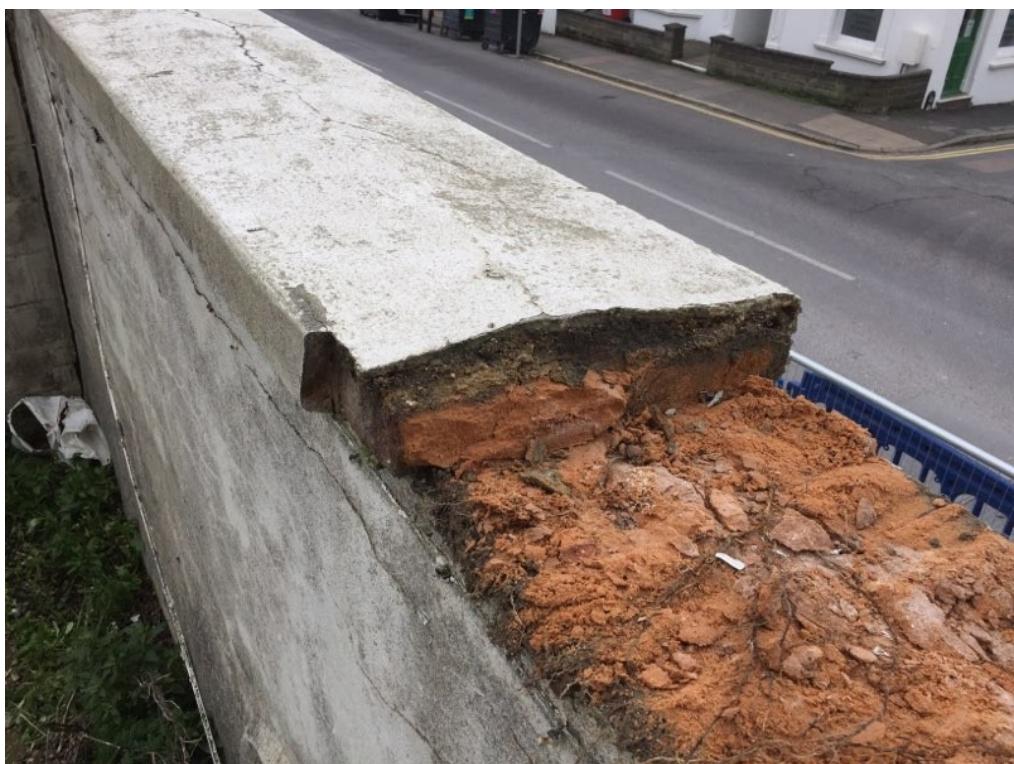
Plate 43. The top concrete removed from the garden wall, revealing soft, degraded brickwork.

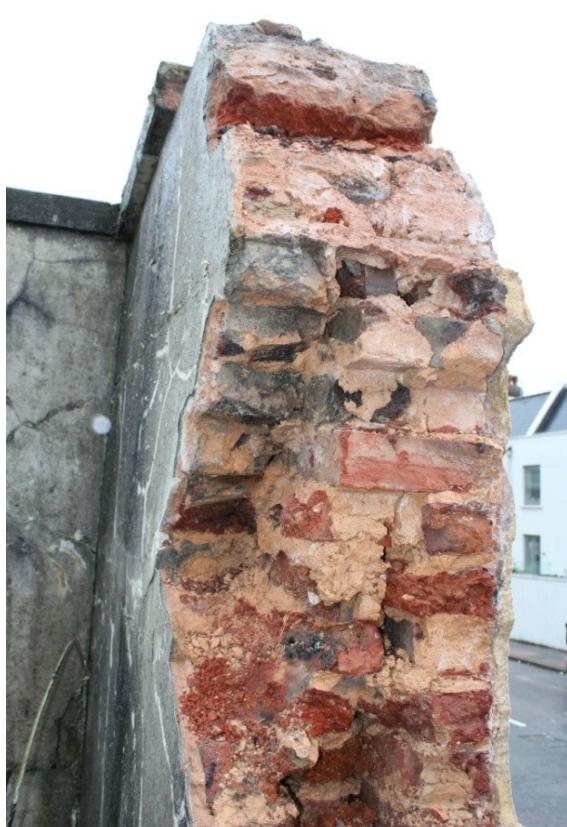
Plate 44. Cross section through wall.

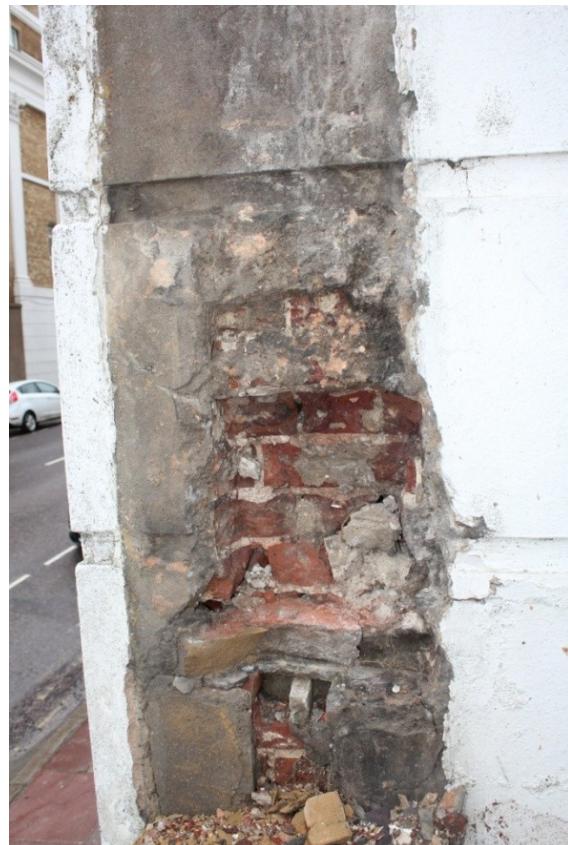
Plate 45. Demolished wall against east wall of number 40, possibly sealing an earlier, lower, keyed-in wall.

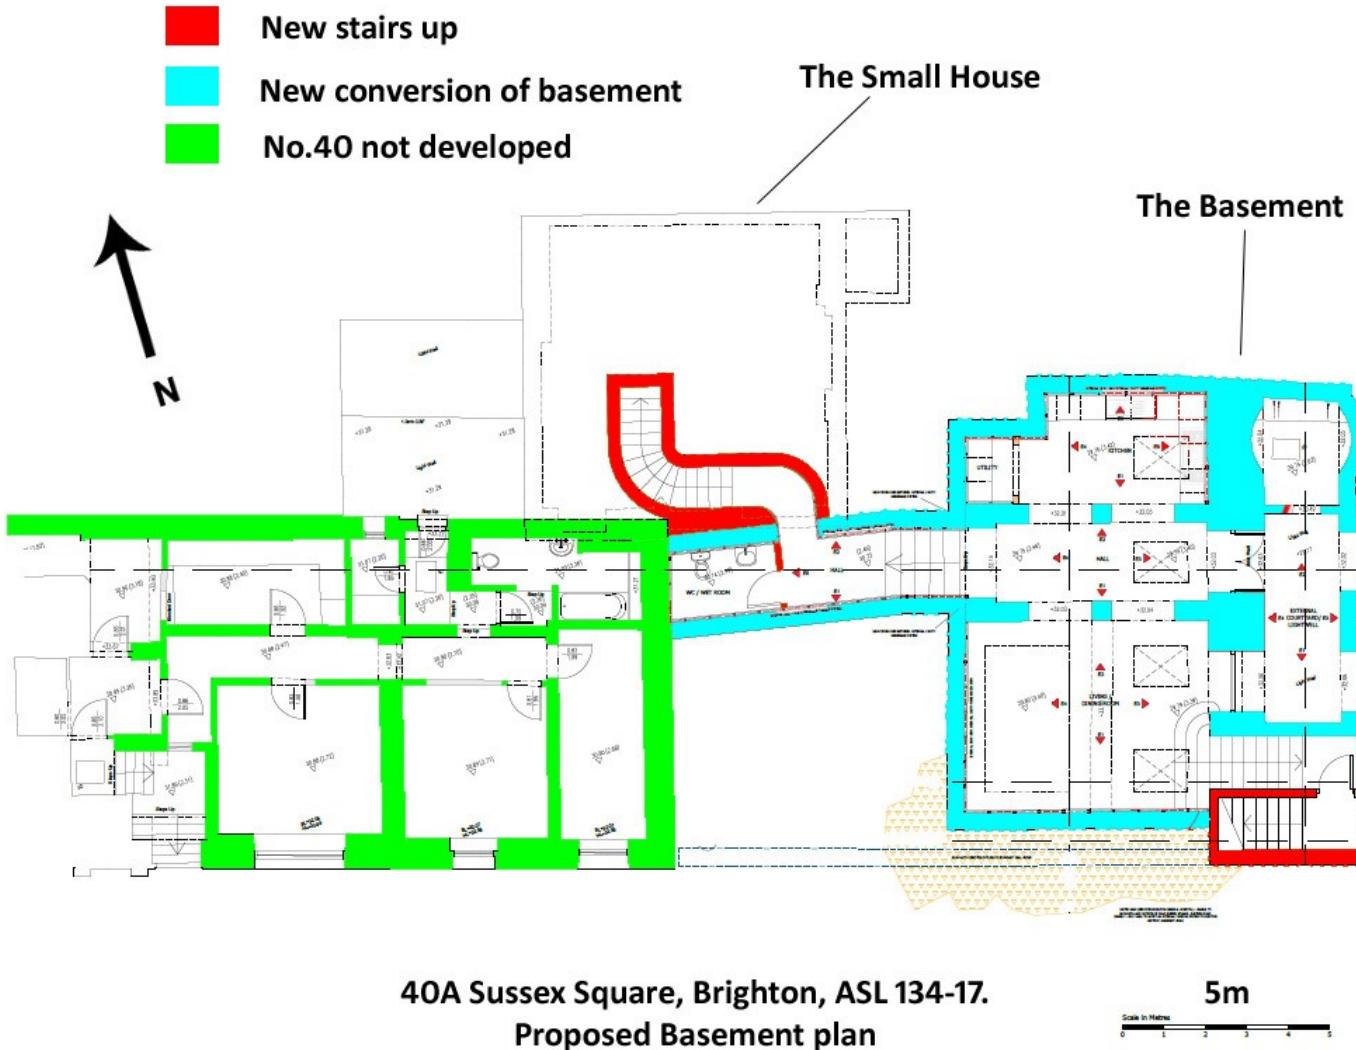
Fig. 3. Proposed basement plan (adapted from Savills' drawing number: 1054512/120, revision E ©2015).

- 1.2 The renovations and alterations (see Figs 3–5) involve the conversion of the lower ground floor basement below the existing garden to create a new living space. This includes the installation of a new internal staircase leading up into The Small House, new waterproof tanking to line the existing basement walls, new external stairs to the garden above and new internal dividing walls with modern services installed. Within The Small House there will be new partition walls and services installed, with walls replastered and a new kitchen and bathroom fitted. This HBR has recorded the building and the basement prior to development and, in particular, inspected

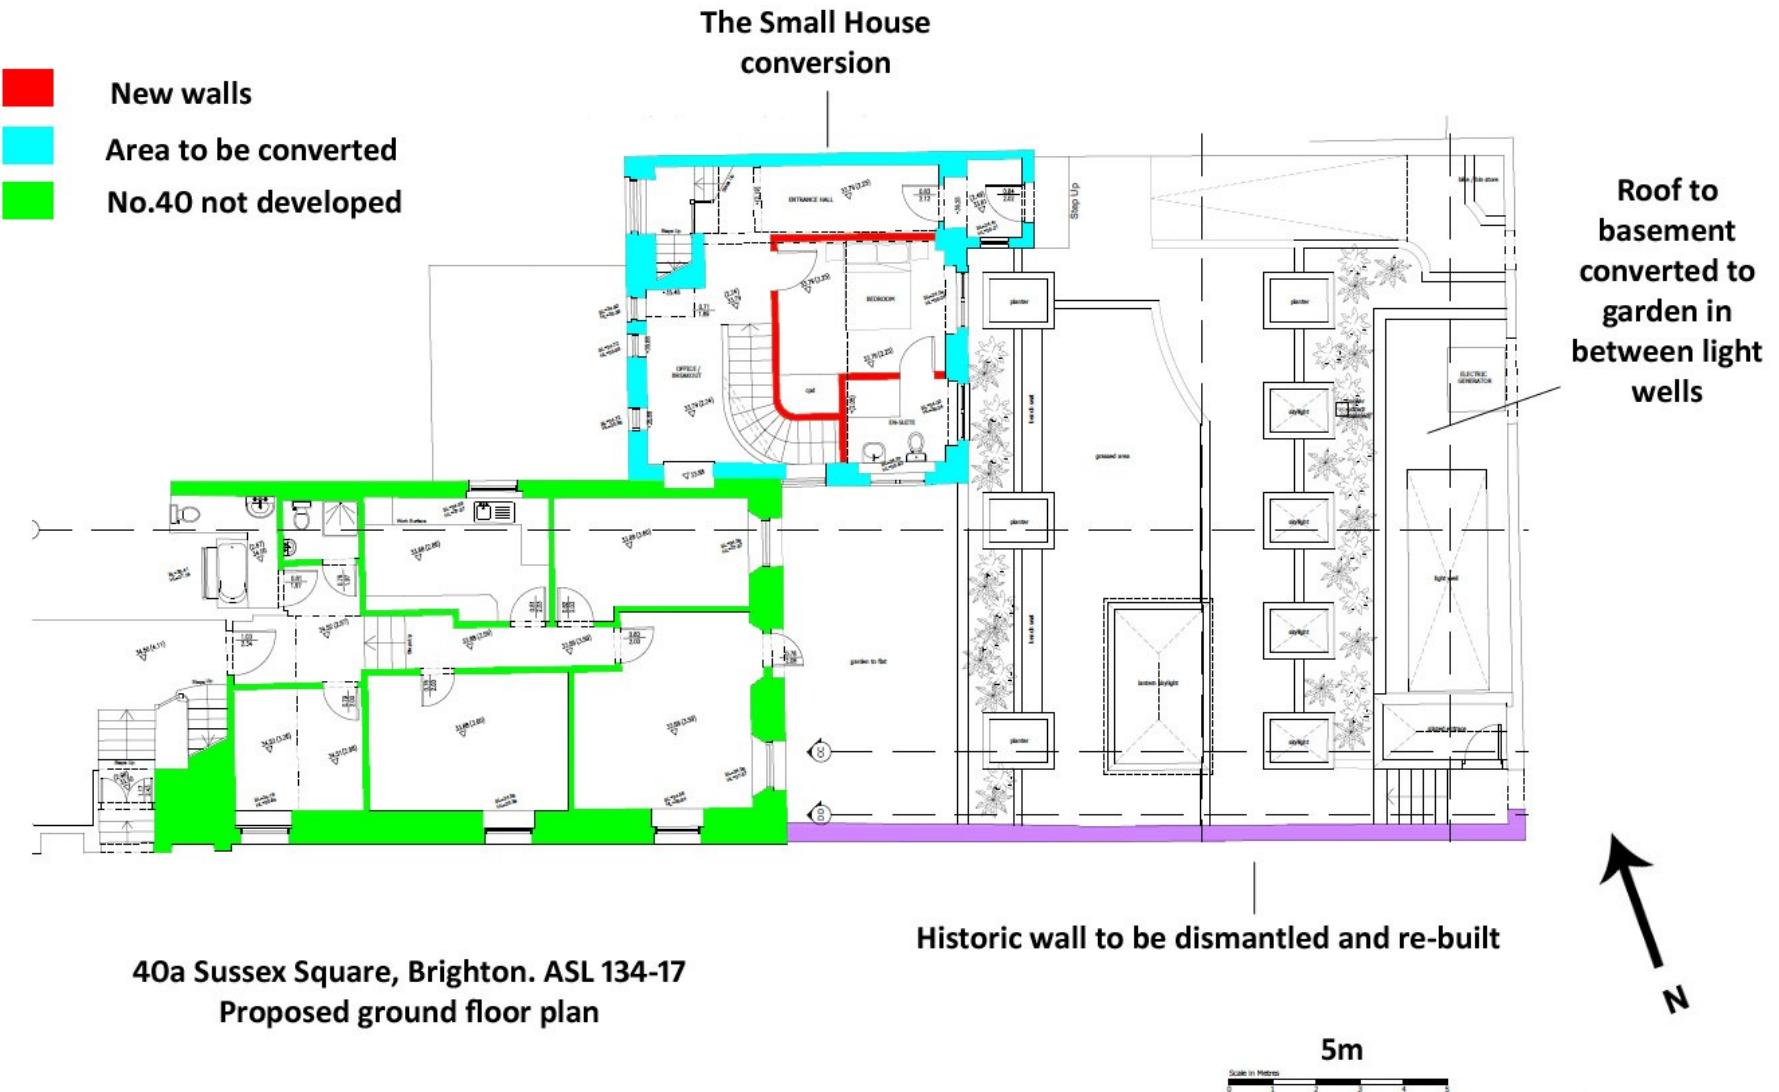
Fig. 4. Proposed ground-floor plan (adapted from Savills' drawing number: 1054512/121, revision D ©2015).

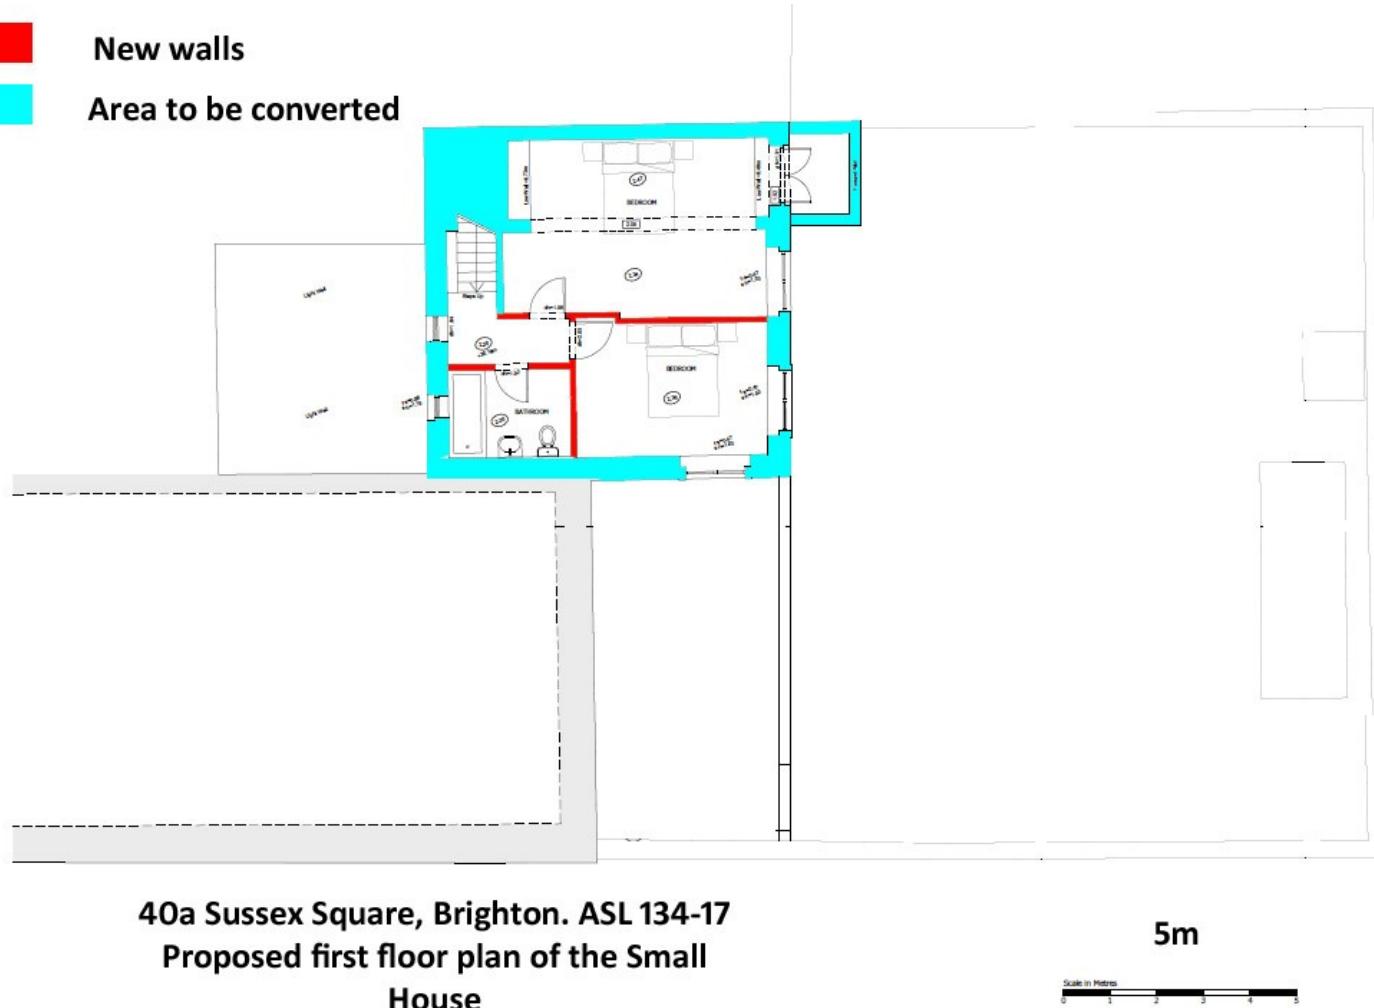
Fig. 5. Proposed first-floor plan (adapted from Savills drawing number: 1054512/122 Revision, B. ©2015).

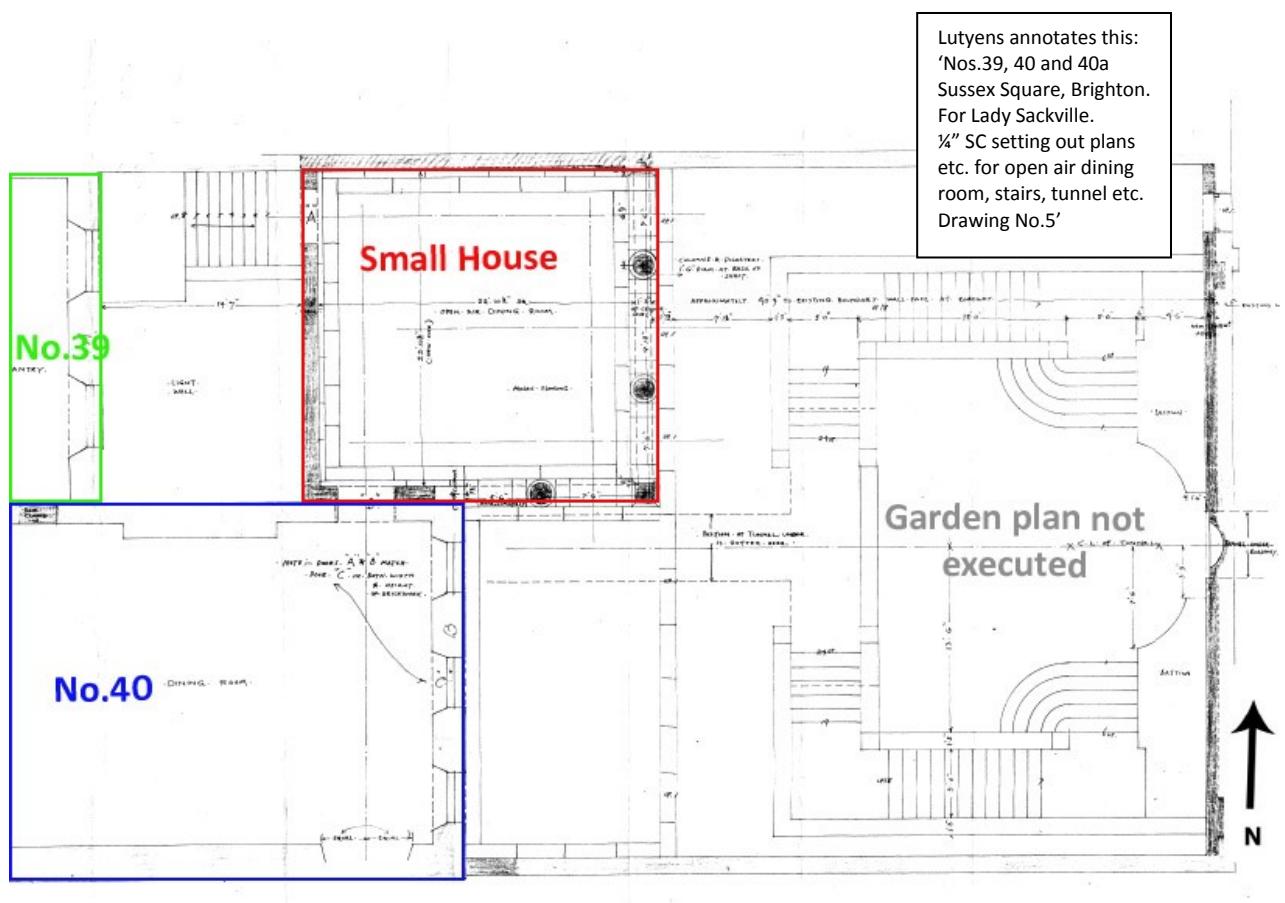
Fig. 11. Lutyens setting out plans for The Small House and garden, 1918.

- 3.1 The Small House was built after the OS 1909 map was drawn [Period A]. The designs by Lutyens (see Fig. 11) are dated 1918–19 and it is believed that the building was completed by 1921, although it appears that the garden plan, complete with terraced steps, was never fully built. The building was sold by Lady Sackville West in 1924. Originally it would have been a one-and-a-half-storey building, with one open plan room on the ground floor and probably a flat, glass roof, which angled downwards, joining the top of the garden boundary wall to the north (see Fig. 15). This would have created a form of pent roof on one side. There were originally three open apertures on the east-facing front elevation, much altered with a later entrance porch and doorway on the north side (see Plate 3). There were two open apertures on the south elevation with a later doorway (see Plate 4). Originally these open apertures created the ‘loggia’. Lutyens’ notes refer to an ‘open air dining room, mosaic flooring’ and the columns and pilasters are noted as being 1'6" in diameter at the base (see Fig. 11), which was confirmed by the excavation. The rear west elevation has a door on the north side at ground- floor level which gives access into 39 Sussex Square, via a roofed basement structure, all of which is present in Lutyens drawings.

The Small House was originally open plan, consisting of one room, 2.90m square in plan, open to the roof which was probably glass. The footprint of the structure is the same size and in the same position as in Lutyens' sketches (see Fig. 11).

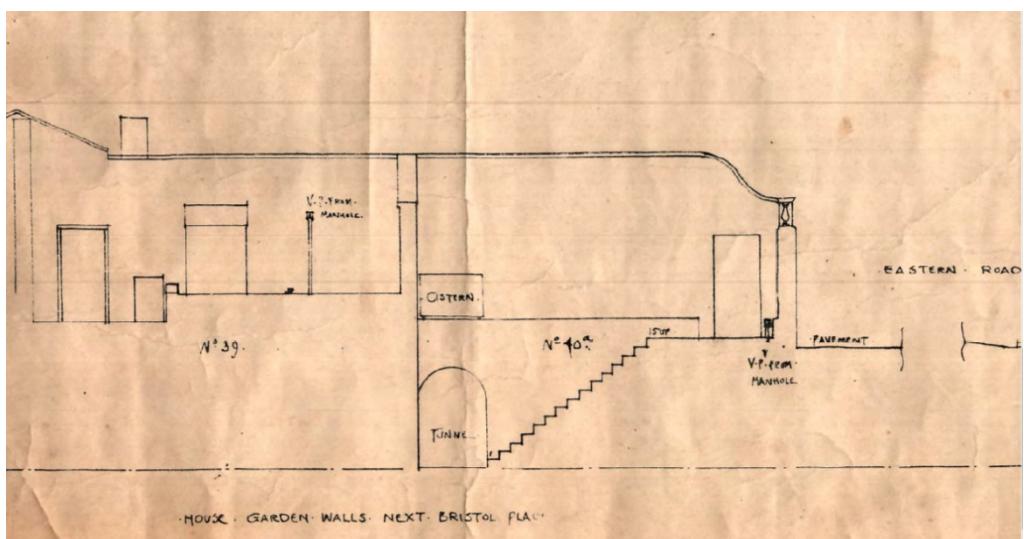
Fig. 13. Lutyens' sketch of the rear eastern wall and tunnel in 1918.

- 2.11 In 1919, plans for alterations were drawn up by Edward Lutyens for the owner of 39 and 40 Sussex Square, Lady Sackville West. They included a garden basement, loggia and landscaping (see Fig. 11). It is uncertain to what extent the landscaping works were carried out. The basement survives, although this was significantly backfilled and has only recently been emptied (see Fig. 12). In our opinion, it is highly probable that The Small House *is* the conversion of the loggia. There is evidence of a late-19th-century tunnel, providing a link between the rear garden of 40 Sussex Square and a large private garden on the opposite side of Bristol Place (see Figs 13 and 14).

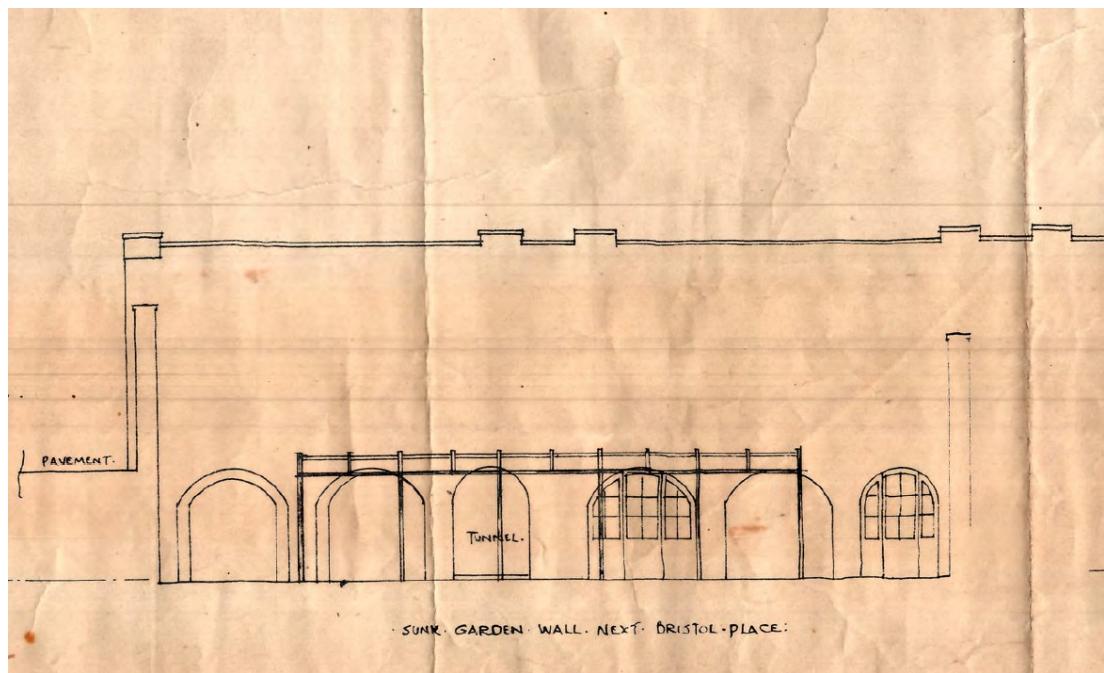
Fig. 14. Lutyens' sketch of the tunnel and arches east of Bristol Place.

However, there is some doubt regarding the tunnel. Lutyens' designs included a grand plan for a sunken garden in Bristol Gardens, beyond the tunnel. It would appear that this was never built, although it is difficult to say for certain, as the site has since been redeveloped and a modern block of flats now occupies the space. To make interpretation more difficult, the tunnel has been bricked up on both sides. However, beyond Bristol Gardens the tunnel appears partly open where a modern electricity sub-station is situated. There are four further blocked arches here which do not appear to have any depth and may have been built purely for show (see Fig. 14).

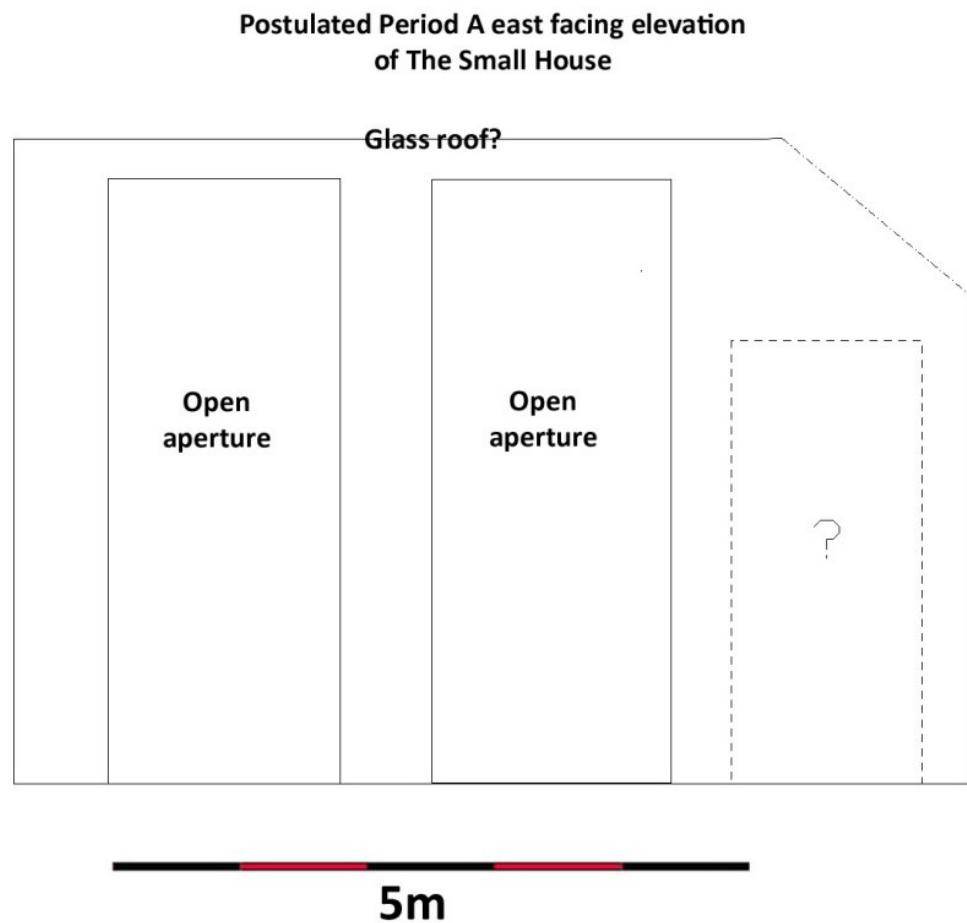
Fig. 15. Postulated east elevation of The Small House.

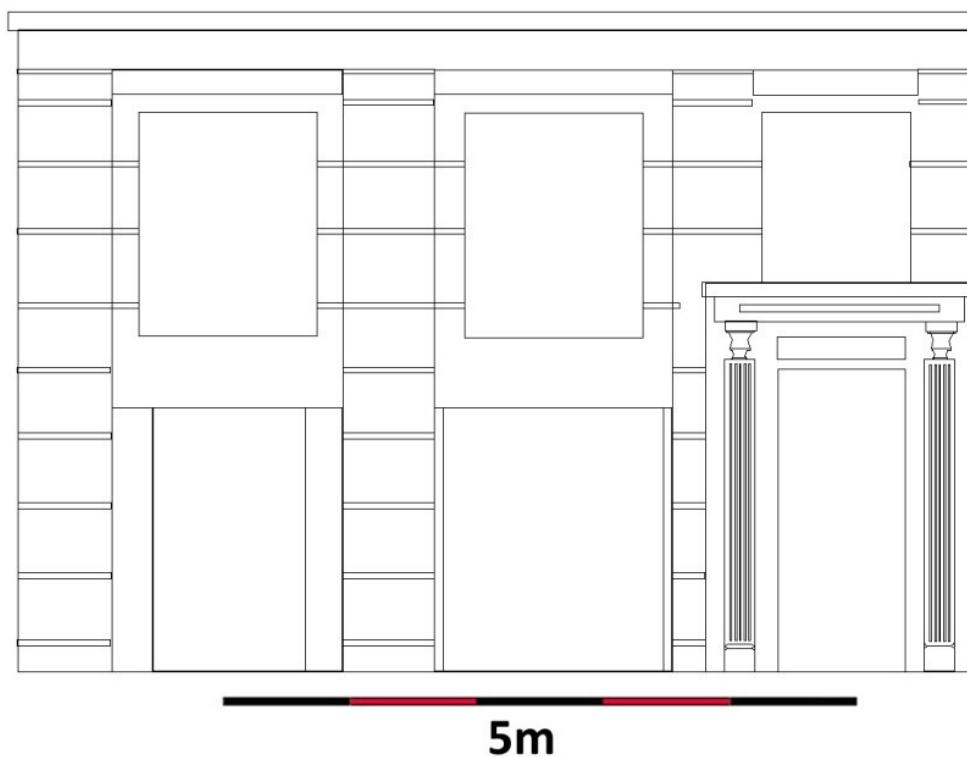
Fig. 16. Existing east elevation of The Small House.

- 3.2 During the second phase, in the 1930s [Period B], the roof was raised in height on the north side and a flat roof was constructed over the whole building. The first floor was inserted and ground-floor partition walls built, creating a separate living room, kitchen and toilet room. A new staircase to the west gave access to the first-floor bedroom and bathroom. A cantilevered, external toilet room was built, which projects off the rear, west elevation (since removed). The entrance porch and doorway was added on the north side of the front elevation with a small balcony above. A doorway in the west side of the south elevation was added, presumably giving access into number 40. All windows would have been inserted at this point (see Fig. 16).

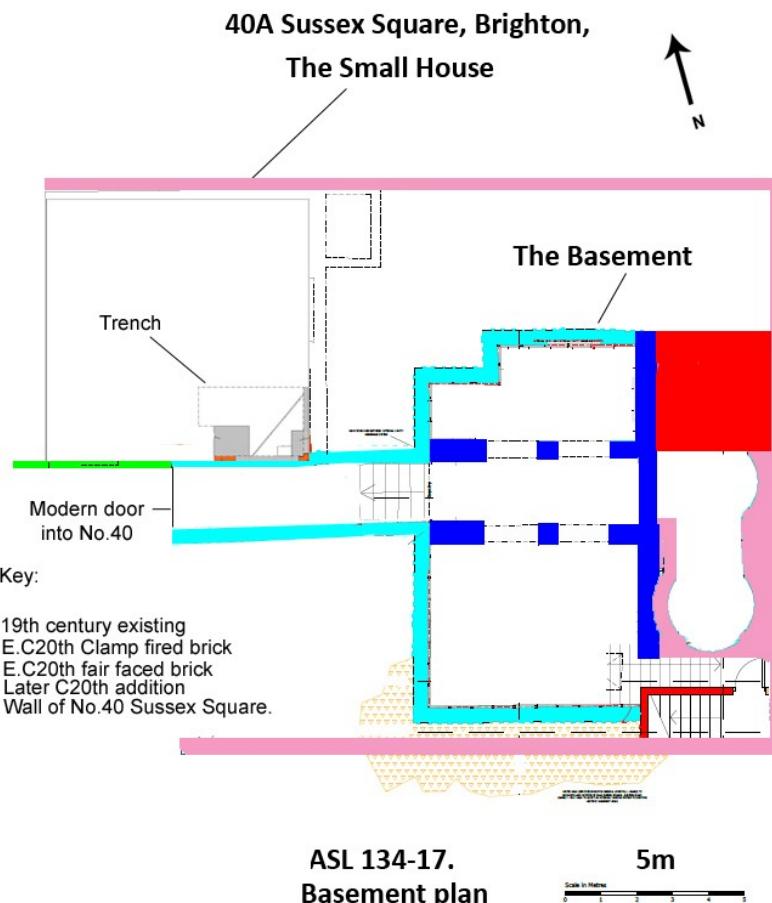
Fig. 17. Phased floor plan of the basement.

- 7.1 The vaulted basement area (see Fig. 17) was also designed by Edward Lutyens. The blueprint plans (see Fig. 18) show the designs, but it appears that they were never completely built or that part of the design has been replaced by the construction of a modern electricity substation and later concrete steps. It is unlikely that this can be resolved.
- 7.2 The basement was originally designed to lead from the rear of 40 Sussex Square, proceeding underground in an easterly direction before exiting into a light well. This light well faced a tunnel which is believed to extend under the road to the rear of numbers 39–40 (see Fig. 13), entered through an arch which is still visible (see Plate 25).

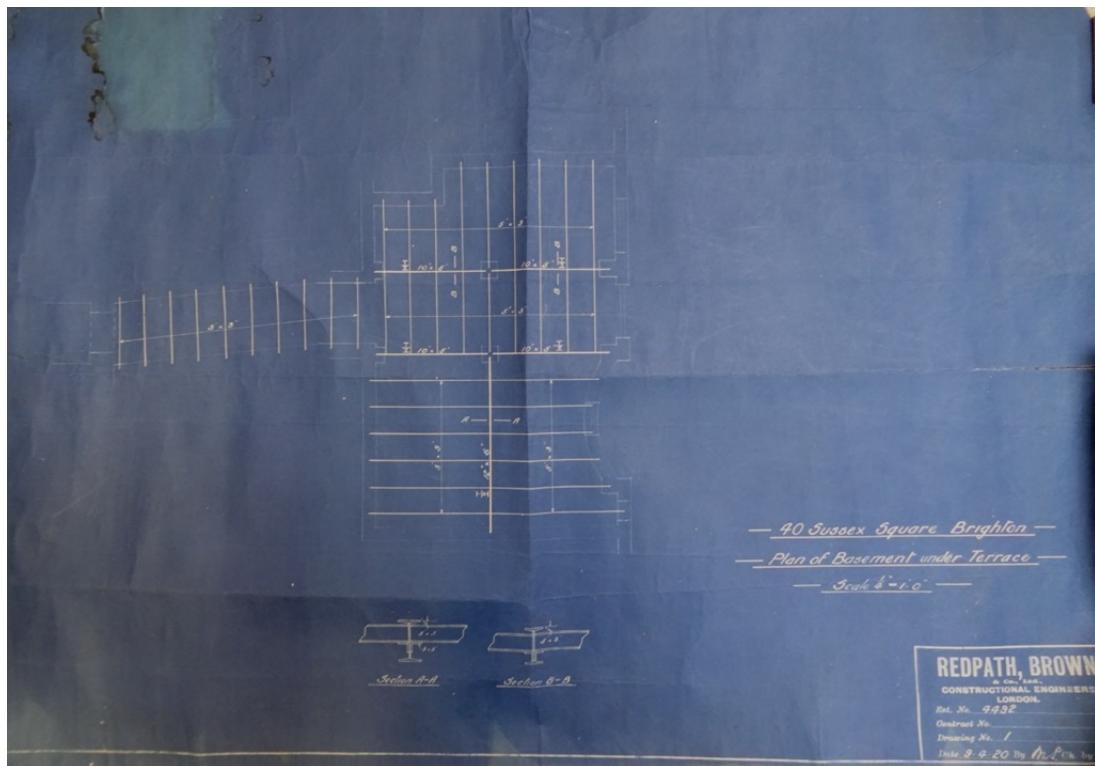
Fig. 18. Engineer's blueprint of the basement plan dated 3/4/1920.
