HISTORIC BUILDING RECORD FOR PRIORS CROFT, COWDEN, KENT.

Report number: ASL 132-17

SUMMARY

This Historic Building Record has been prepared by Archaeology Services Lewes for the owners, Mr and Mrs Burrows (The Clients) who put forward a planning application for a scheme of renovations and alterations within their property known as Priors Croft, Spode Lane, Kent, TN8 7HW.

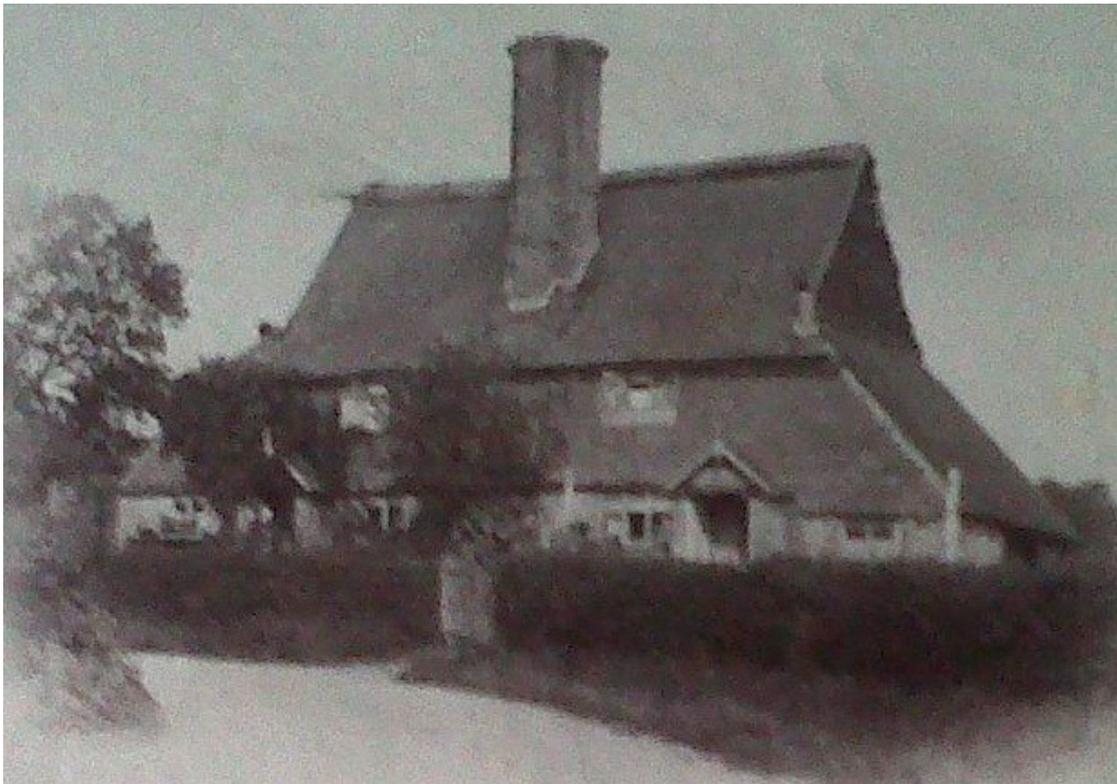
Fig.7 An early photograph shows two single-storey outshots with two front entrances

- 2.9 An early but undated photograph (Fig.7) of the building⁴ taken from the south shows two front entrance doors to either side of the cottages with small porches above. Additionally, the two outshots are single-storey and the roof has the appearance of being thatched although the detail is not clear and this might be thicker ridge tiles.

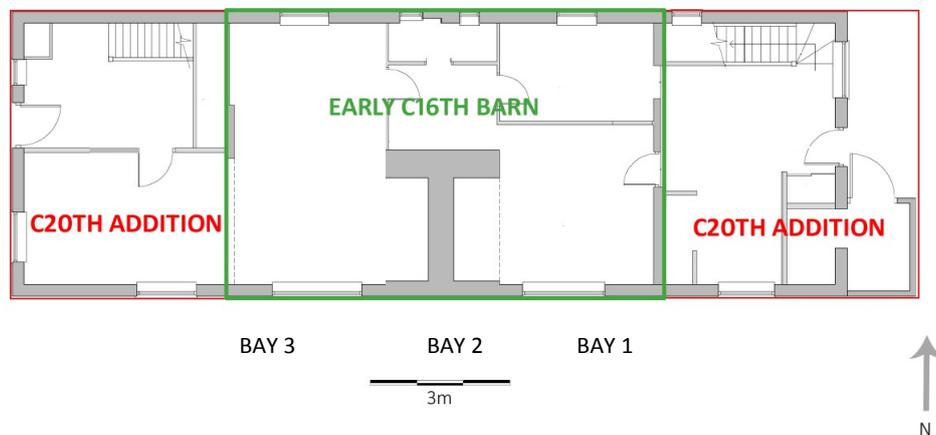
Fig.8 The current floor plan of the building showing the 16th century original core.

- 3.1 The building is rectangular shaped and faces Spode Lane. At present there are two modern 20th century extensions added on the east and west sides of the building. At its core is an early – mid 16th century **[Period A]** timber framed building originally built as a barn which was gabled on both sides with a clasped purlin and Queen strut roof. This was built on a sandstone plinth with weather-boarded walls below and daubed panels above. It is probable that the roof was thatched. This has been significantly altered over the years and would originally have housed a central wagon way (or midstrey) within the north elevation. The south elevation *may* have had a half-height entrance although internal plastered walls and later additions make interpretation of this side somewhat problematic (see Figs. 12 and 13 in the appendix).

- 3.2 At a later date, at or around the late 17th – early 18th century **[Period B]** the building was converted for use as a domestic dwelling. This was facilitated by flooring over the side bays and building a central stack in the middle bay. Two entrances were created in the front (south) elevation.

- 3.3 During the late 18th – early 19th century **[Period C]** further conversions took place, including the sub-dividing of the ground floor room in the eastern cottage, facilitated by building a dividing wall within the first bay. Two small iron ranges were inserted in the ground floor fireplaces of both cottages and a further fireplace was added at first floor level in the western cottage. Additionally, two single storey outshots are likely to have been added during this period to the west and east sides of the house with access doors opening up into the cottages. The front entrance doors had new porches built over them and a rear door was inserted in the western cottage with a porch over.

- 3.4 During the 20th century **[Period D]** further modifications took place including the demolishing and re-building of the side extensions to give two-storey accommodation, re-tiling the roof with peg tiles and the insertion of two bathrooms at first floor level. Various other partition walls have also been added.

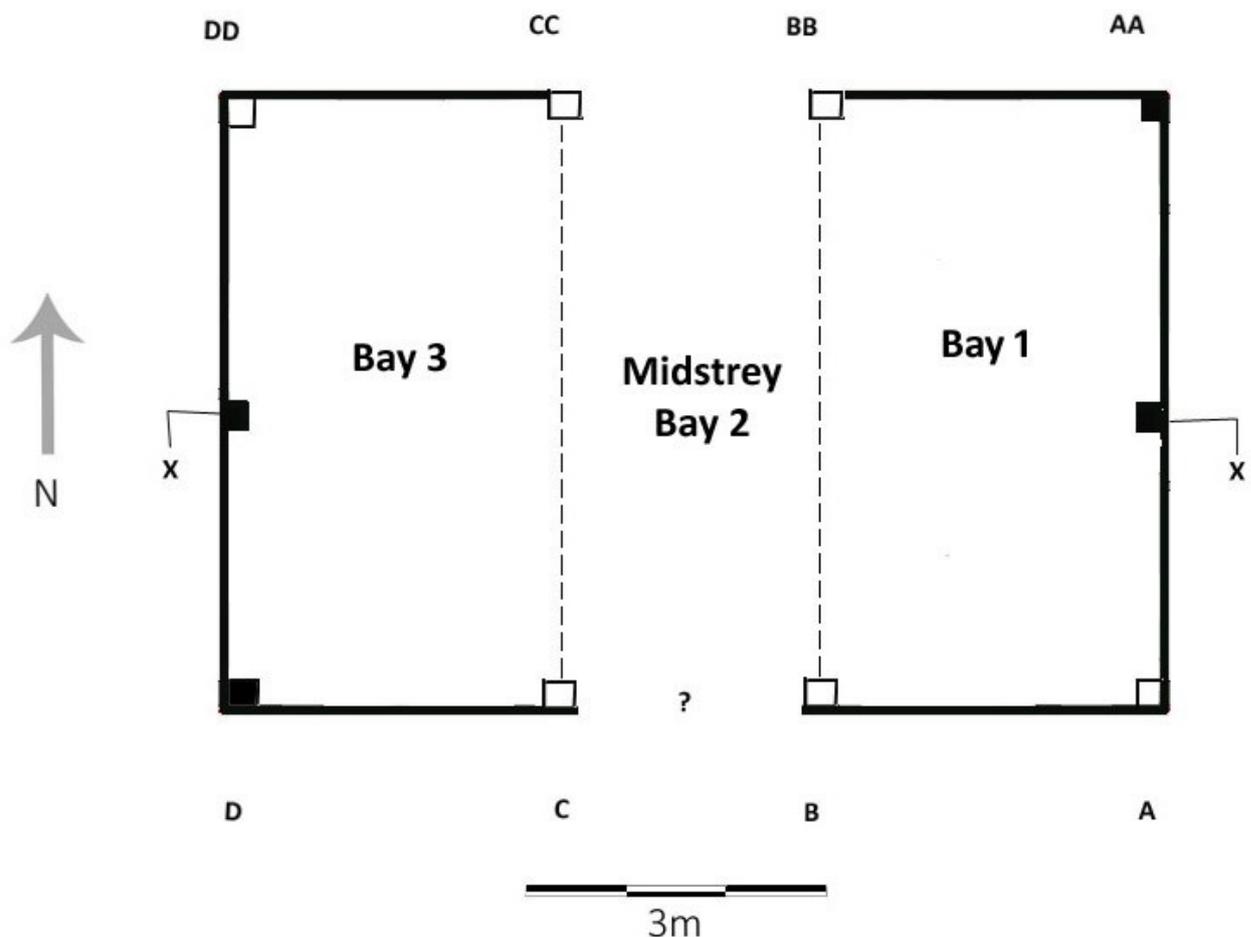
Fig.9 Ground floor plan for Period A

The earliest building, as discussed above, was a timber framed, 3-bay barn which was not floored and had a full height wagon way within the middle bay. The roof was gabled at both ends (see also Fig.12 and 13 in the appendix for the cross section of Truss B and the long section).

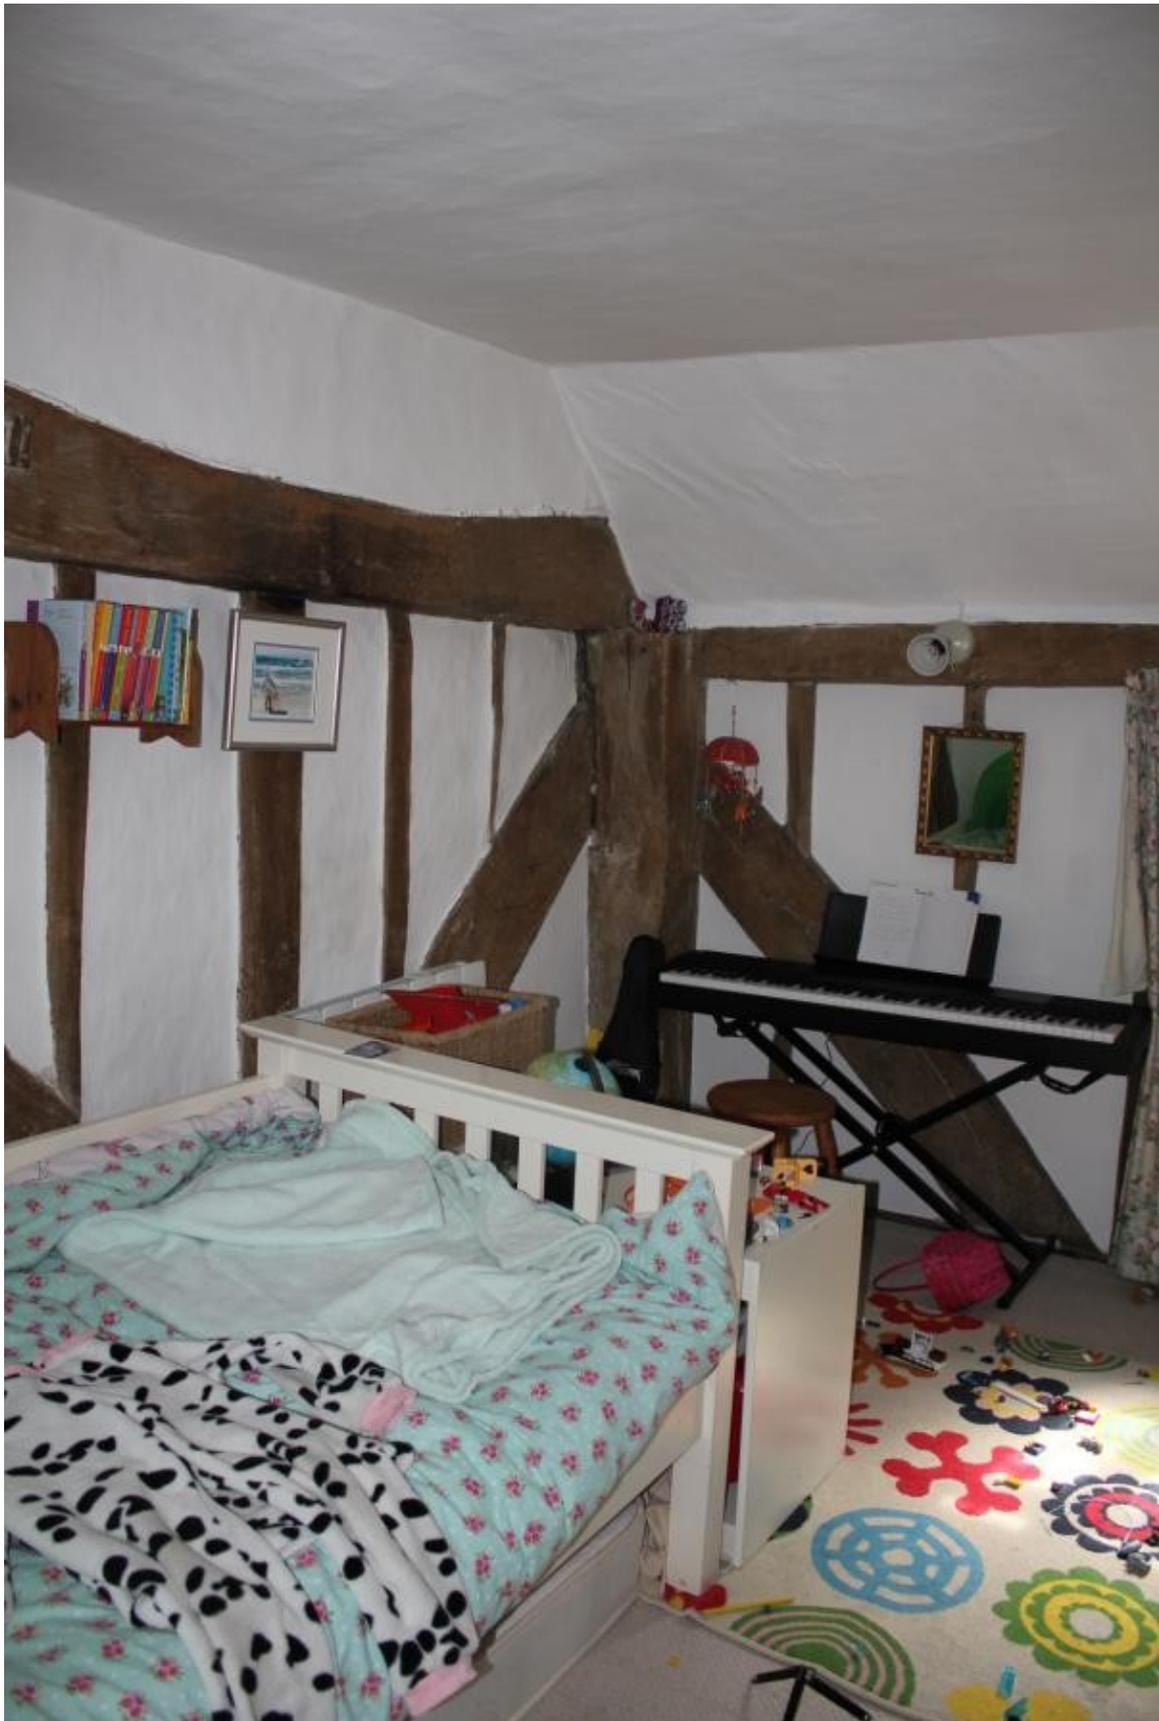
Plate 2: Full bracing to Post A at first floor level in Bay 1

At First Floor level all posts are 300mm thick and have slightly swelling jowls and all of the timbers from this period are of thick scantlings (dimensions). There is full down bracing (Plate 2) at the higher level to the side and facing elevations (some nearly straight) as well as to the intermediate posts on the west and east walls. The presence of central bay studs within the north elevation are a tradition which disappears in the early-mid 17th century⁵. As the barn was not floored at first floor level the barn would have been open to the roof. Within Trusses B and C there were full up braces to the tie beam on the south and north sides but these have since been removed.

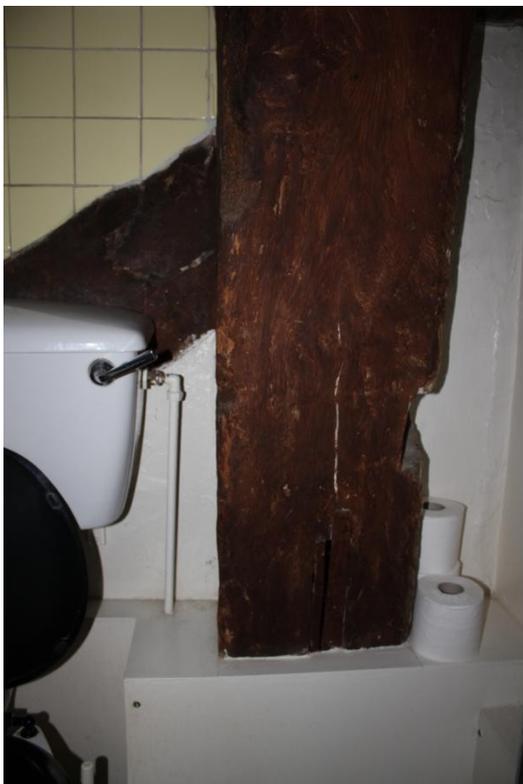
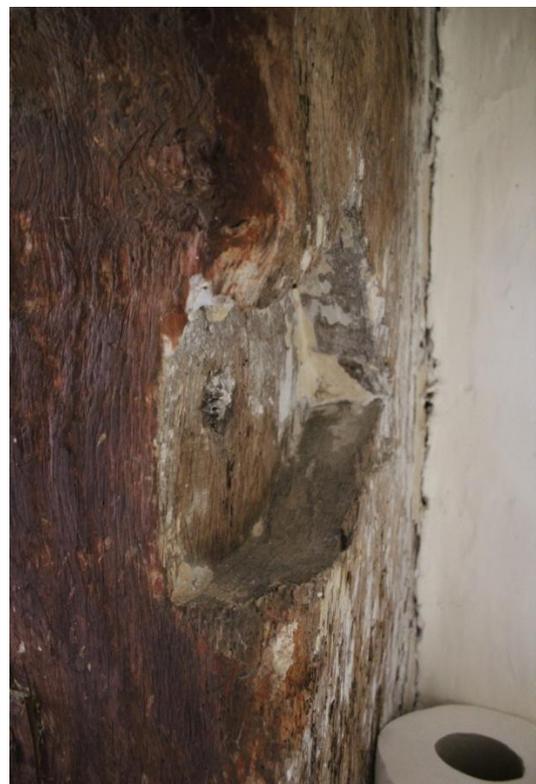
Plates 4 and 5: empty mortice for a raking shore on the east face of Post C. Note also removed head brace mortice

There were raking shores (now removed) on the west side of Post B within the jowel at the top of the post and on the east side of Post CC (Plates 4 and 5). These are likely to be later additions attached to the face of the posts rather than morticed in, which are known to date to the early 17th century. They were used within agricultural buildings to keep high stacked crops from toppling to the side, particularly hay and straw.

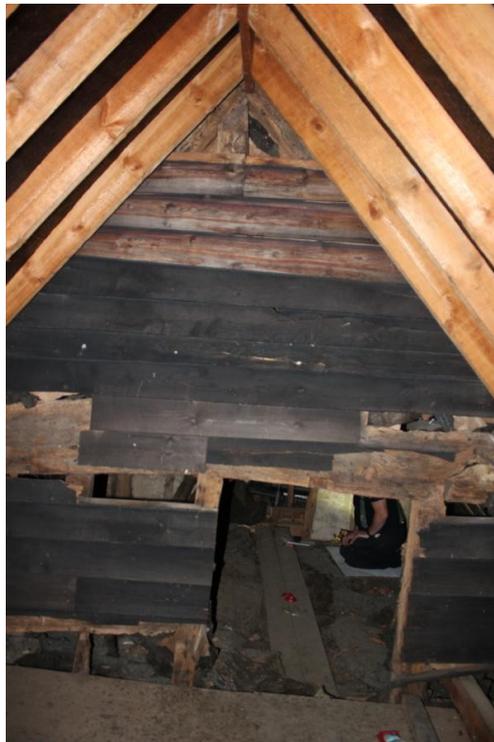
Plate 5: Weather-boarding on the eastern gable (Truss A) of the Period A roof

At Truss A in the east gable there are three pegged Queen struts and the gabled end has some existing (but modern) feather edged weatherboarding above and below the collar (Plate 5). These measure 170mm (deep) x 15mm (thick) and are grooved into the principal rafter and there is significant weathering on the rafters. The top of the collar is approximately 350mm deep and 90mm wide and is cambered by approximately 100mm in the middle. The collar is pegged to both sides and the purlins are trenched within. The curved windbraces measure (on average) 300mm (wide) x 30mm (deep) and are still *in-situ* apart from the north side of Bay 3. It was noted that some of the pegs projected considerably. There are five sets of common rafters to each bay which vary in size ranging between 115mm – 150mm wide and between 70-95mm deep.

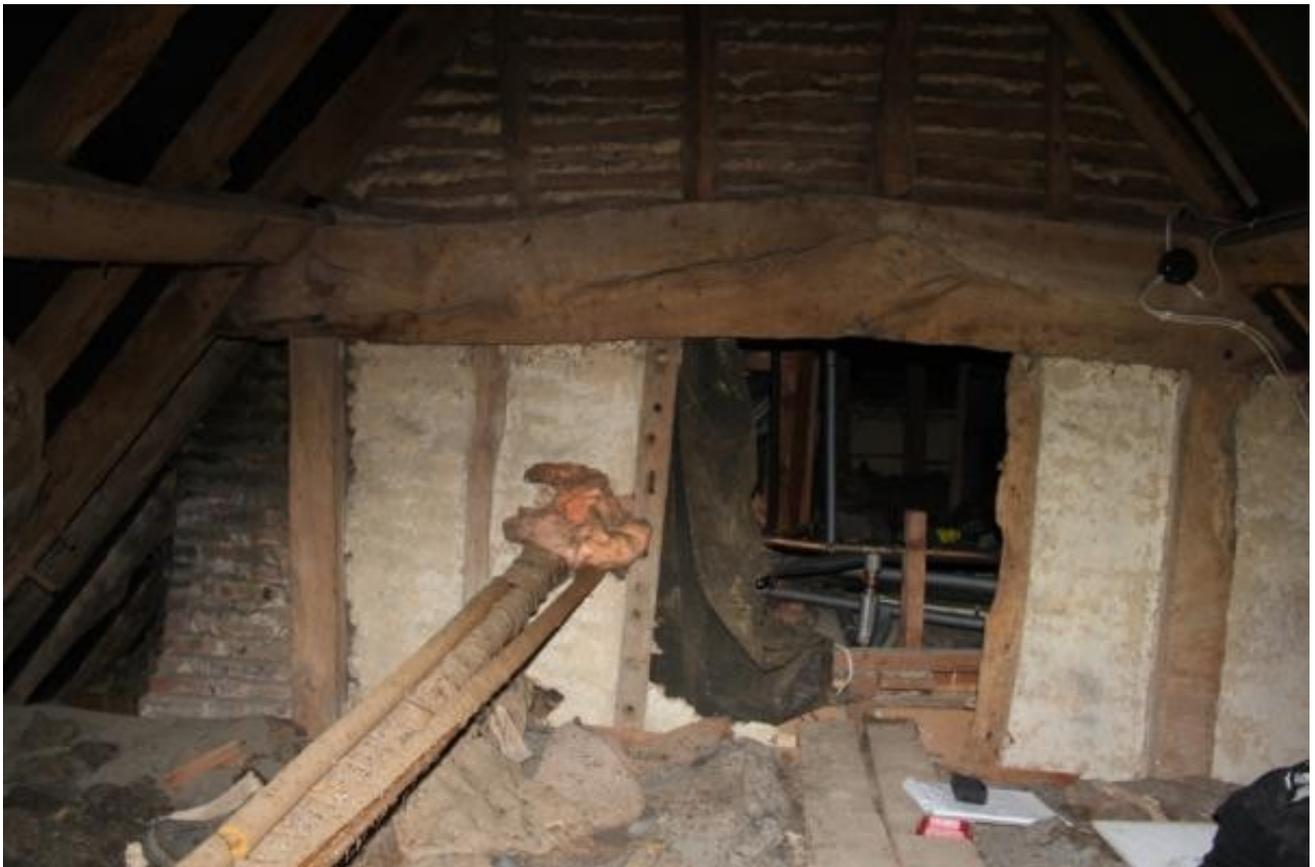
Plate 6: Later nailed studs and daub in-between the Period A Queen struts on the east side of Truss B

Truss B is the same construction but with two pegged Queen struts (Plate 6).

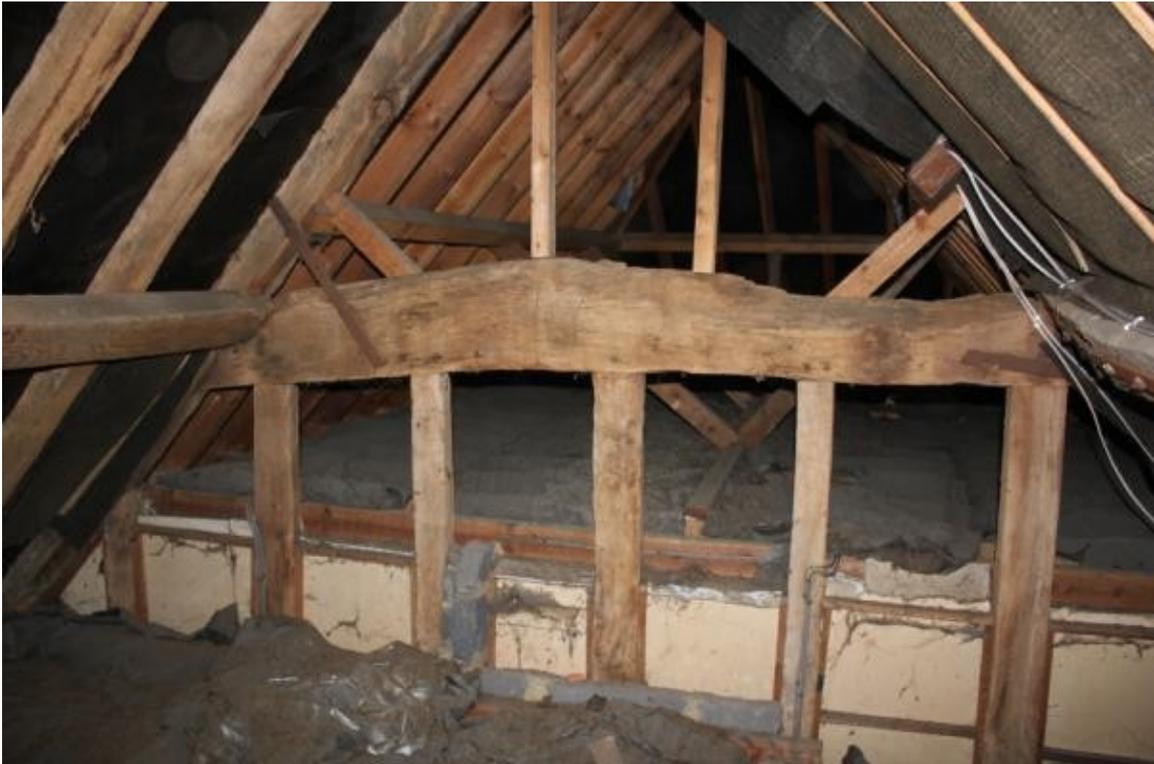
Plate 7: The east side of Truss D gable with three Period A Queen struts and later nailed studs

Truss D (Plate 7) has three pegged Queen struts (one central and with Period B nailed studs flanking this) and there is no *in-situ* weatherboarding but rebates for these are evident and the west gable has also seen some weathering.

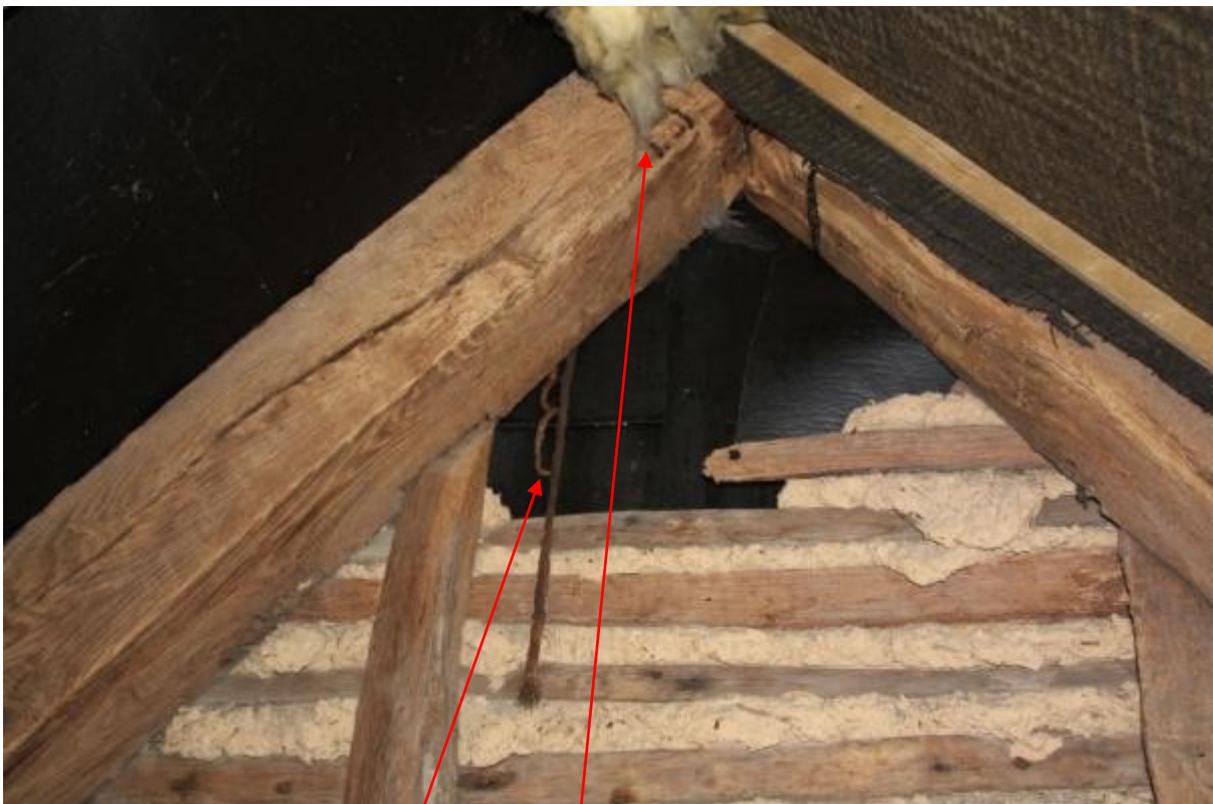
Plate 8: In-situ thatching cord with tar marks evident on principal rafter on Truss B

The roof would have been thatched with some binding cord still evident hanging from the top of rafters (hemp?) and occasional tar marks seen where the tarred cord would have formerly attached the thatch to the rafters (Plate 8).

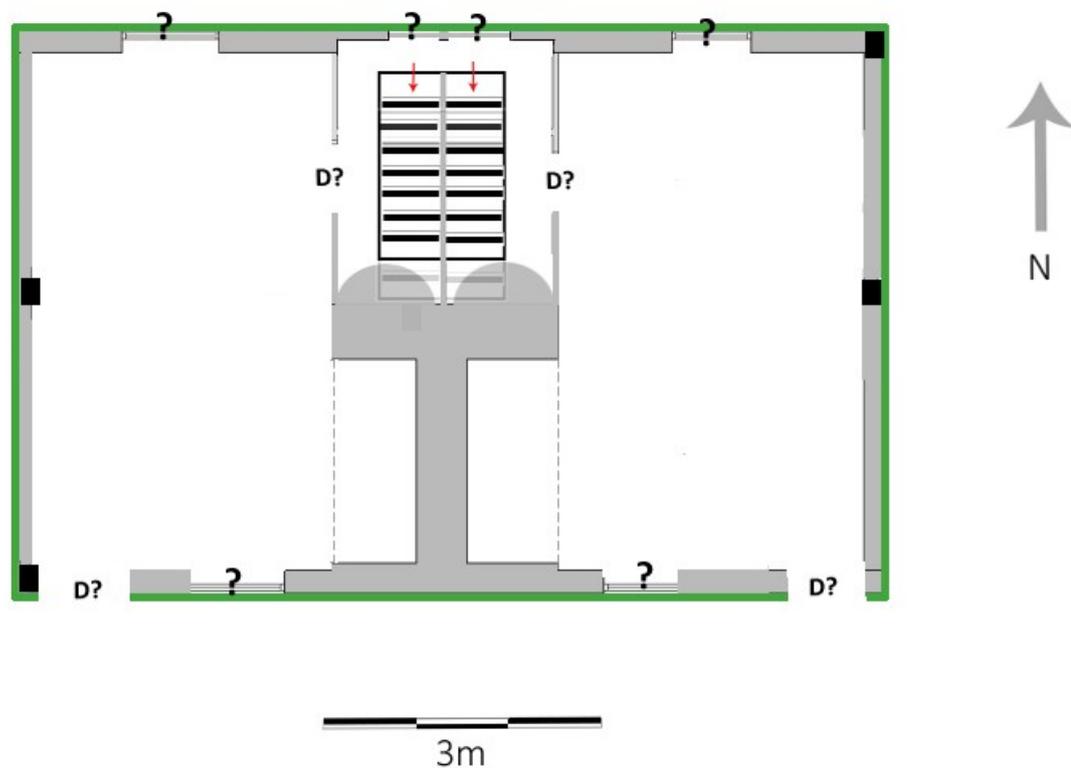
Fig.10 Postulated ground floor plan for Period B

During this period the building was floored over and the large central stack inserted and it is likely that it was divided during this period to provide two separate cottages (see also Fig.12 and 13 in the appendix for the Cross section of Truss B and the long section).

The stairs for this period are no longer *in-situ*. It is likely that the stairs were located within Bay 2, as postulated in Figs. 10 and 11 above. The exact orientation of the stairs can only be surmised based on archaeological principles of phasing. Without being certain where the **Period B** doors were it is difficult to be sure. As postulated, it would be possible to enter the stairwell on the ground floor level via side doors (if indeed they were in this location) to both cottages with the first tread being situated to the north side of the stairwell. There would have been ample space to the sides of the stairwell giving access through doorways into the first floor rooms above the ground floor doorways. This would also provide room house the bread ovens to the north side of the chimney on the ground floor below the landing area.

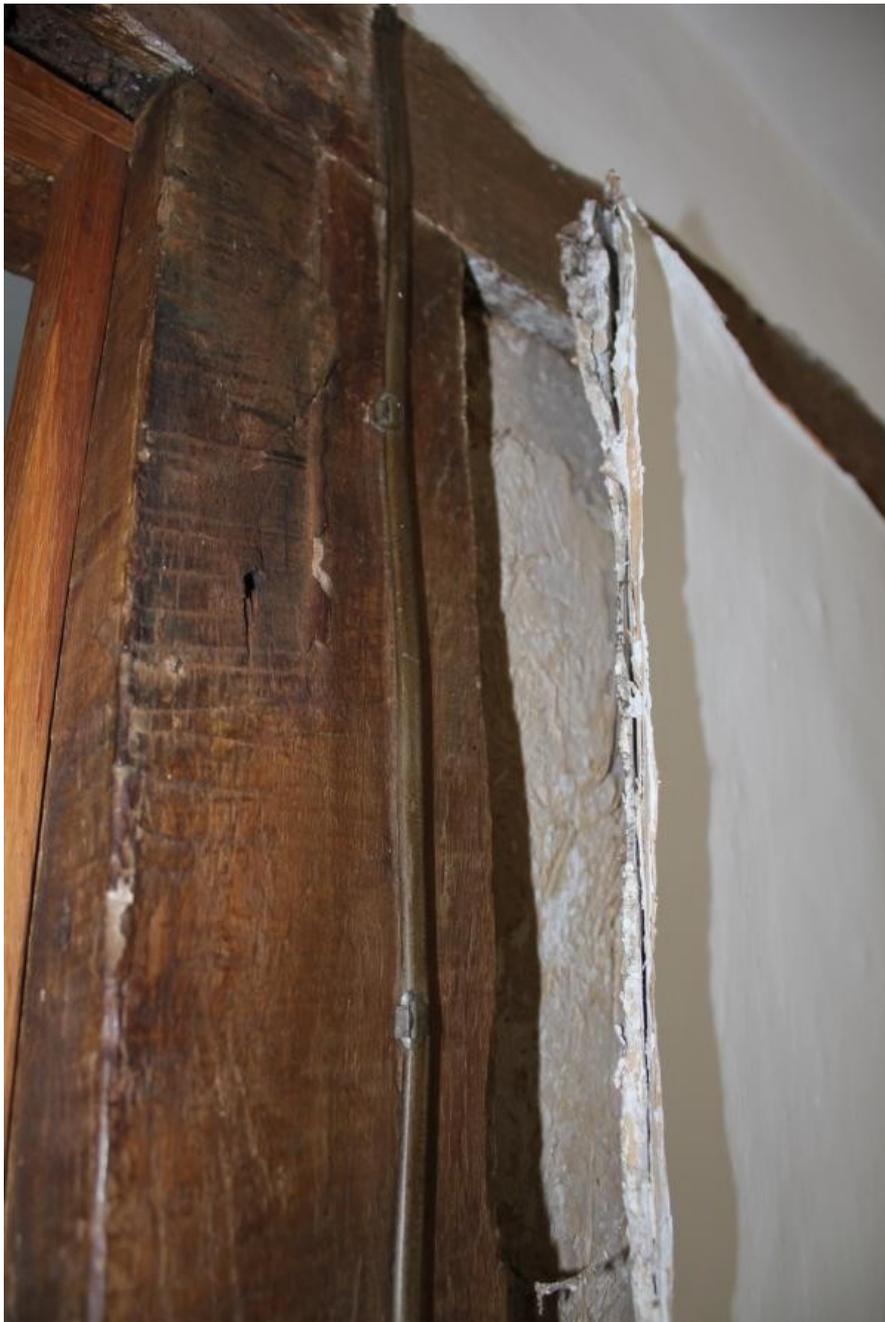
Plate 9: Period B daub seen in Bay 1 underneath modern plaster

At first floor level the majority of the walls are daubed and are likely to date from this period although an earlier Period A date cannot be ruled out for the side walls. The south wall is daubed but not Period A as the former empty mortices for staves from this period are evident. The rear north wall and a partition wall in Bay 1 is also daubed (Plate 9) but more likely to be from Period B. This partition wall runs in an east to west direction to the side of the main chamber in Bay 1 and currently has a modern doorway within. A careful study of this wall would point to no Period B doorway within (as indicated by a continuous sole plate which has since been cut through). So the entrance into this room would have been from the probable central stairwell in Bay 2 (see Fig.10 below), where a later partition wall has been added with modern cupboards now filling the space. This design would have given one larger chamber and one smaller chamber with independent access.

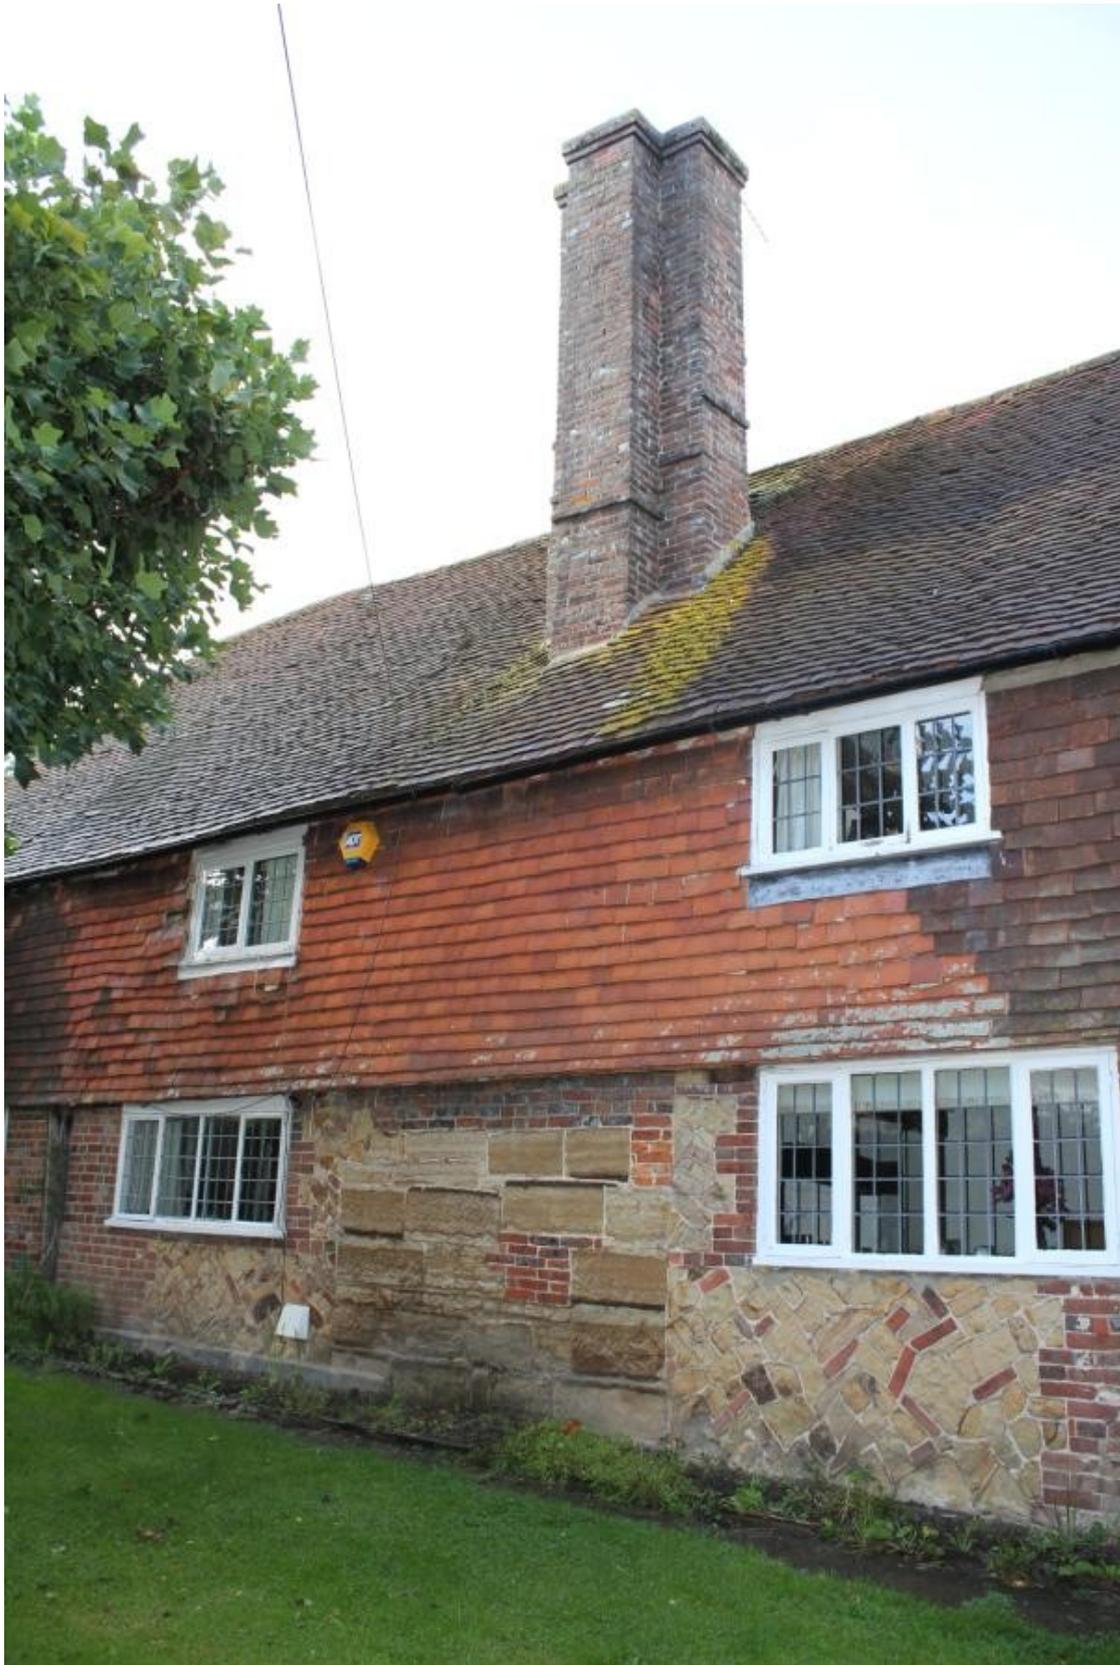
Plate 10: Modern windows in the south elevation are likely to be in Period B apertures

There are no original **Period B** windows surviving within the building but it is highly likely that the existing modern windows within Bays 1-3 at both levels are situated within **Period B** apertures (Plates 10-11). The windows in the southern elevation at ground level would have been smaller than those that exist today, as seen in the lines of brickwork which the modern windows cut through. Two probable contemporary south facing doorways to either side of the cottages have since been blocked up in these locations (see Section 5.4). Plate 11 shows another larger window to the western cottage at ground floor level. The brick quoins show that the window would have matched the smaller one on the eastern side. Without further evidence for these, nothing further can be stated about the likely position of the **Period B** windows, especially at first floor level.

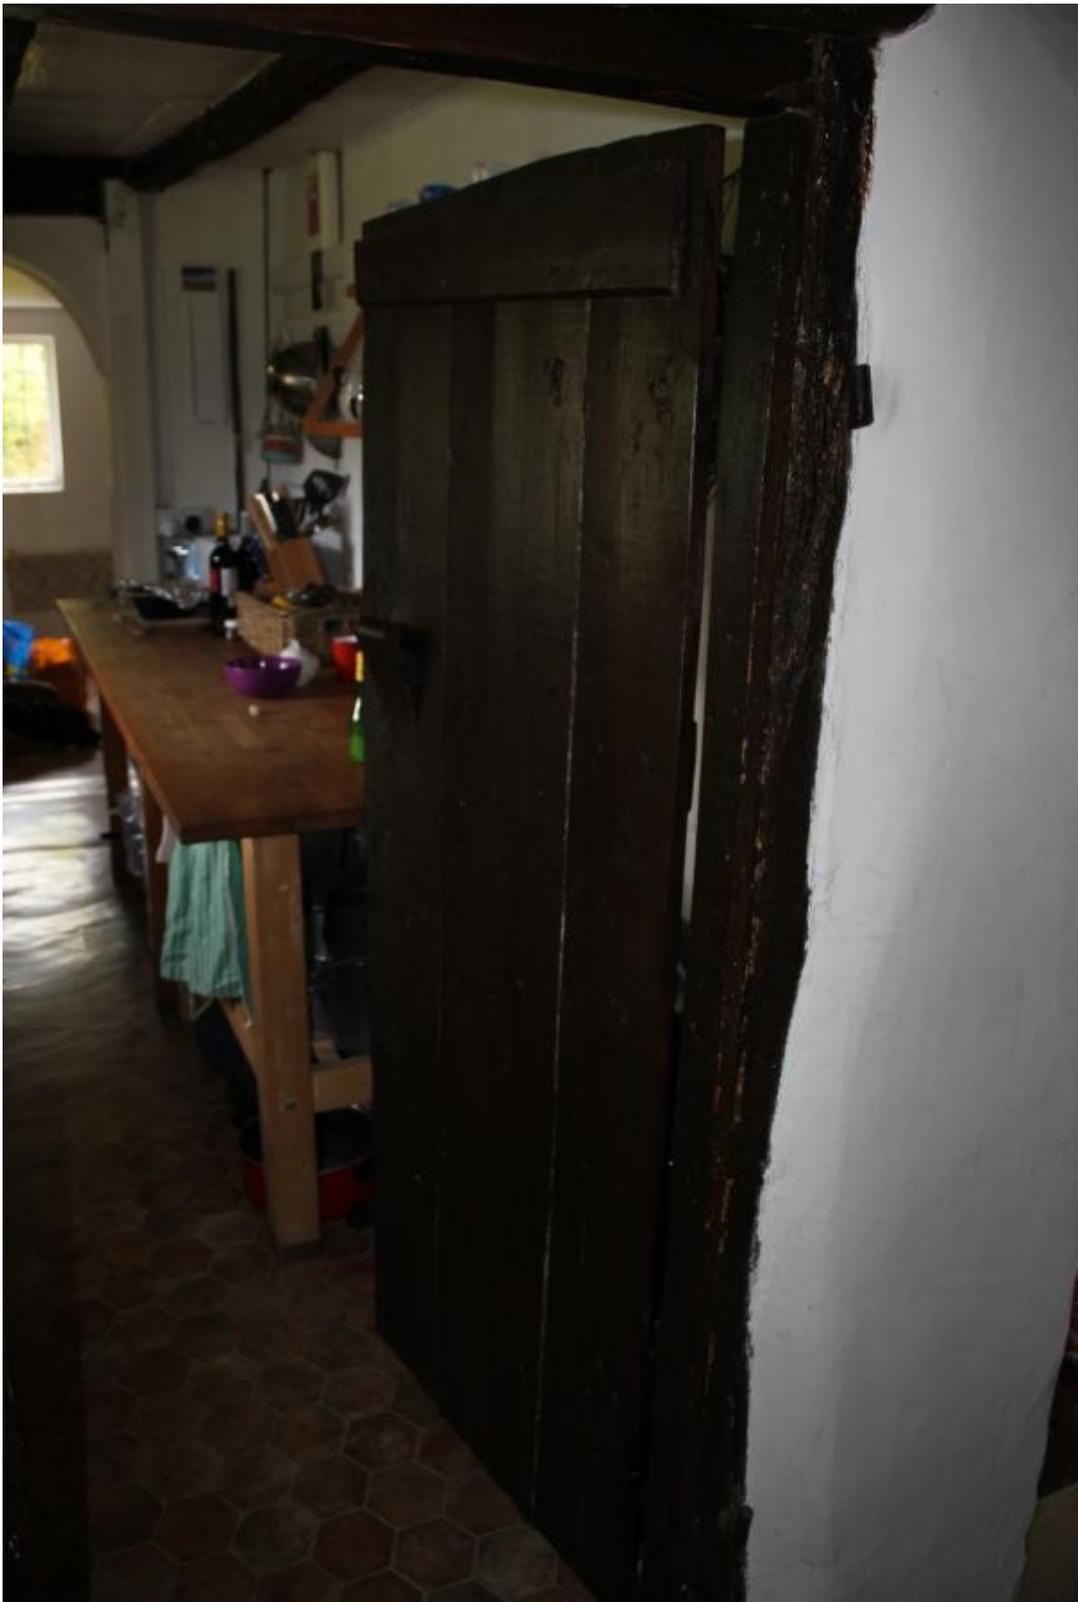
Plate 12: Possible Period B ledge and brace door in Truss B at ground floor level

Within Truss B at ground floor level there is a Ledge and brace door into a modern kitchen in Bay 1 which is potentially an *in-situ* door from **Period B** (Plate 12). An opposing doorway in Truss C has been moved slightly to the north (Plate 13). There is a second Ledge and brace door on the first floor within Truss A which is very similar to that on the ground floor but has been re-positioned (Plate 14).

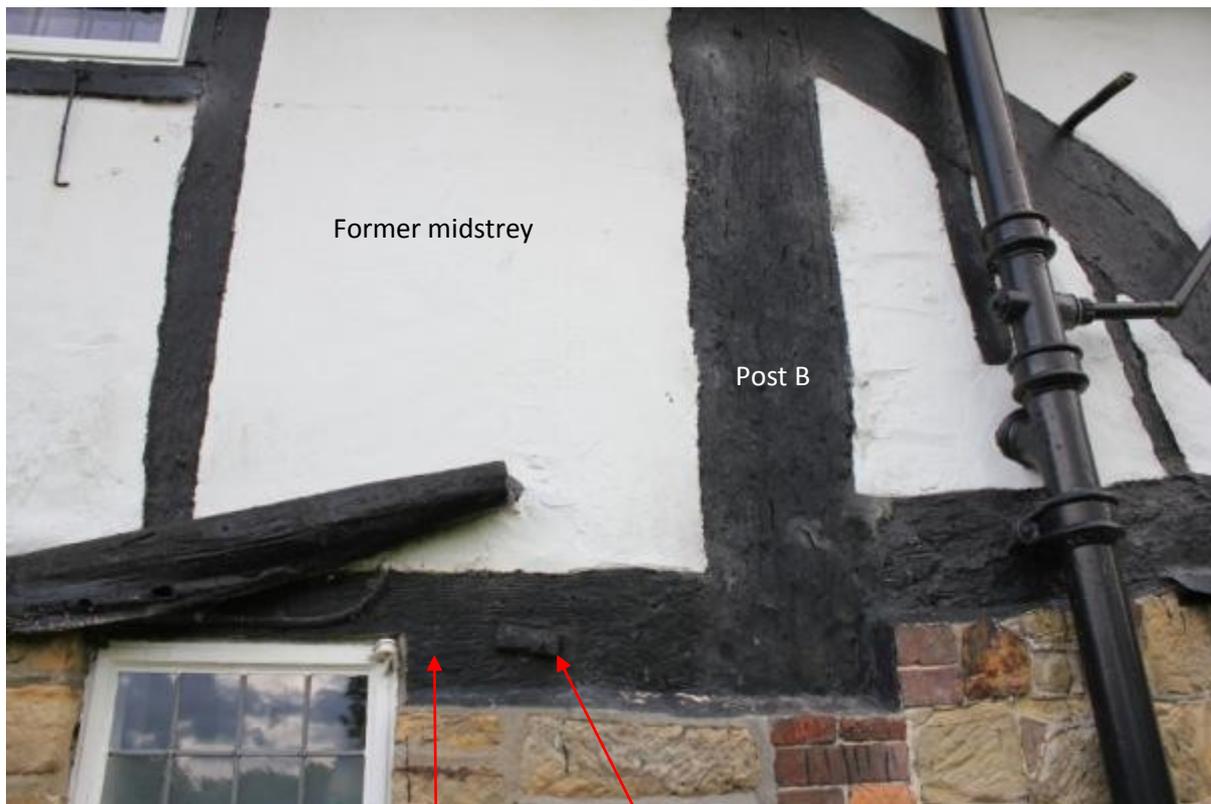
Plate 15: Inserted side girt with end tenon of cross beam of new floor projecting behind Truss B

At ground floor level the Joists measure 100mm (wide) x 90mm (deep) as a minimum. These form the inserted floor which has been constructed by the addition of two cross beams within Trusses B and C, which have been morticed into the new side girts (Plate 15). These new side girts have, in

turn, been inserted into the **Period A** midstrey to the north and south elevations of the building.

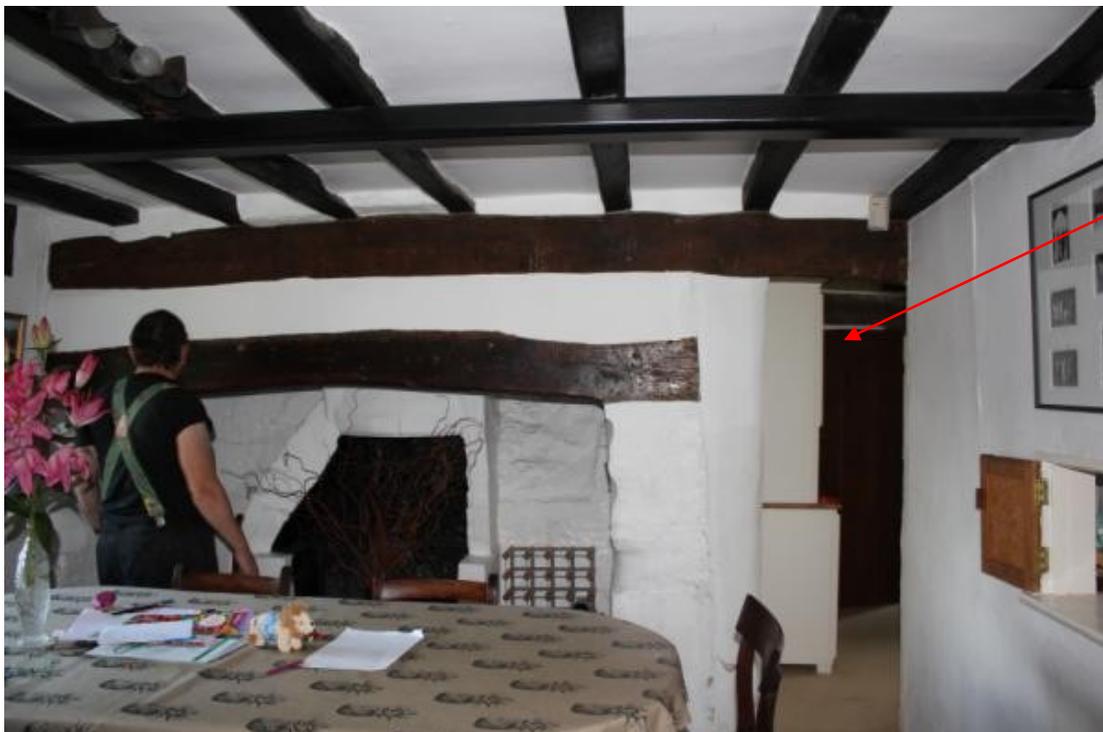
Plate 16: The fireplace in Bay 1

At ground floor level in Bay 1 the fireplace once housed a bread oven to the north side of the fireplace which would have occupied a large space in Bay 2 and is now removed with only the blocked up door visible inside the fireplace. There are empty peg holes for former shelf pegs in the bressumer above (which is slightly cambered) and the fireplace is currently occupied by a later brick support and flue for a former cast iron range (Plate 16). The sandstone jambs to either side have been painted and there are two protection or Apotropaic burn marks on the cross beam above with the initials 'I.B' carved into the bressumer. The cast iron fireback within is inscribed '1651 & I.T' but this is unlikely to be original to the building. There are deeply cut knife sharpening marks on both jambs.

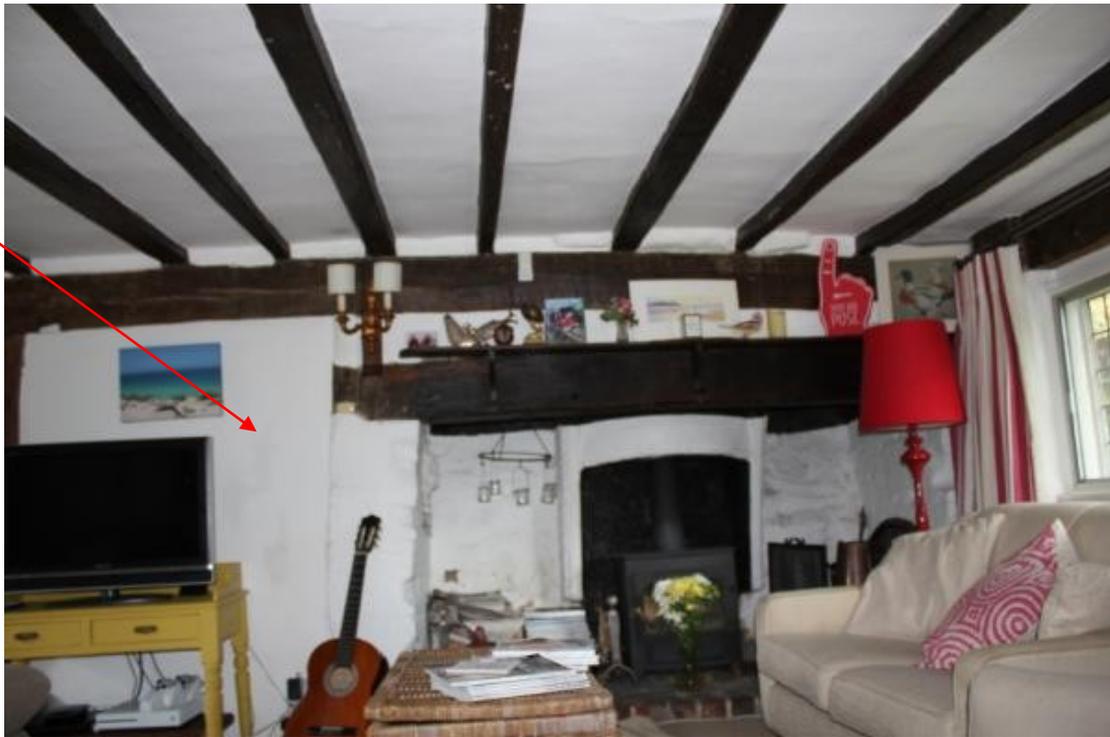
Plate 17: Fireplace in Bay 3

Bay 3 at ground floor level mirrors that in Bay 1, except the range flue is of a slightly different design and the bressumer not so cambered. There are also empty peg holes for a shelf in the bressumer and one protection or Apotropaic burn mark in the cross beam. The cast iron fireback within is inscribed "1571" and there are additional knife sharpening marks on both jambs.

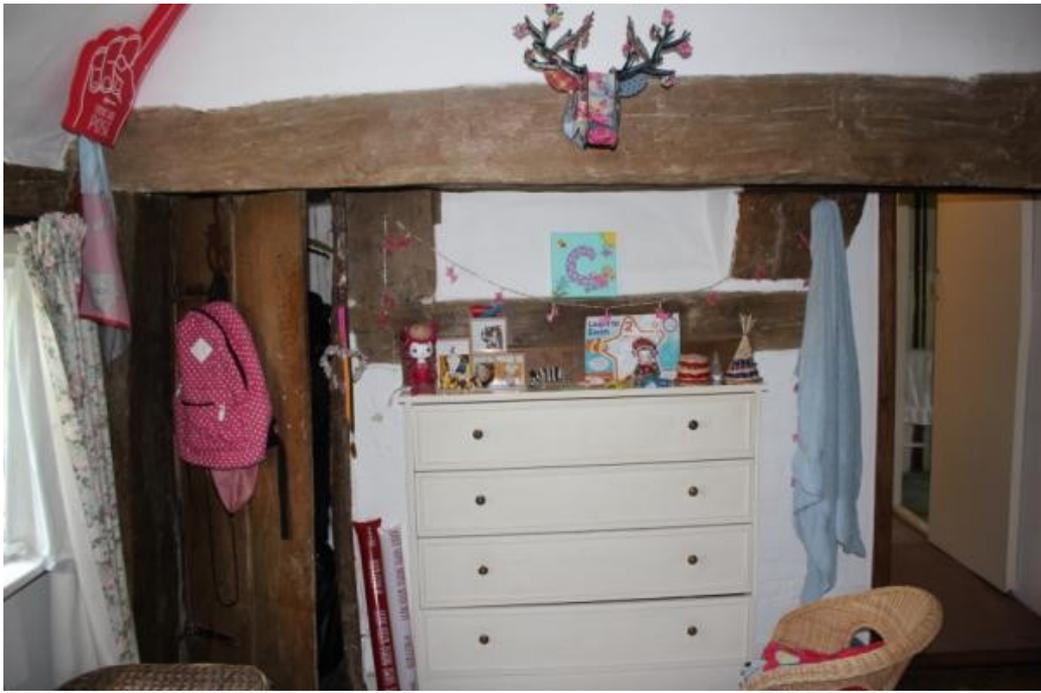
Plate 18: Blocked fireplace in Bay 2 set back from the face of Truss B

At the first floor level in Bay 2 is a blocked **Period B** fireplace which is set back to the west side of Truss B (Plate 18) with some boxing of space between the tie-beam and the stack. The fireplace serving Bay 3 is also set back to the east face of Truss C (Plate 19). There are two small cupboard spaces situated to the south side of the stack which may even have given access into the roof space during this period, possibly by means of ladder. The doors to these small spaces would appear to be contemporary with this period; as are the strap hinges (Plate 20) which compare favourably with ones dated to 1727 from Wight⁶.

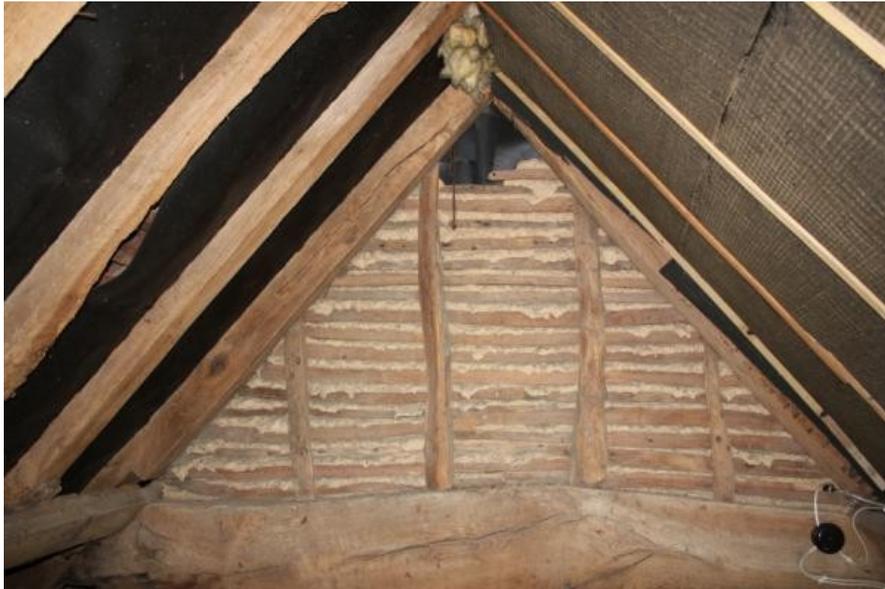
Plate 21: pushed through daub on eastern face of Truss B

Truss B in the roof has had some additions during this period. Further studs have been nailed above and below the collar (inserted by means of a grooved mortice in the top of the collar) so that daub could be applied; one of these is possibly a re-used feeding rack. The daub is smoothed and lime-washed on the eastern face below the collar but coarsely pushed through the laths (possibly riven chestnut?) above the collar (Plate 21). On the reverse western side, all of the daub above and below the collar is smoothed but none of it is lime-washed (Plate 22).

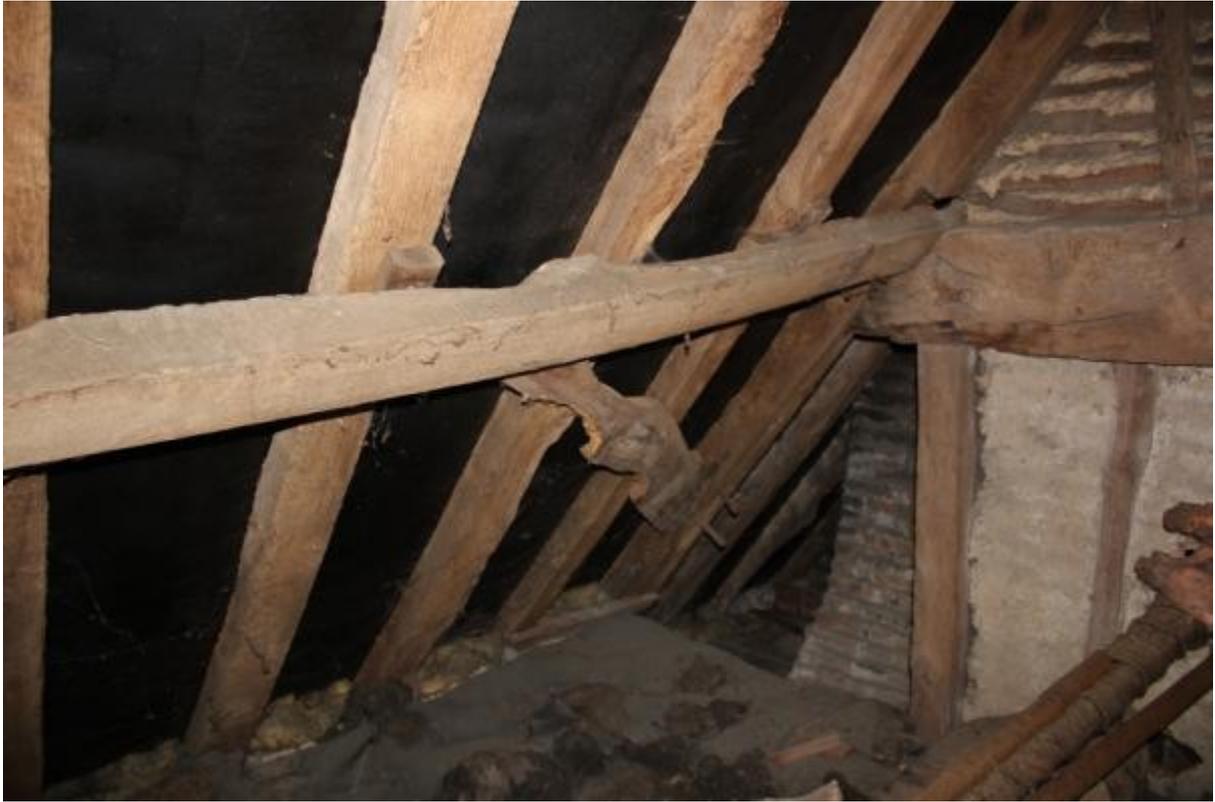
Plate 23: Open access area beside the stack in Truss B

There is no daub to the sides of the stack. The open space beside the stack on the south side (Plate 23) is large enough for access as previously discussed in section 5.7. Where this space opens up into the roof, it is not partitioned off below the collar as elsewhere below Truss B, thus ensuring access into Bay 1 only. Bay 2 and 3 would have been accessed by the opposing space on the western side of the stack as the partition wall in Truss B did not originally open into Bay 2.
