HISTORIC BUILDING RECORD FOR PRIORS CROFT, COWDEN, KENT.

Report number: ASL 132-17

SUMMARY

This Historic Building Record has been prepared by Archaeology Services Lewes for the owners, Mr and Mrs Burrows (The Clients) who put forward a planning application for a scheme of renovations and alterations within their property known as Priors Croft, Spode Lane, Kent, TN8 7HW.

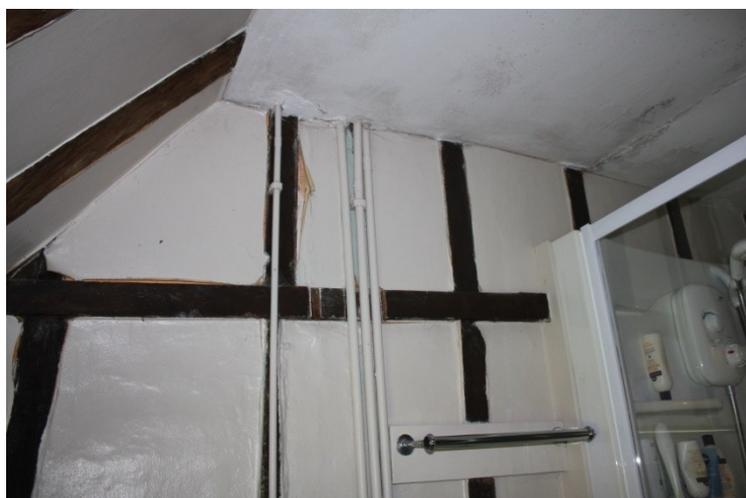
Plate 24: Additional 'fillets' inserted into Truss B to raise the ceiling height

- 6.5 The ceiling height on the first floor was also raised in order to give adequate head room. This increase can clearly be seen in Plate 24 where additional partition 'fillets' have been added above the line of the tie-beam.
