**AN ARCHAEOLOGICAL WATCHING BRIEF AT BUCKHURST
PARK, WITHYHAM, EAST SUSSEX.**

Archaeology Services, Lewes.

Project No: ASL 21/14

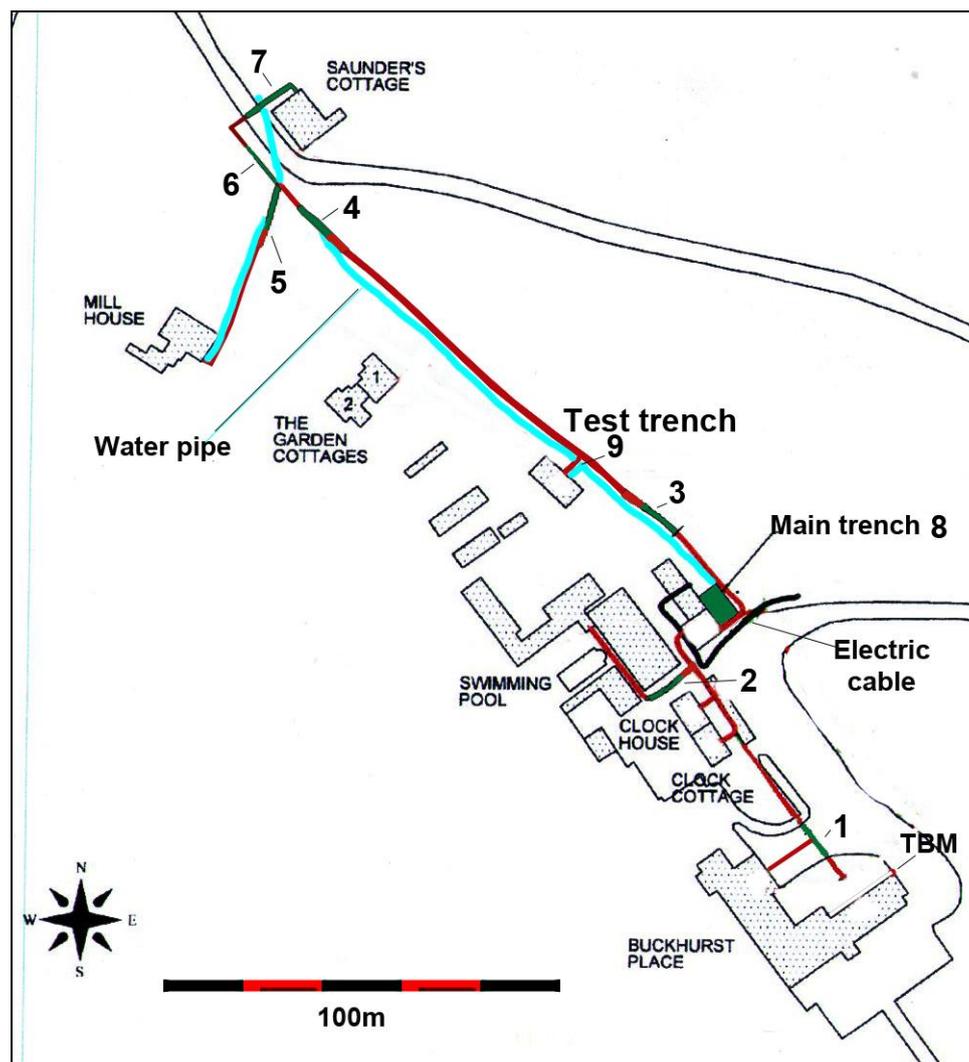
Fig.2 - Site plans showing pipe runs in red with monitored areas highlighted in green and numbered 1-9. The blue lines indicate areas previously excavated for water pipes.

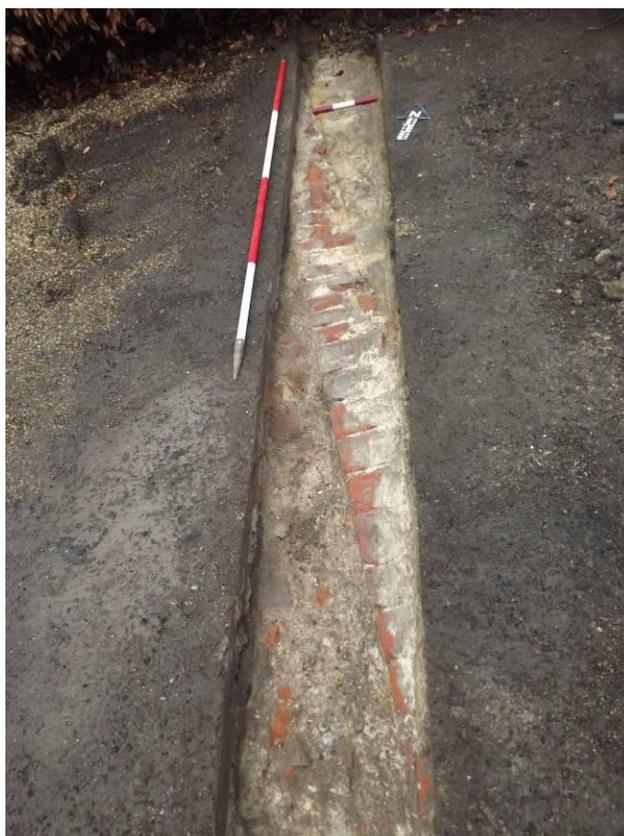
Plate 1. Pipe trench 1 with feature [100] Scales 2m and 30cm

There were three features found within this 10m x 40cm trench, which consisted of demolished foundations for the Victorian north wing of the main house, for which an existing ground plan was consulted to place any foundations uncovered (Fig.10). As there was no topsoil and the trench opened straight onto demolition rubble, this layer was not given a context. The first foundation uncovered was given context number [100] and was the remains of the outside, north east facing wall which consisted of rough faced ashlar block on the inside face but the outside face lay under Tarmac and was not revealed. The top of the sandstone was covered in mortar and so it was not possible to draw each block individually and has been shaded in the scale drawing.

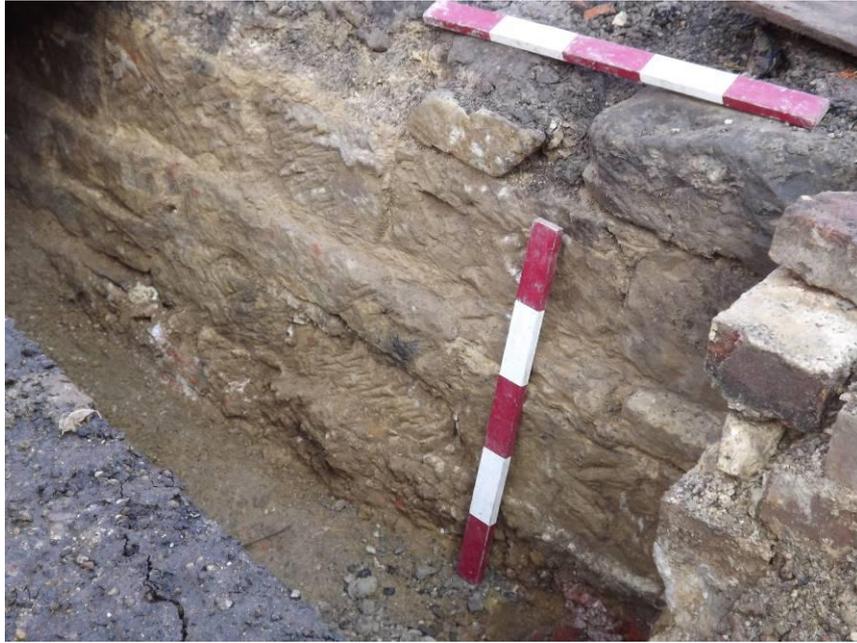
Plate 2. Shot facing NE, view of the sandstone foundation once the bricks had been removed.
Scales 50cm.

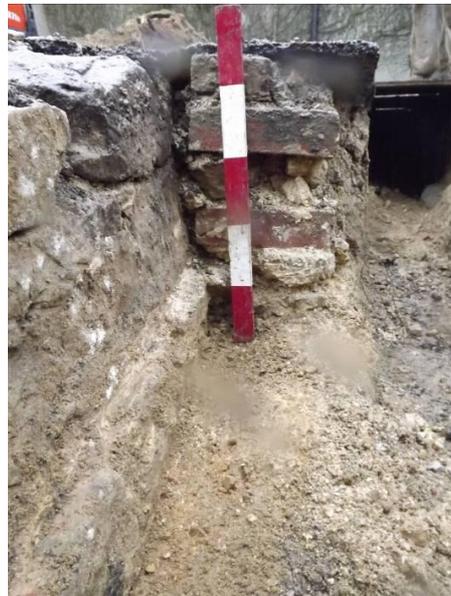
Plate 3. Shot facing south east, section across the brick and stone foundation of [100] scales
50cm.

To the inside of this wall was a single skimmed brick wall laid in a rather haphazard way with some bricks on edge and some on bed, which did not appear to be tied into the main sandstone wall although this is likely, so it was kept as the same context as it was not initially clear if the two foundations were one wall. It is unlikely that this was structural and its purpose is unclear. A slot was dug down the side of the footings to see if the base could be revealed, which was evident at a depth of 78cm below the top level of the tarmac driveway.

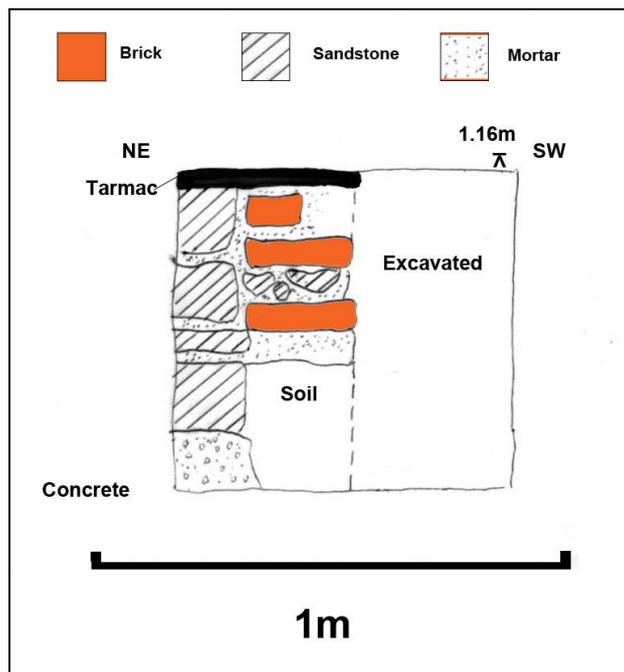
Fig.8. Section drawing of wall foundation [100] in pipe trench 1 drawn at 1:10

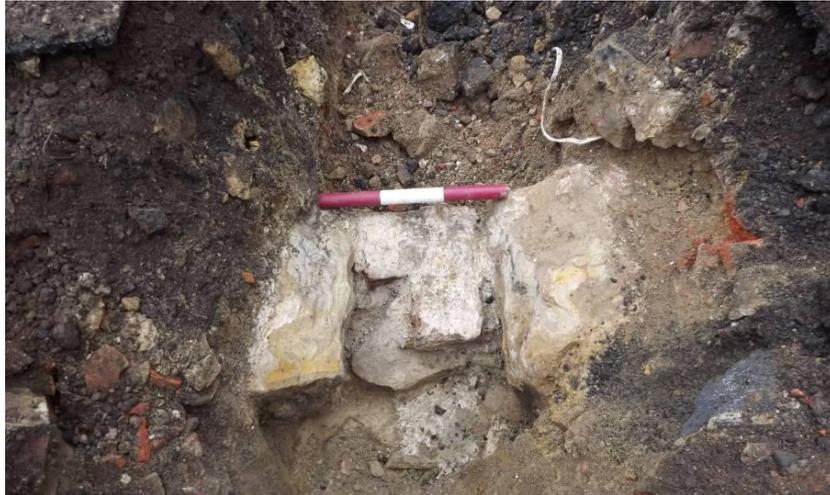
Plate 4. Shot facing north west, foundation [101] scales 30cm

The second foundation wall [101] was equally odd in that a large gap lay between two substantial sandstone blocks which were effectively blocked brick only 20cm in width, with glimpses of some brick underlying the sandstone. It would appear to be a wall built from re-used materials and this wall is indicated on the ground plan drawn before the wing was demolished. There was a very loose area of hardcore and demolition rubble to either side of the wall. It was faced to the south with concrete render painted white. This was not drawn in section but on plan and photographed only. On the ground plan which was drawn up before the Victorian wing was demolished, this section of wall would appear to demarcate the internal north wall between the Butler's pantry and a corridor next to a store room. This would explain why it is not a substantial foundation.

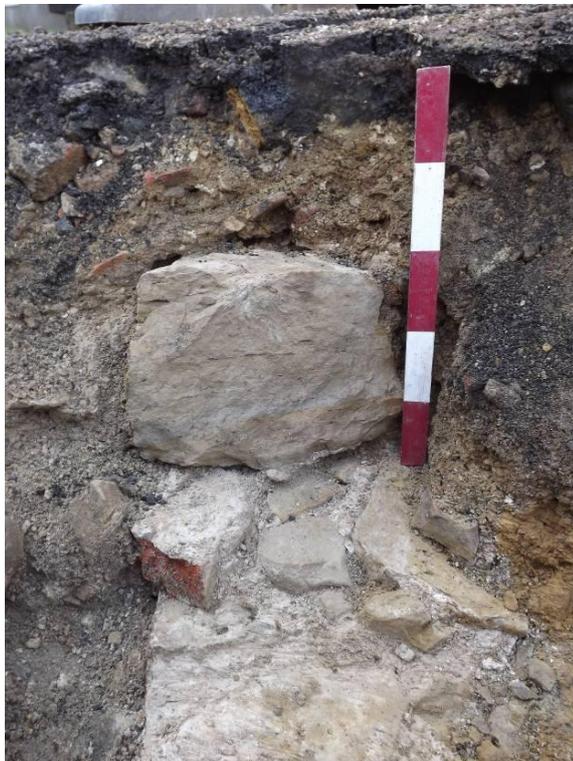
Plate 5. Shot facing west section through [101] with removed brick. Scales 50cm.

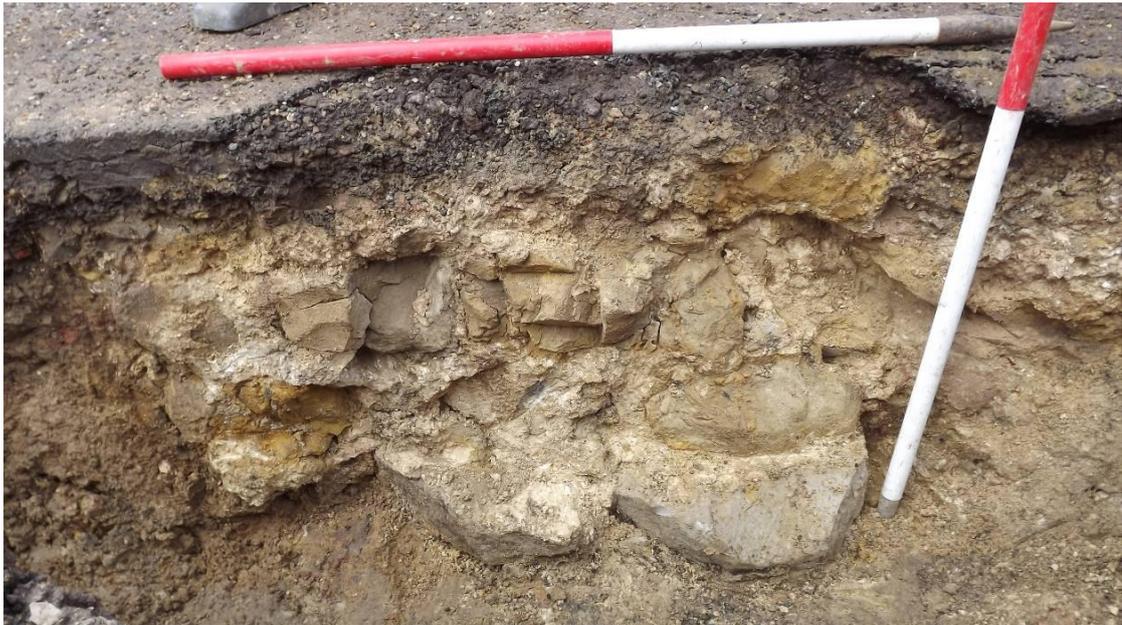
Plate 6, shot facing west showing [102] foundation. Scales 1m.

The third wall [102] was also sandstone but not bottomed but likely to be of a similar depth to the other foundations. This wall appears on the ground plan as the side of a fireplace in the Housekeepers room which would explain the width of it, at 1m wide which is effectively the depth of the flue. This is backed up by further work by the contractors who extended to the side of this trench and reported that the fill consisted of very sooty and burnt deposits with a solid concrete hearth further down trench where a second fireplace was positioned. This would nicely confirm that the ground plans for the north wing can be relied on to tie in the archaeology.

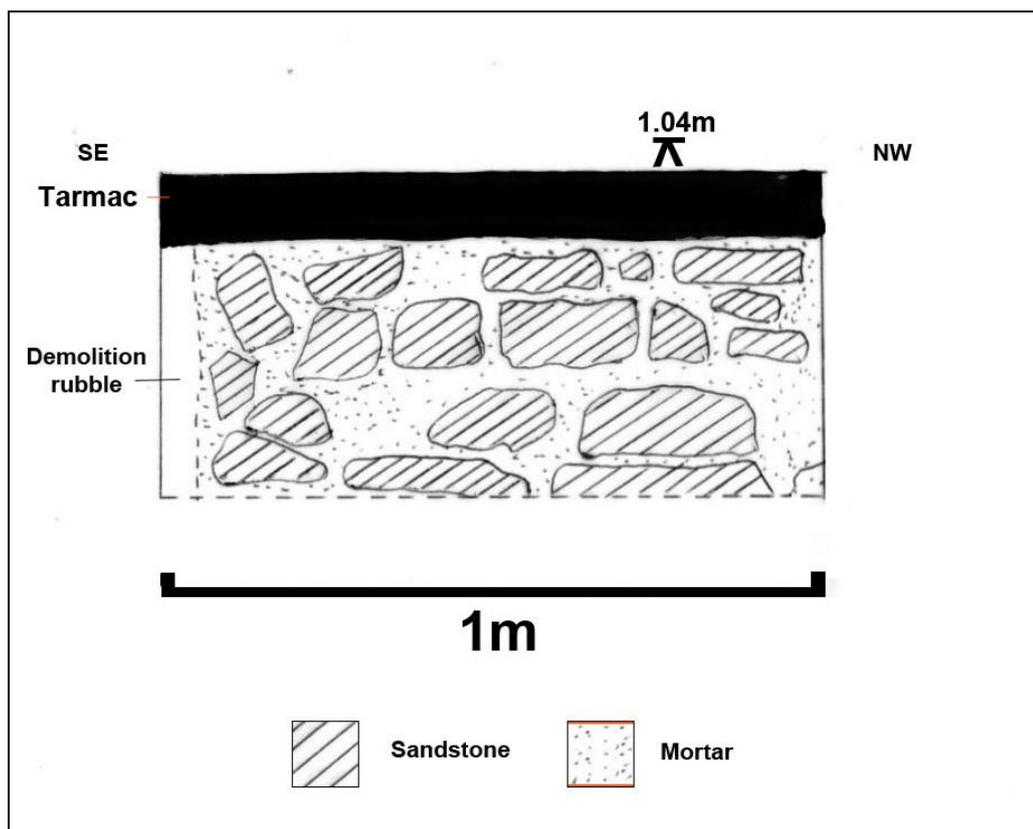
Fig.9. Section drawing of wall foundation [102] in pipe trench 1 drawn at 1:10.

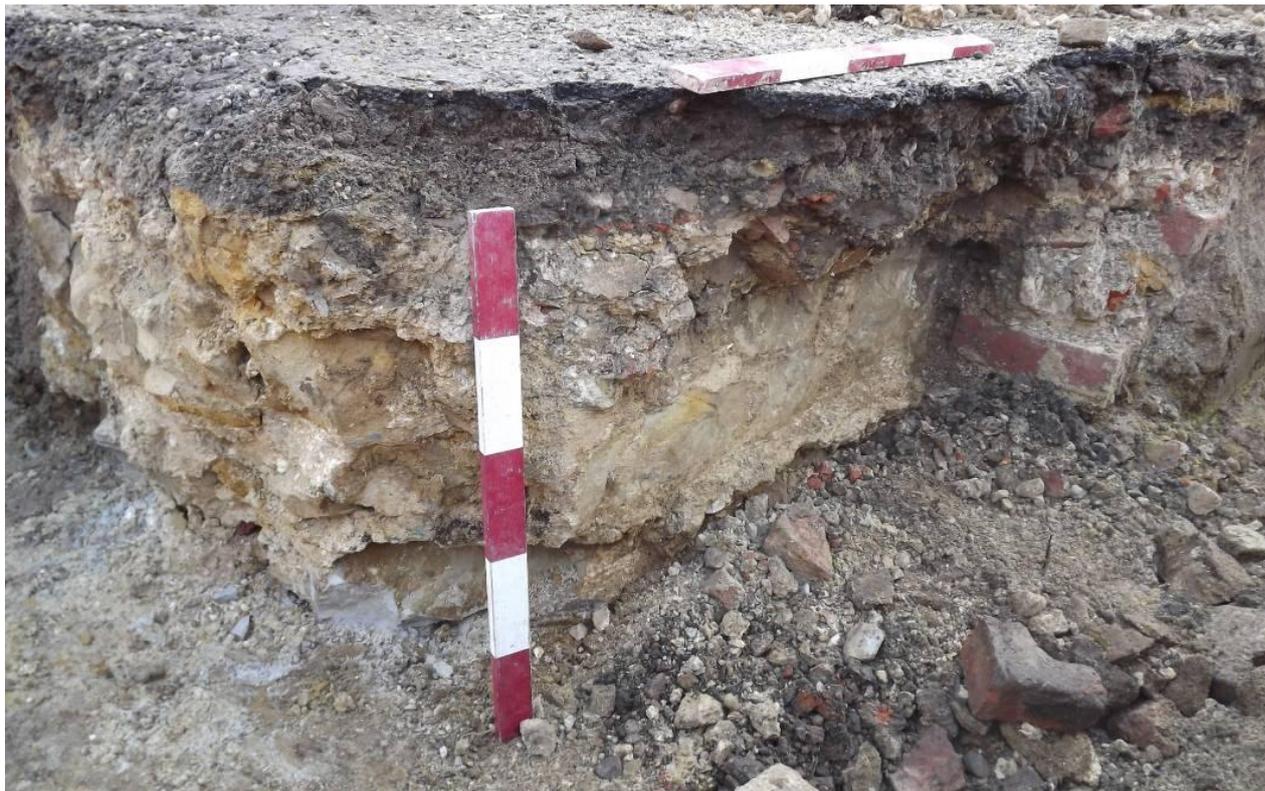
Plate 7. Shot facing south looking at corner of [102] showing brick fireplace beyond. Scales 50cm.

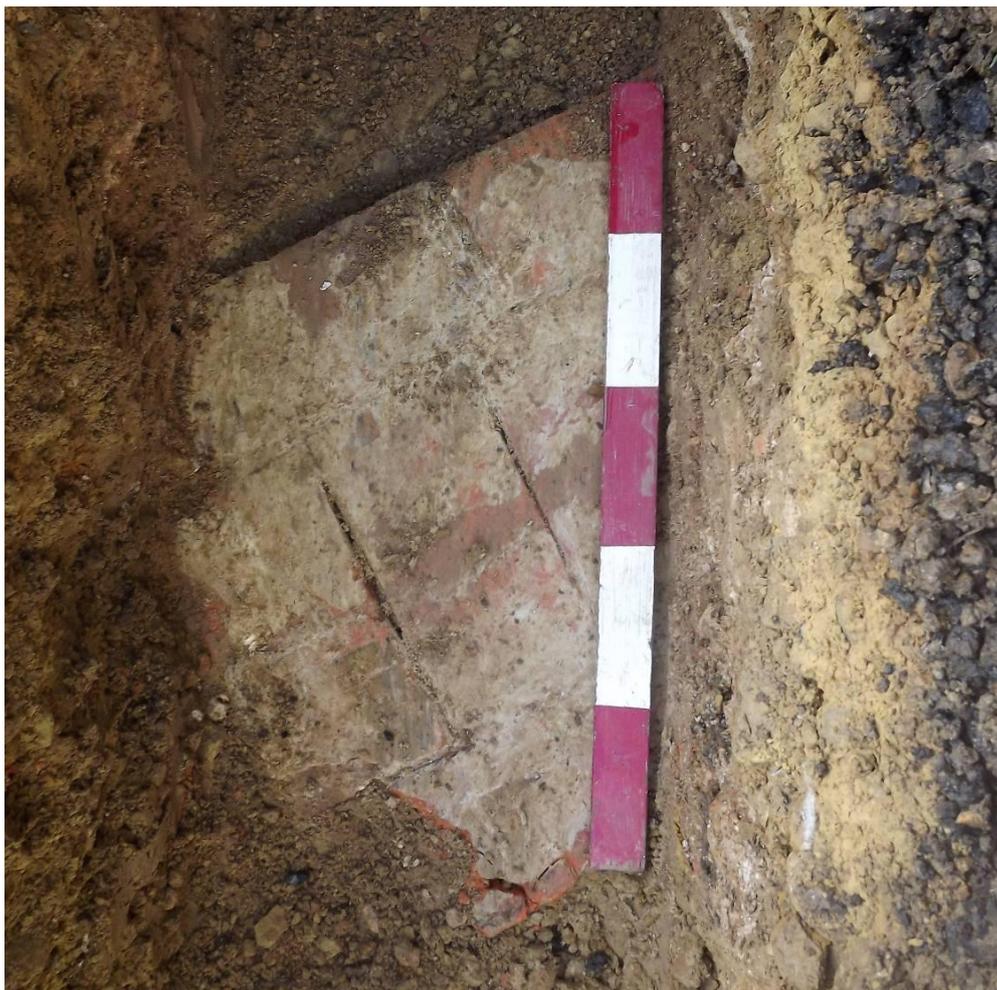
Plate 8 .Wall foundation [200] Shot facing NE (scales 50cm)

This trench, also 10m x 40cm, revealed two features, also wall foundations but ones which were not included on the ground plans of the north wing so this potentially reveals buildings not recorded before. The first wall [200] was brick built in English Bond, laid on bed and 46cm in width. The orientation of this wall is interesting as it does not lie at right angles with any of the nearby buildings. Nearby Clockhouse Cottages is also English Bond brick built. However, if this wall continued for any distance it would effectively block off the NE gateway and entrance to the farm yard. This wall, therefore, potentially pre-dates the Victorian phase of the north wing construction. The size of the bricks would suggest a likely Victorian date though. One piece of painted white render was found adjacent to it.

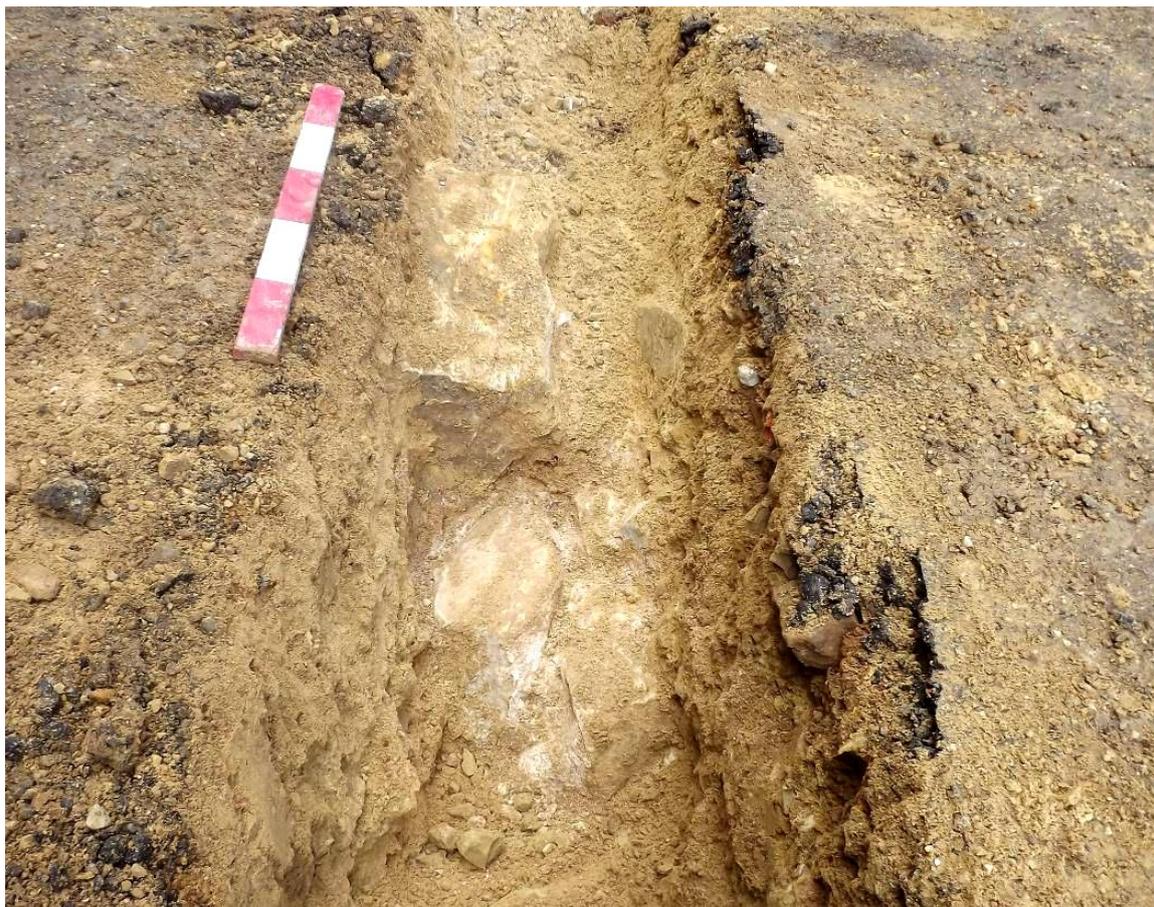
Plate 9. Shot facing north west, showing foundation [201] scales 50cm.

The second wall [201] is very substantial, measuring 1m in width and constructed from rubble sandstone with no clear facing side. Both of these wall foundations were surrounded by Victorian demolition rubble, containing sandstone, broken brick and other CBM, Victorian pottery and fragments of iron and as this was not an in-situ soil worthy of recording this layer was not given a context number. The sandstone wall was only 9cm under the Tarmac which is consistent with the depth below ground levels of the foundations in pipe trench 1. This foundation has clearly been hacked at during demolition as it was not entirely clear which direction it faced and there were chunks which had previously been removed. With such a narrow trench it is difficult to interpret this further other than to say that as it lie in the middle of the entrance from the NE gateway to the farm yard, it probably pre-dates the Victorian phase. It lay equidistant between Clockhouse Cottages (3m) and the listed Racquet court (3.10m) which was built in the late C18th and is also made of sandstone. It would be logical to suggest that this wall perhaps formed a flanking boundary wall adjacent to the side of the building or some sort of porch to the entrance but there is no evidence on the outside of the building to suggest any kind of attachment.

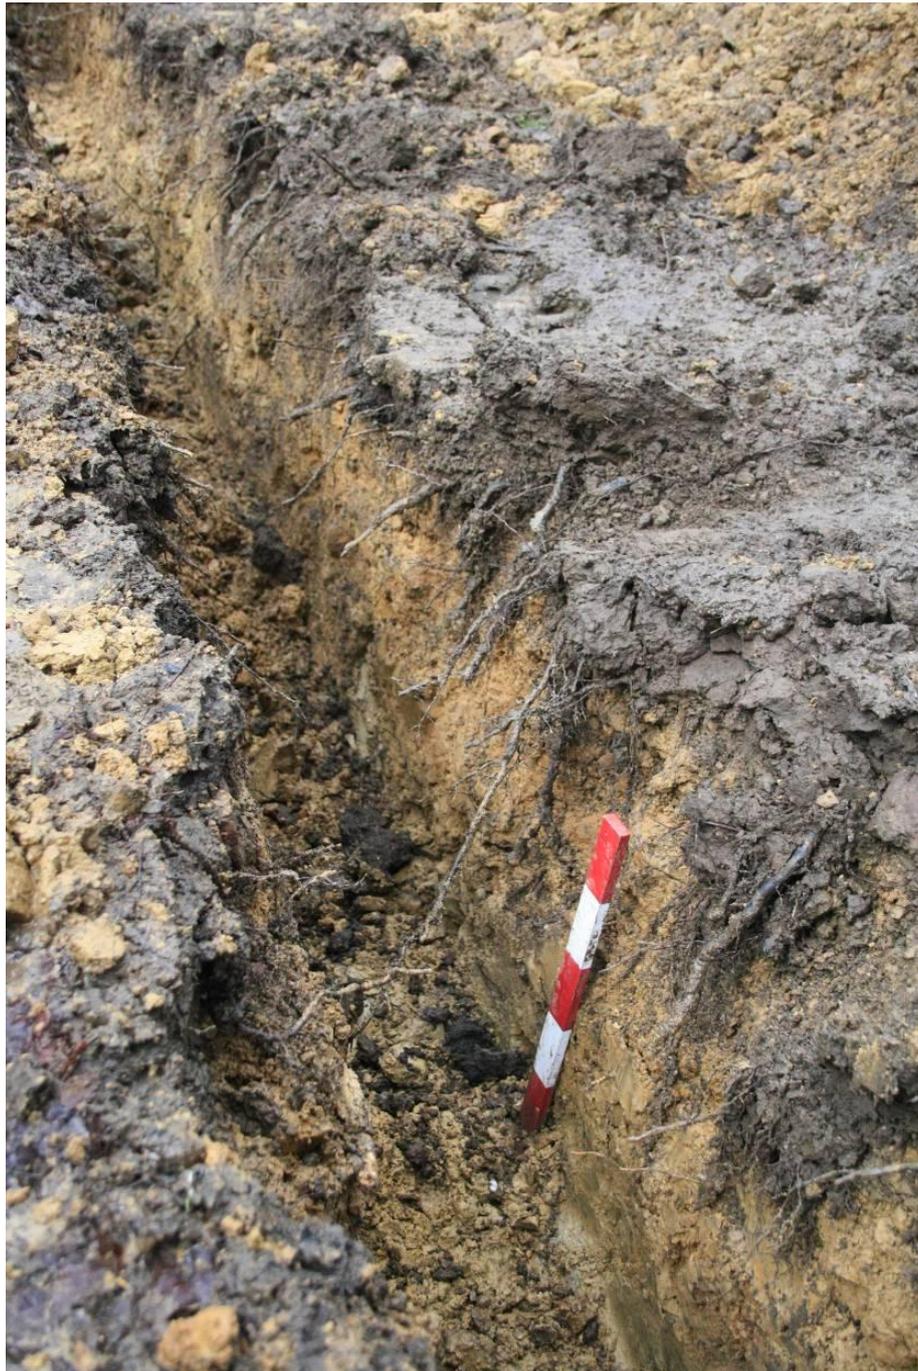
Plate 10. Shot facing south. View looking up pipe trench 3, scales 50cm.

This area contained no features except for a Victorian brick lined drain which lie on the surface at current ground levels. This surface drain ran all the way down the trackway to the bottom road surface. It was evident that the nearby, recently excavated water pipe (Nov. 2013) lie close by within a metre or so (westwards). Very little in-situ soils remain in this area and it became fairly apparent that the trackway had, in fact, been levelled to create the flat surface which had removed any in-situ soils that were once in existence. The story was similar all the way down the track way and so this area was watched but a cursory record made of the area due to the lack of stratigraphy or features. This trench was dug to a total depth of 75cm but in general was only 55cm deep.

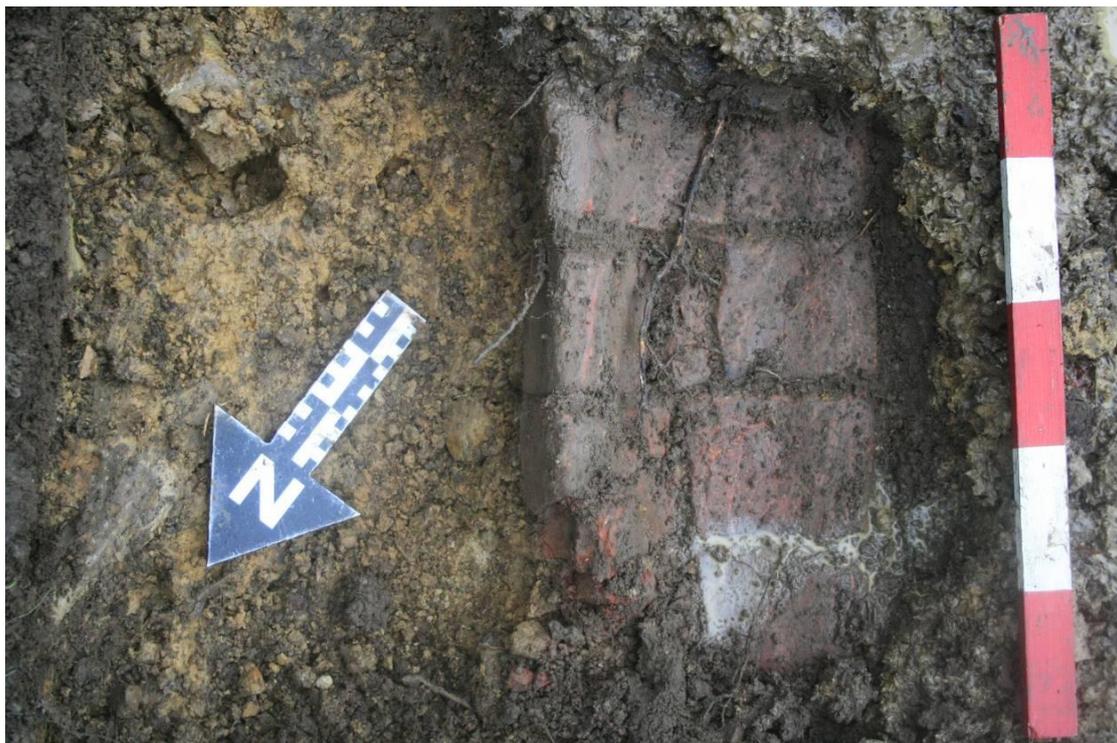
Plate 11. Drain feature which runs down extent of trackway. Scales 50cm.

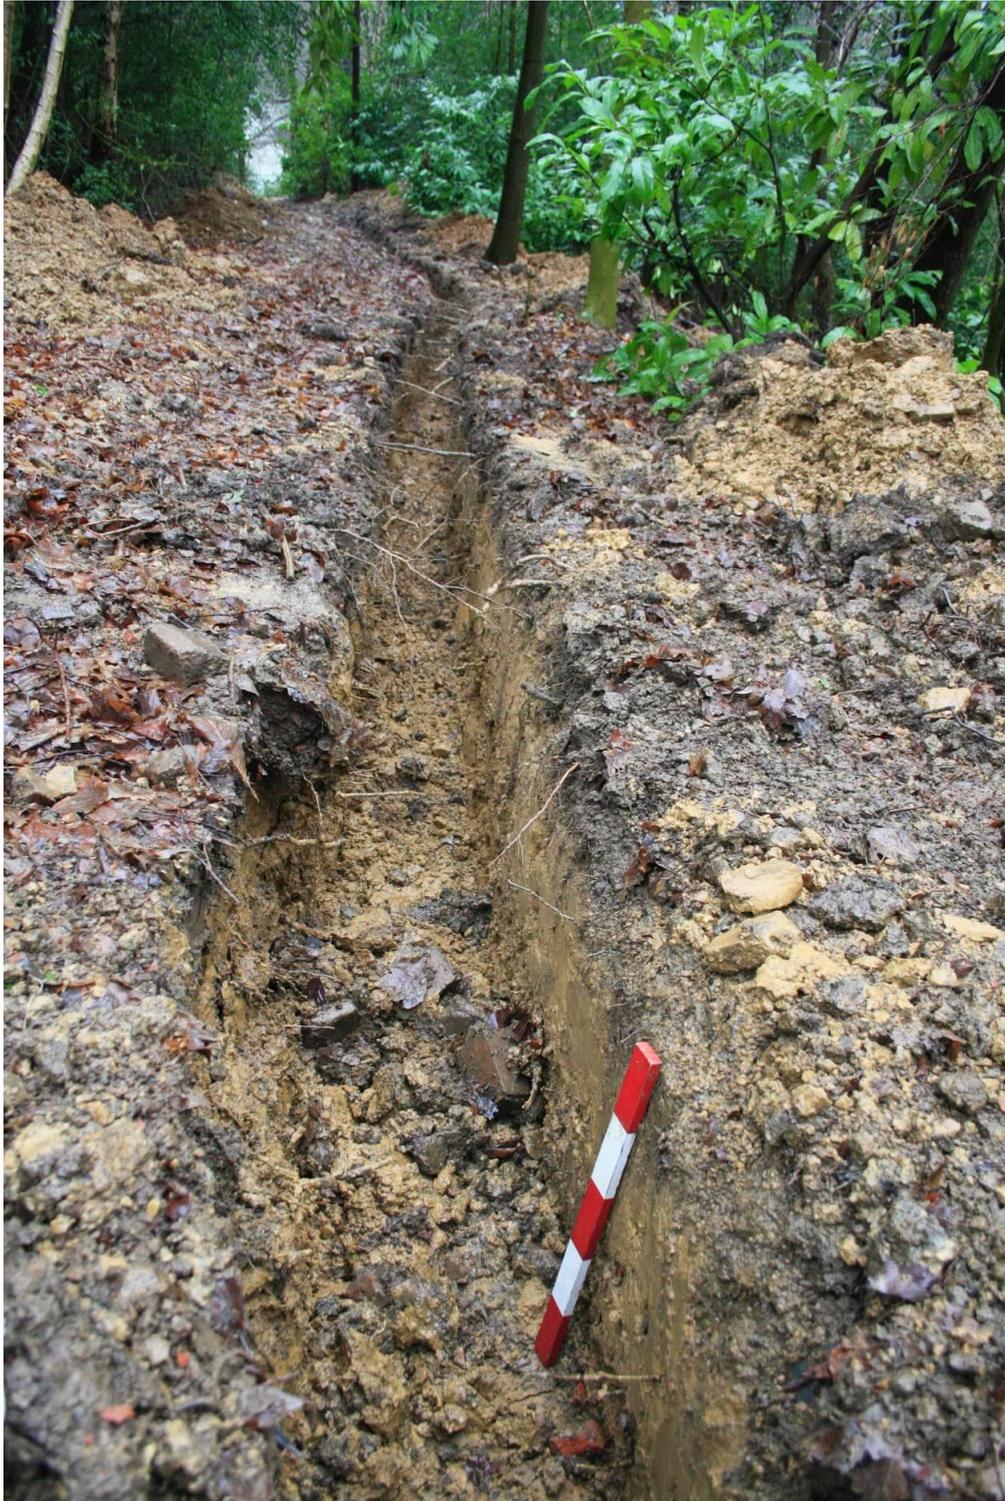
Plate 12. Shot facing north, pipe trench 4, scales 50cm.

This area was not watched during excavations but inspected after it had been excavated and it had a very shallow topsoil deposit. No features were evident and the bottom few metres of the targeted 10m stretch had previously been excavated for the insertion of the aforementioned water services which was visible for 3-4m in length down the trench. Half way uphill, solid, natural sandstone was encountered in the top 2m stretch of the trench and once more, very little surviving stratigraphy remained. No further action was taken, other than a cursory photographic record and context assignment for the topsoil.

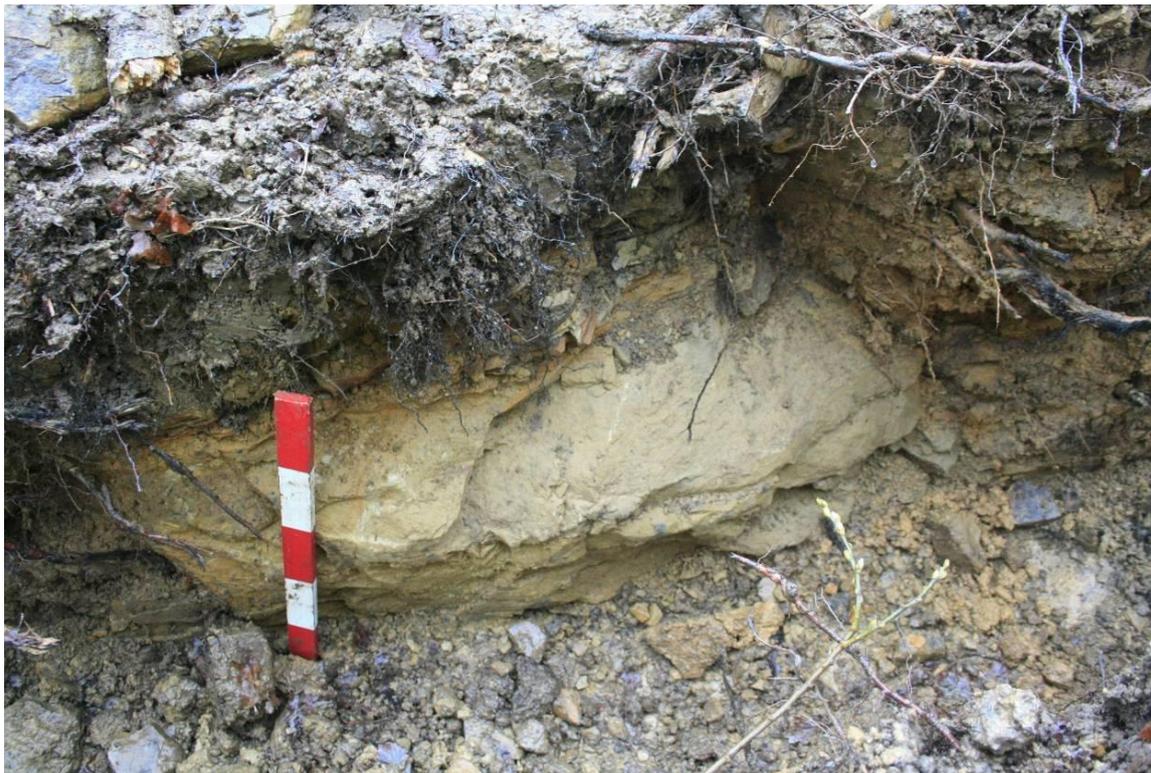
Plate 13. Shot facing east, natural sandstone in trench 4. Scales 50cm.

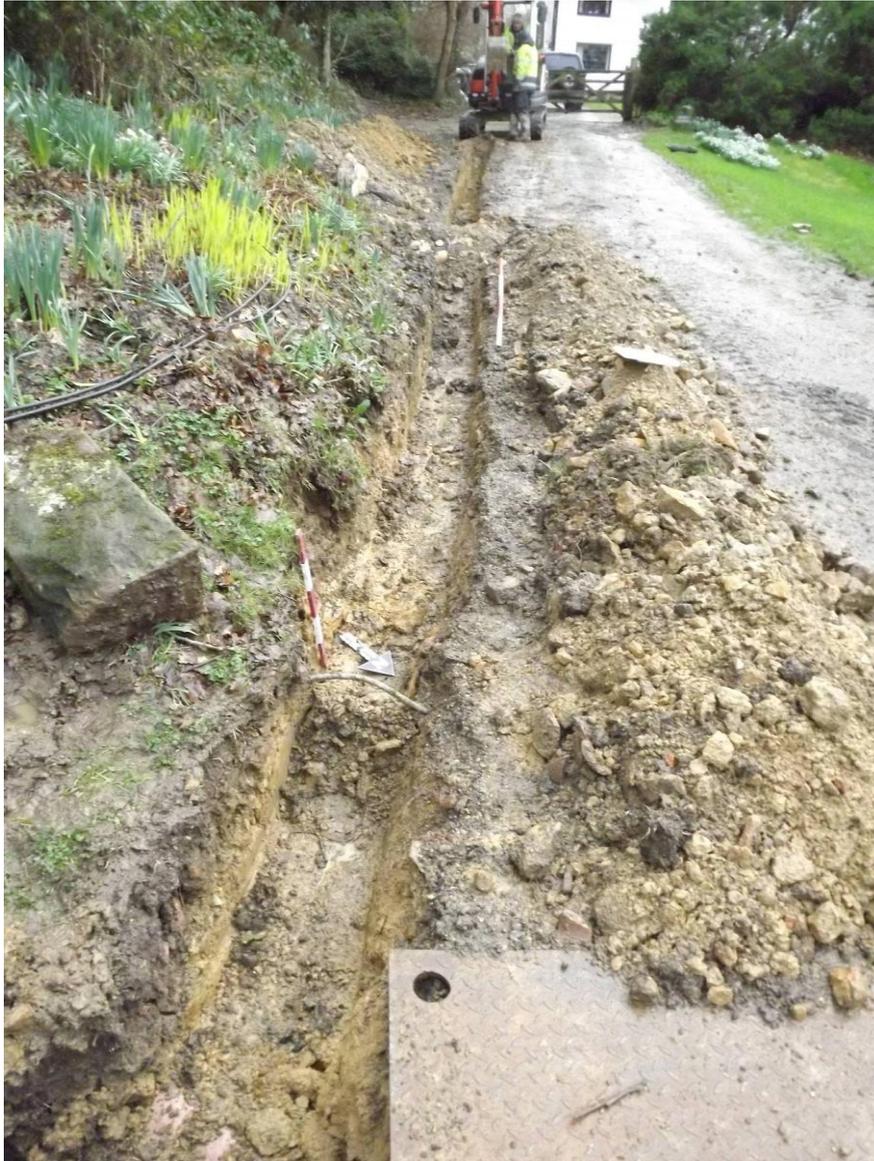
Plate 14. Pipe trench 5 running up to the Old Mill House. Scales 50cm.

Pipe trench 5 was targeted on a run up to the old Mill House and was originally sited so that the area up to the foundations could be observed. A change of plan was actioned as the water services previously excavated were to be re-used to put the pipe into this trench, after the MOT had been removed. Consequently, the monitored area was moved back down the track to watch an area not thought to have been previously excavated for the water mains. As a consequence, pipe trench 5 was watched at the same time as pipe trench 6 which was at right angles to pipe trench 5. In this trench, previous disturbance was noted where the mains sewer ran though this area and had been diverted. In addition, a further service pipe ran up part of the trench. These service areas have all been sketch planned and kept in the archive. No other features were apparent in this area, top soil was very thin and came down very rapidly onto natural sandstone.

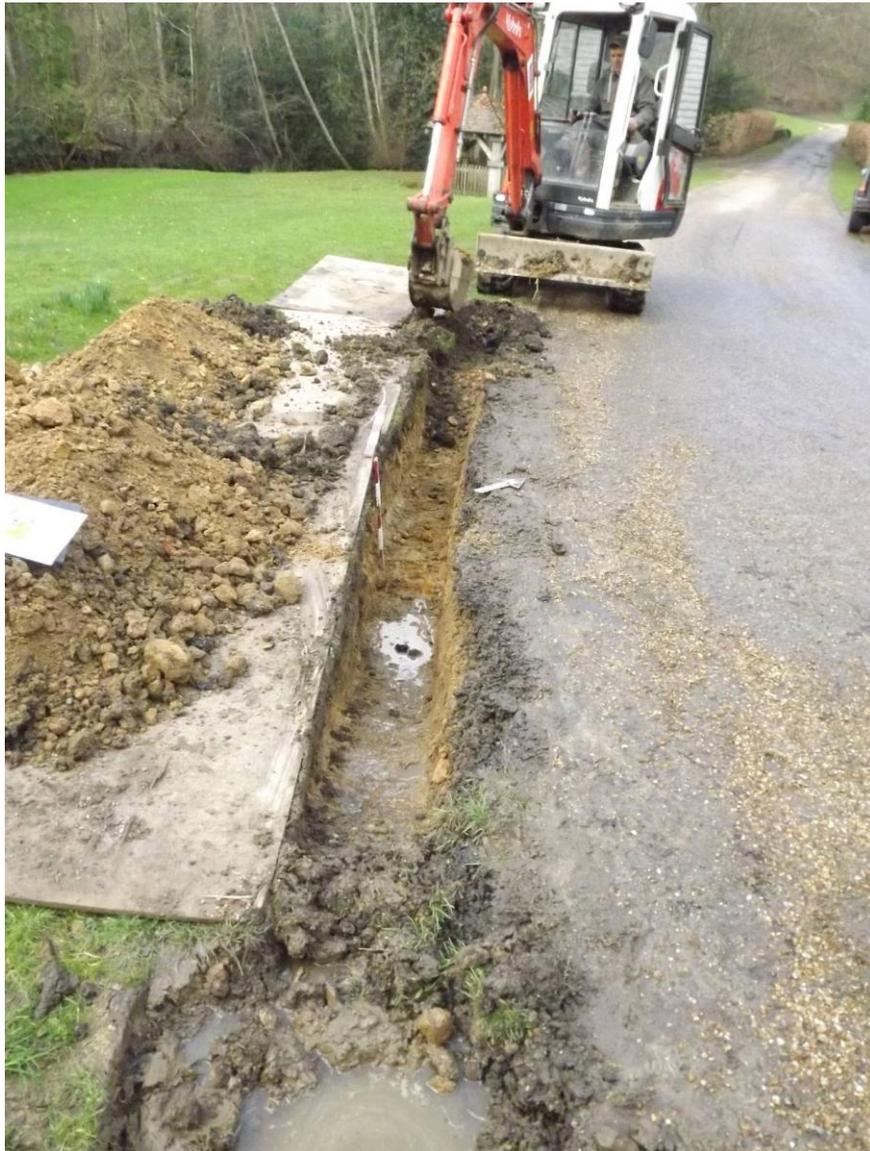
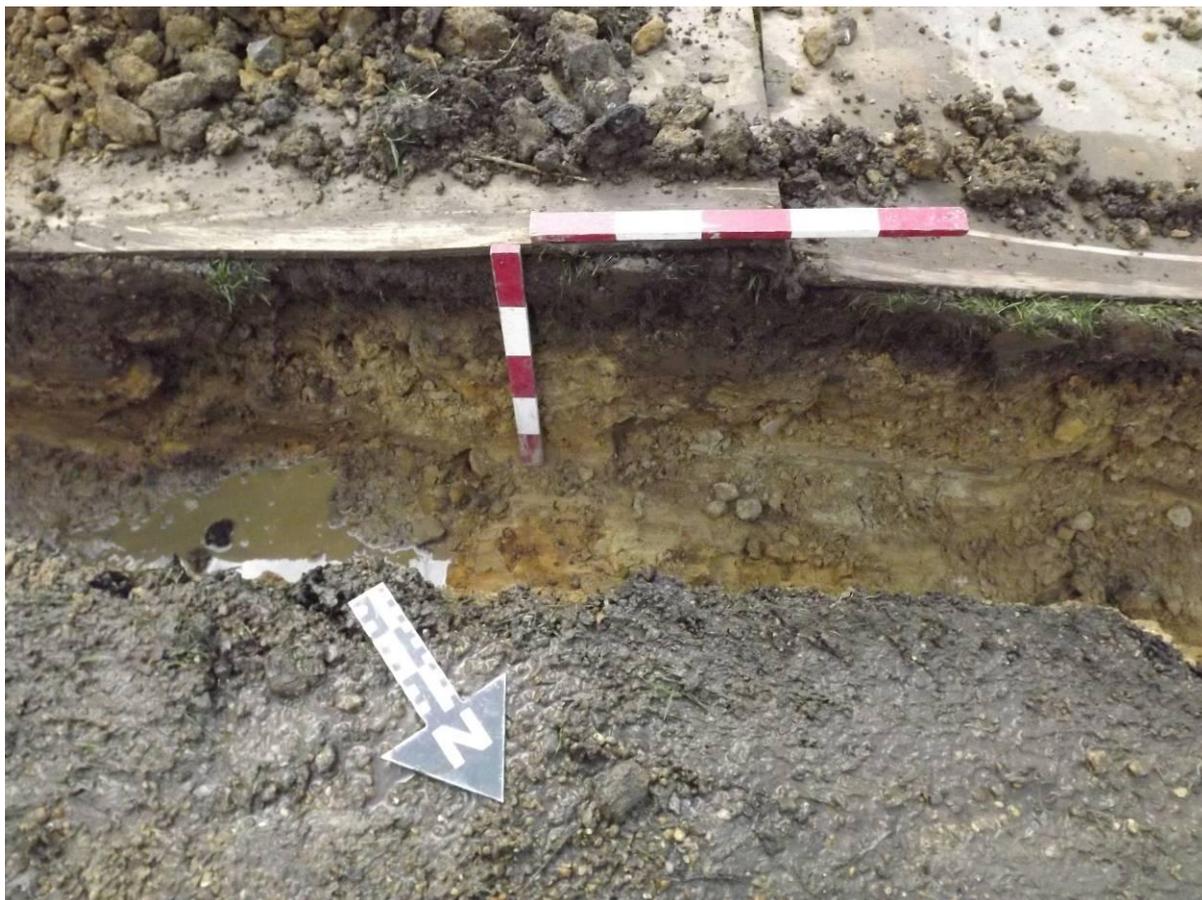
Plate 15. Pipe trench 6, scales 50cm.

Plate 16. Pipe trench 6, scales 50cm.

This 10m trench area was watched at the same time as pipe trench 5 above and this too contained some element of mains sewer pipes which has also been sketch planned and kept in the archive. This trench was south west of the road which runs through the estate, with the recent water mains adjacent to the trench to the west. Once again, very little topsoil remained and it is very probable that this area was scraped flat in order to construct the road. Once the 'topsoil' was removed, it came down on to a very disturbed layer of natural sandstone mixed with CBM. Trench excavated to a total depth of 52cm.

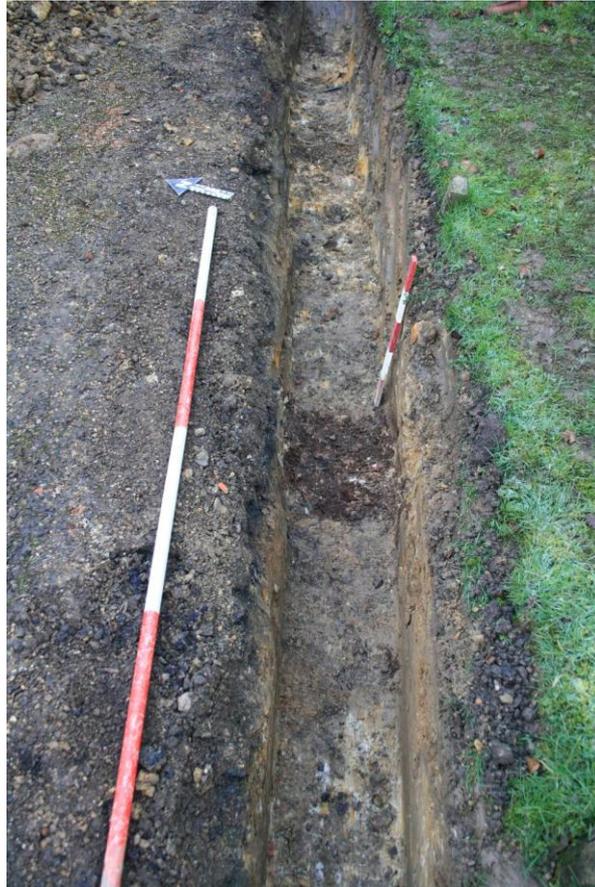
Plate 17. Pipe trench 7 showing pit feature. Scales 2m and 50cm.

The final pipe trench was targeted next to the listed building known as Saunders, in order to investigate any possible features which might lie adjacent to the building. This trench did uncover three pit features, filled with only Victorian rubbish which was subjected to finds retrieval only and a measured sketch plan for the archive. In general, this stratigraphy was once more a made up soil.

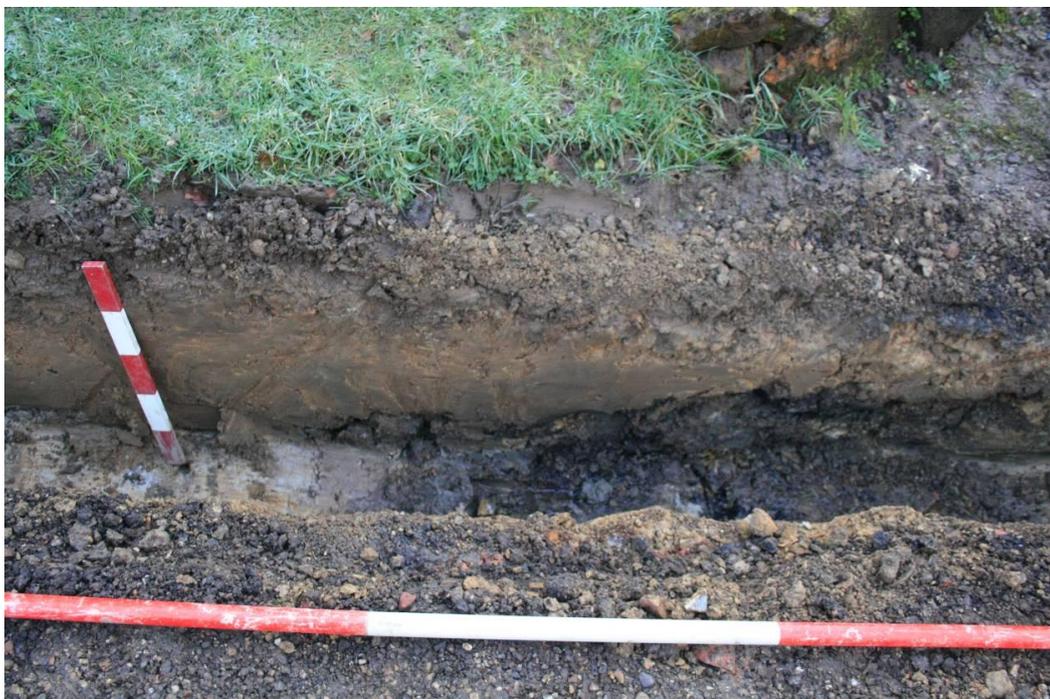
Plate 18. Pipe trench 7 showing further pit feature. Scales 50cm.

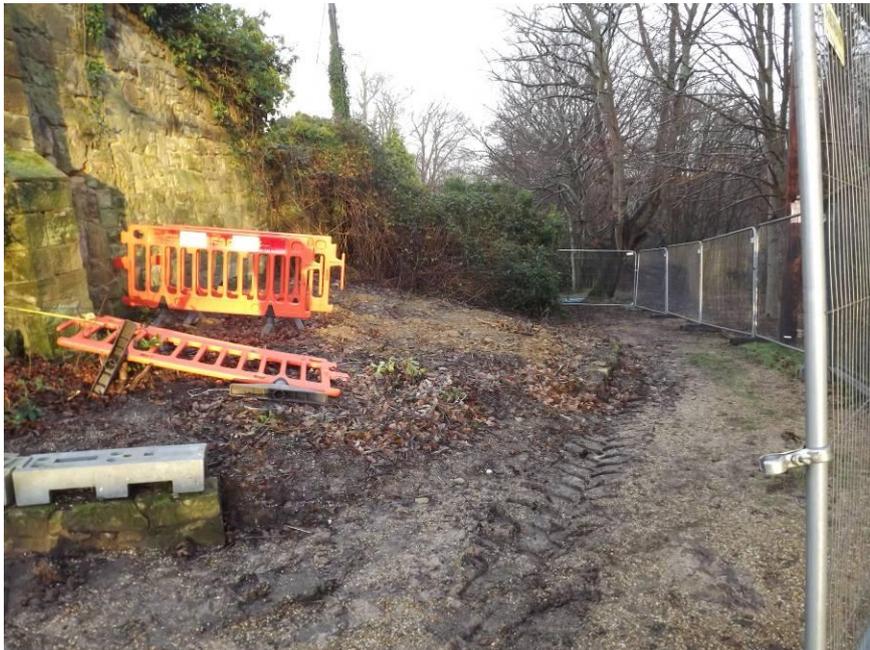
Plate 19. Main trench 8 before excavation, shot facing north west.

This area was the main trench and not one of the ancillary pipe trenches. This area lay adjacent to the garage, which had already been recorded by a standing building survey. The area to the east of the garage is now being filled with the hopper for the Biomass boiler, which is situated inside the garage. Trench 8 was watched over two separate days, initially to flatten the area in preparation for the arrival of the machine sheet metal piler. This first phase was conducted by using a mini-digger with a toothless 1.6m wide bucket to scrape back the topsoil to inspect the ground. Several services were found to run across this area and these a sketched and measured plan was made, which is in the archive. No features were found and the ground was a very disturbed and made up soil. Natural geology was not encountered during this first phase with the area excavated to a depth of approx. 55cm.

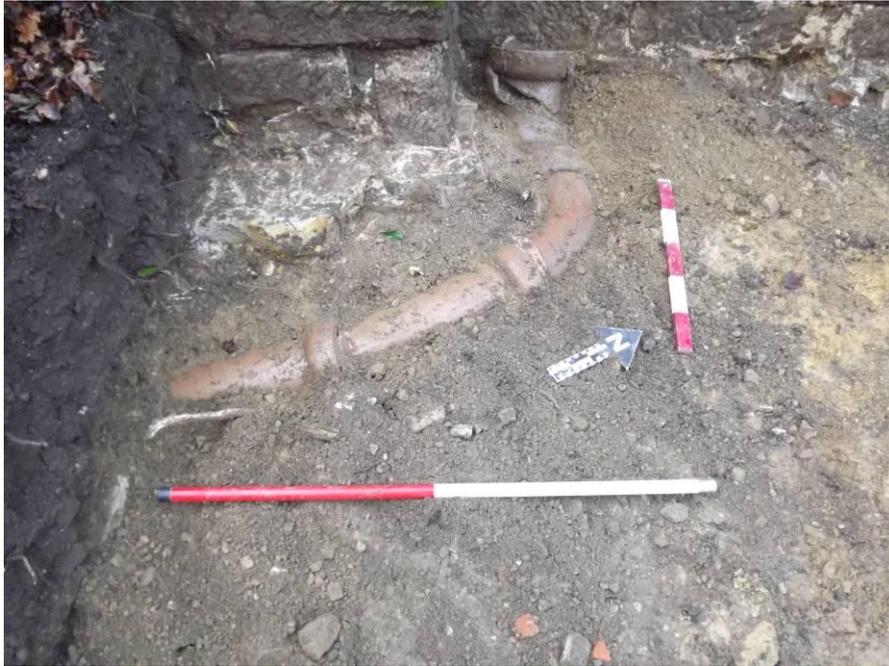
Plate 20. Excavation revealed the garage foundations and drainpipes. Scales 50cm and 1m.

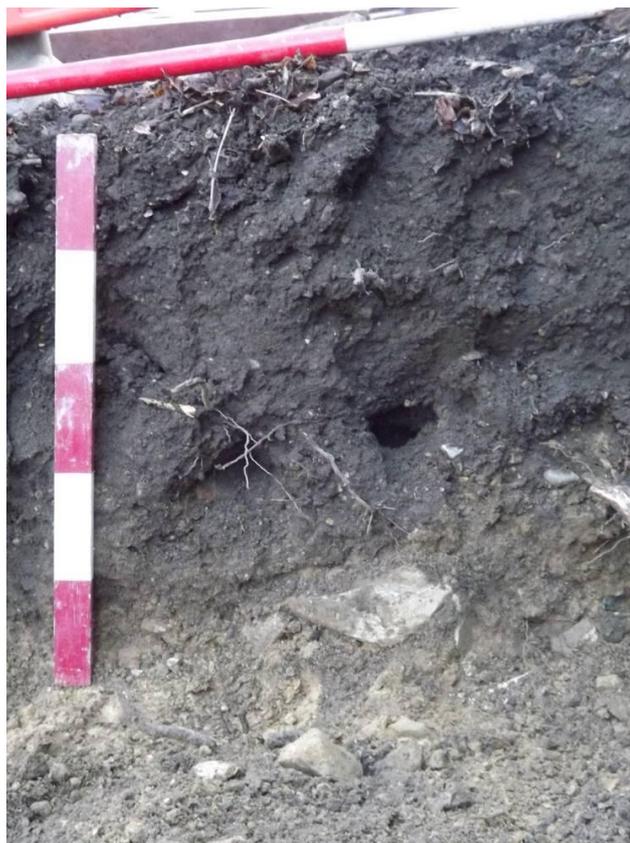
Plate 21. Section through levelled trench 8, showing humic soil probably bought in to create garden bed in this area. Soil underneath still not reaching natural at the end of the day. Scales 50cm.

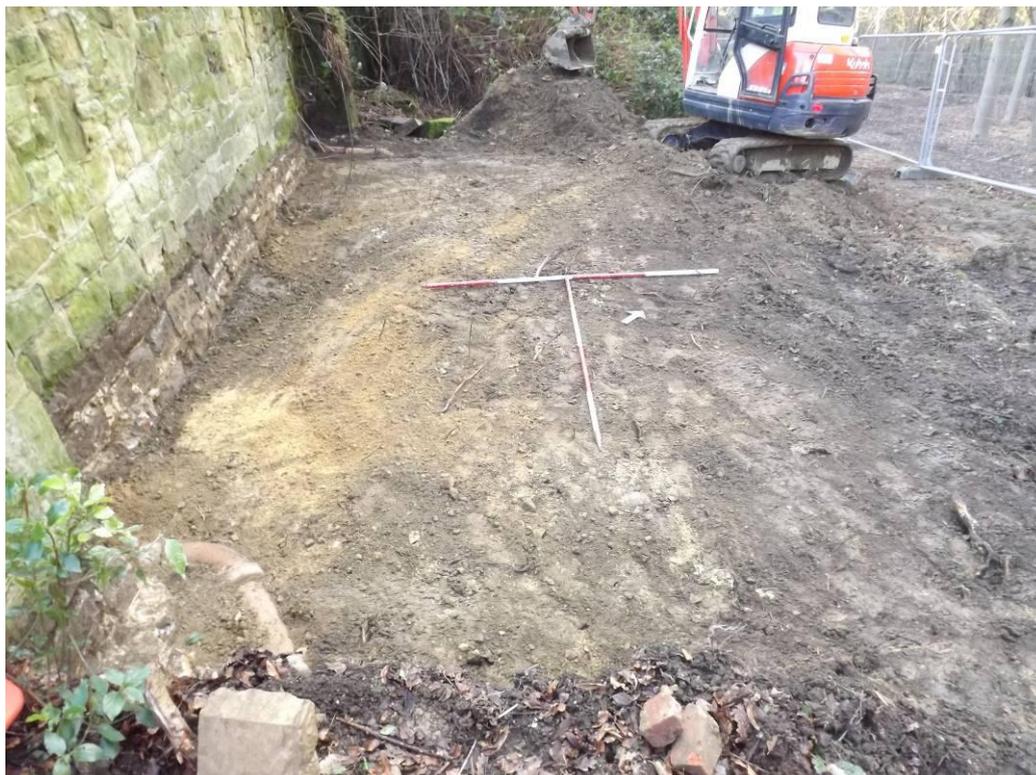
Plate 22. Trench 8 after day 1 excavation still in disturbed soil. Scales 2m.
