**AN ARCHAEOLOGICAL WATCHING BRIEF AT BUCKHURST
PARK, WITHYHAM, EAST SUSSEX.**

Archaeology Services, Lewes.

Project No: ASL 21/14

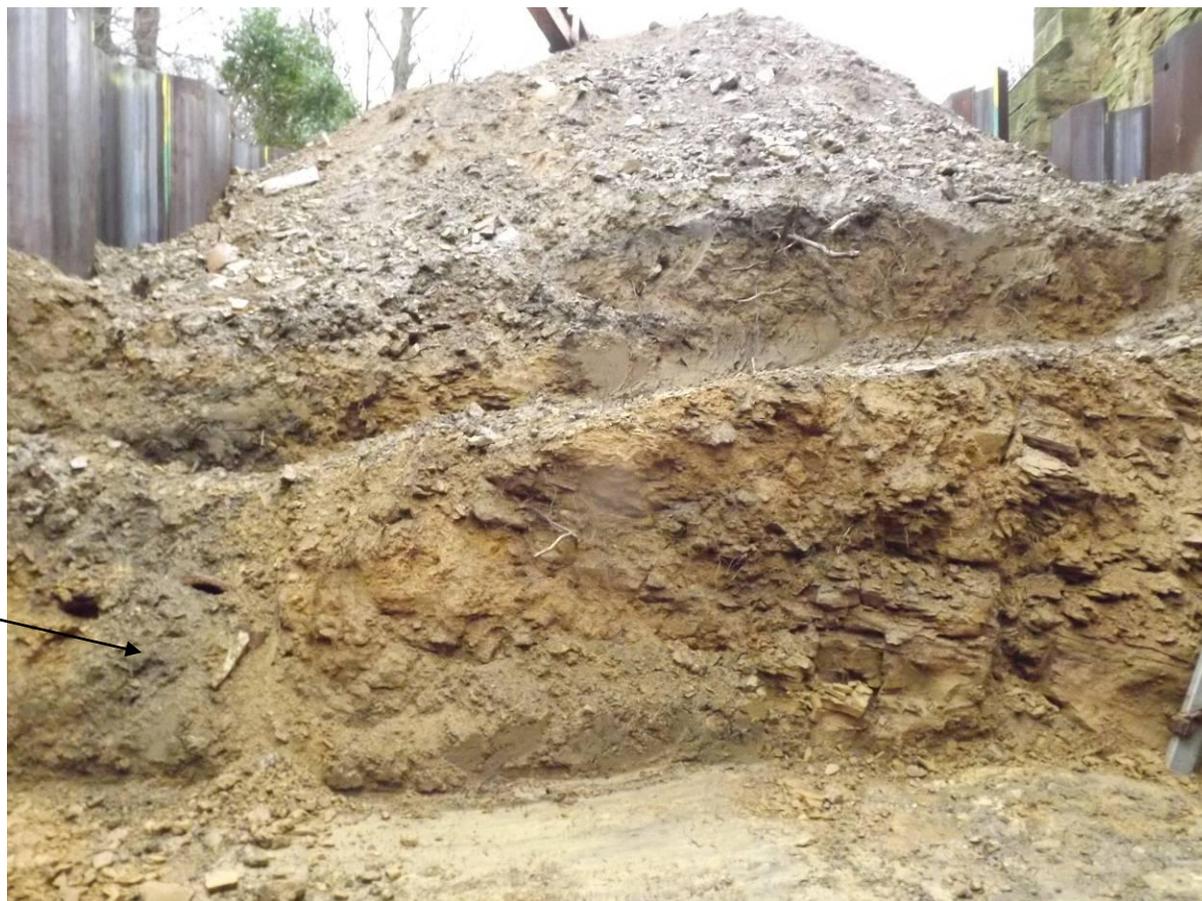
Plate 23. Shot facing south. Section through trench 8 after excavation.

The strategy was to section the area to give a cross section which could be recorded. Permission was sought from the Assistant County Archaeologist for the contractors to remove half of the trench prior to being watch. Once this section had been removed, the cross section was measured and sketched but not to scale for various reasons;

1. This trench was now over 2m metres deep (at 3.5m deep) posing numerous Health and safety issues
2. No features were apparent in the section, save the mains sewer pipe which runs straight down the track to the side of the garage.

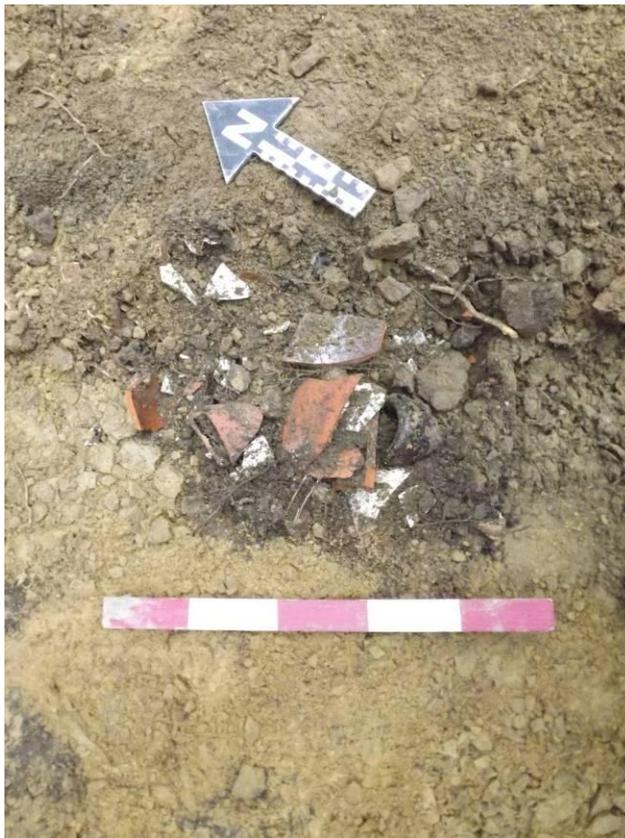
Plate 24. The smaller Victorian pit which was sampled only and not given a context. Scales 50cm.

However, the pits, both oval in shape, were recorded and a sample of the smaller pit fill was taken in order to help date it. The artefacts all dated from the Victorian period and have been summarised below as this pit was not given an individual context in the circumstances ;

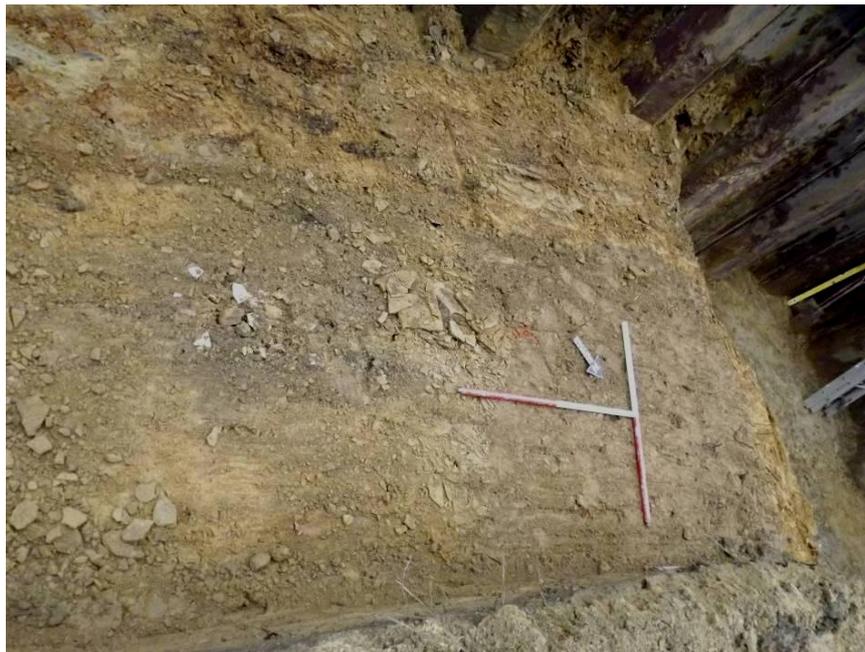
Plate 25. A second pit [803] is revealed adjacent to the smaller pit.

Adjacent to this small rubbish pit was a larger and less straightforward pit [803] which was filled with the same soil that sealed it. It was only evident as a pit as it was cut into the natural around it. The full extent at the top of the pit was not revealed as it went under the baulk of the section that was not monitored, but it is unlikely that a substantial amount was missed. It was approx. 1.80 x 2.60m across, somewhat oval in shape and approx. 1m deep. Much of this was evident in section after the trench was excavated, thus enabling a measured sketch of this section which is in the archive. The fill did contain some pieces of CBM and a piece of fairly modern pottery but the purpose of the pit was not clear.

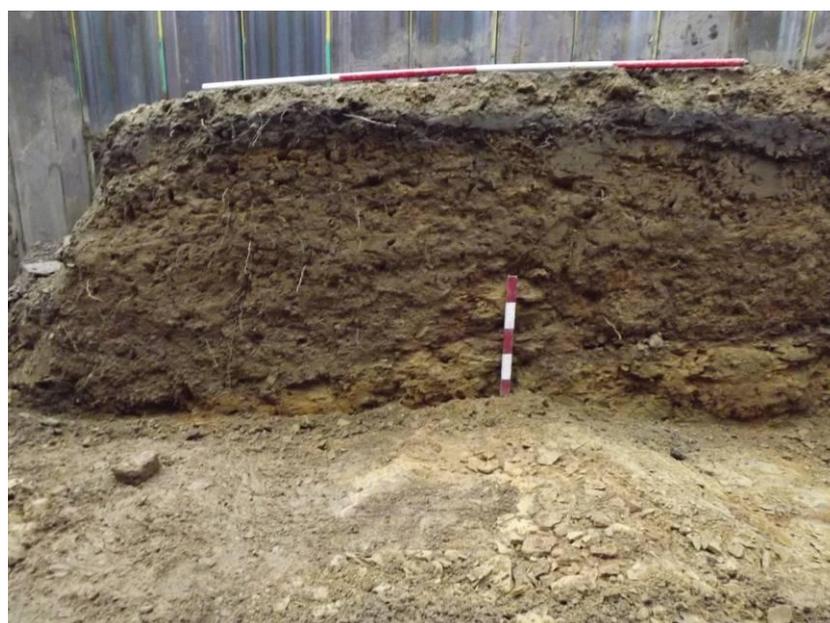
Plate 26. SW facing section showing pit [803] extending under baulk. Scales 2m and 50cm.

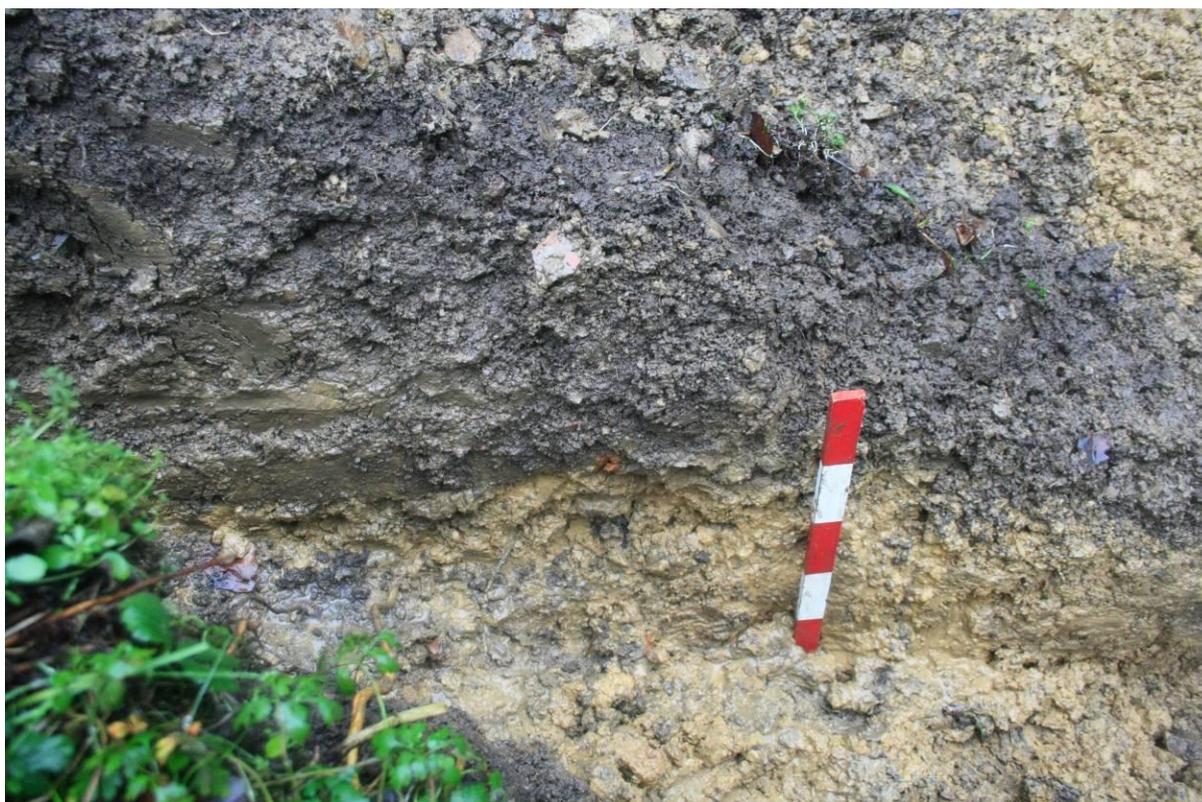
Plate 27. Test trench 9 showing level platform excavated into bank. Shot facing north, scales 50cm.

A small area of pipe run up to bungalows on the side of the trench was recorded in order to see if a section across the track was clear. Although this wasn't watched, it was photographed and a measured sketch made for the archive. A few finds were recovered from the spoil heap. It was fairly evident that the hill side had been subjected to landscaping over the years, with at least two episodes of terracing evident from the section. Also it was fairly clear that the track had been cut into the side of the hill with the topsoil removed at some point and seemingly thrown up the side of the bank. It is presumed that it was also thrown down the side of the hill as well but the section did not extend this far and could not be seen, although it is fairly likely, given the topology on site.

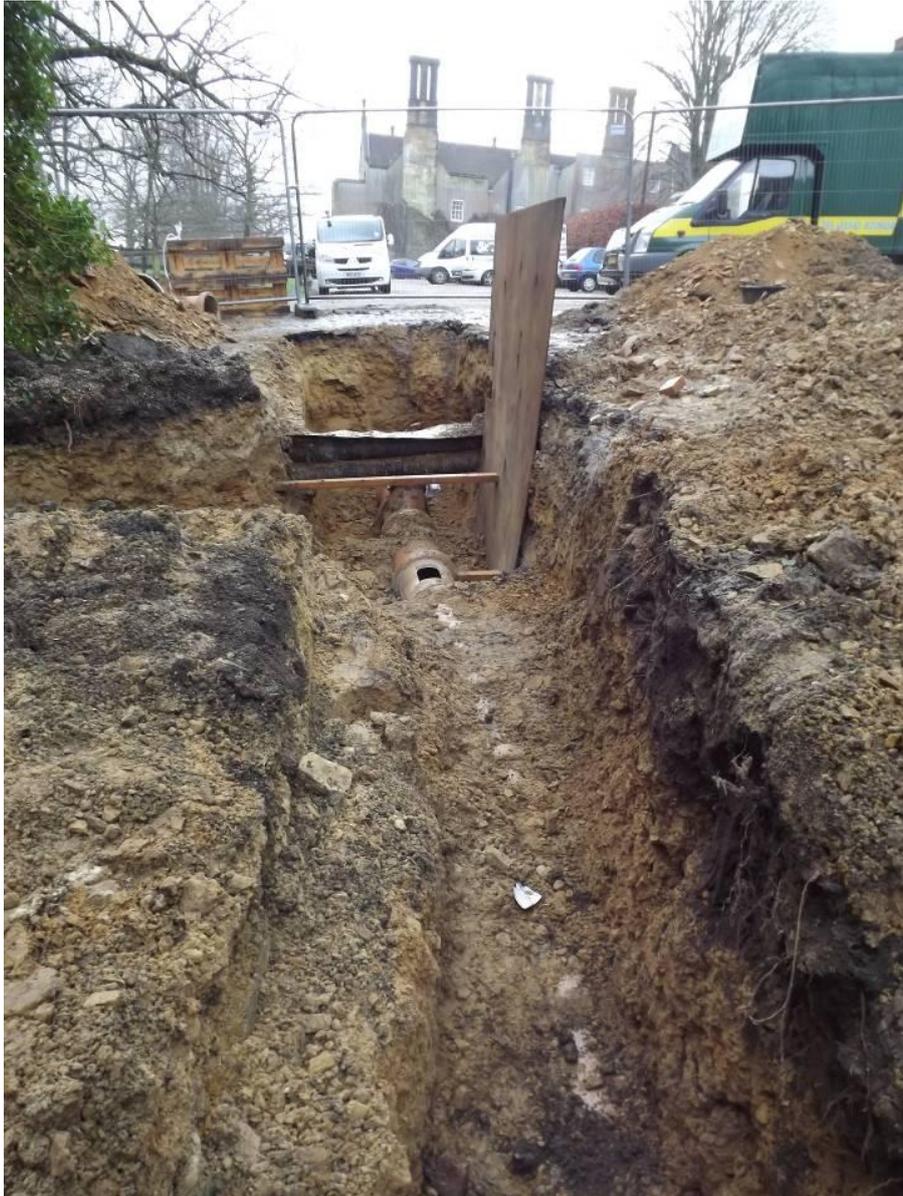
Plate 28. Re-excavation of mains sewer pipe showing old sewer before replacement.

During excavations on site it became apparent that a mains sewer which appears to run down the trackway had been compromised and needed replacing. The old sewer pipe was dug up and removed, being replaced with a new pipeline. Although continuous watching of this area did not occur, it was intermittently observed and photographed but because it was not removing any previously undisturbed soil, this work continued unmonitored. No features were evident and only previously disturbed soil was excavated. Again, this area was subjected to a measured sketch for the archive.

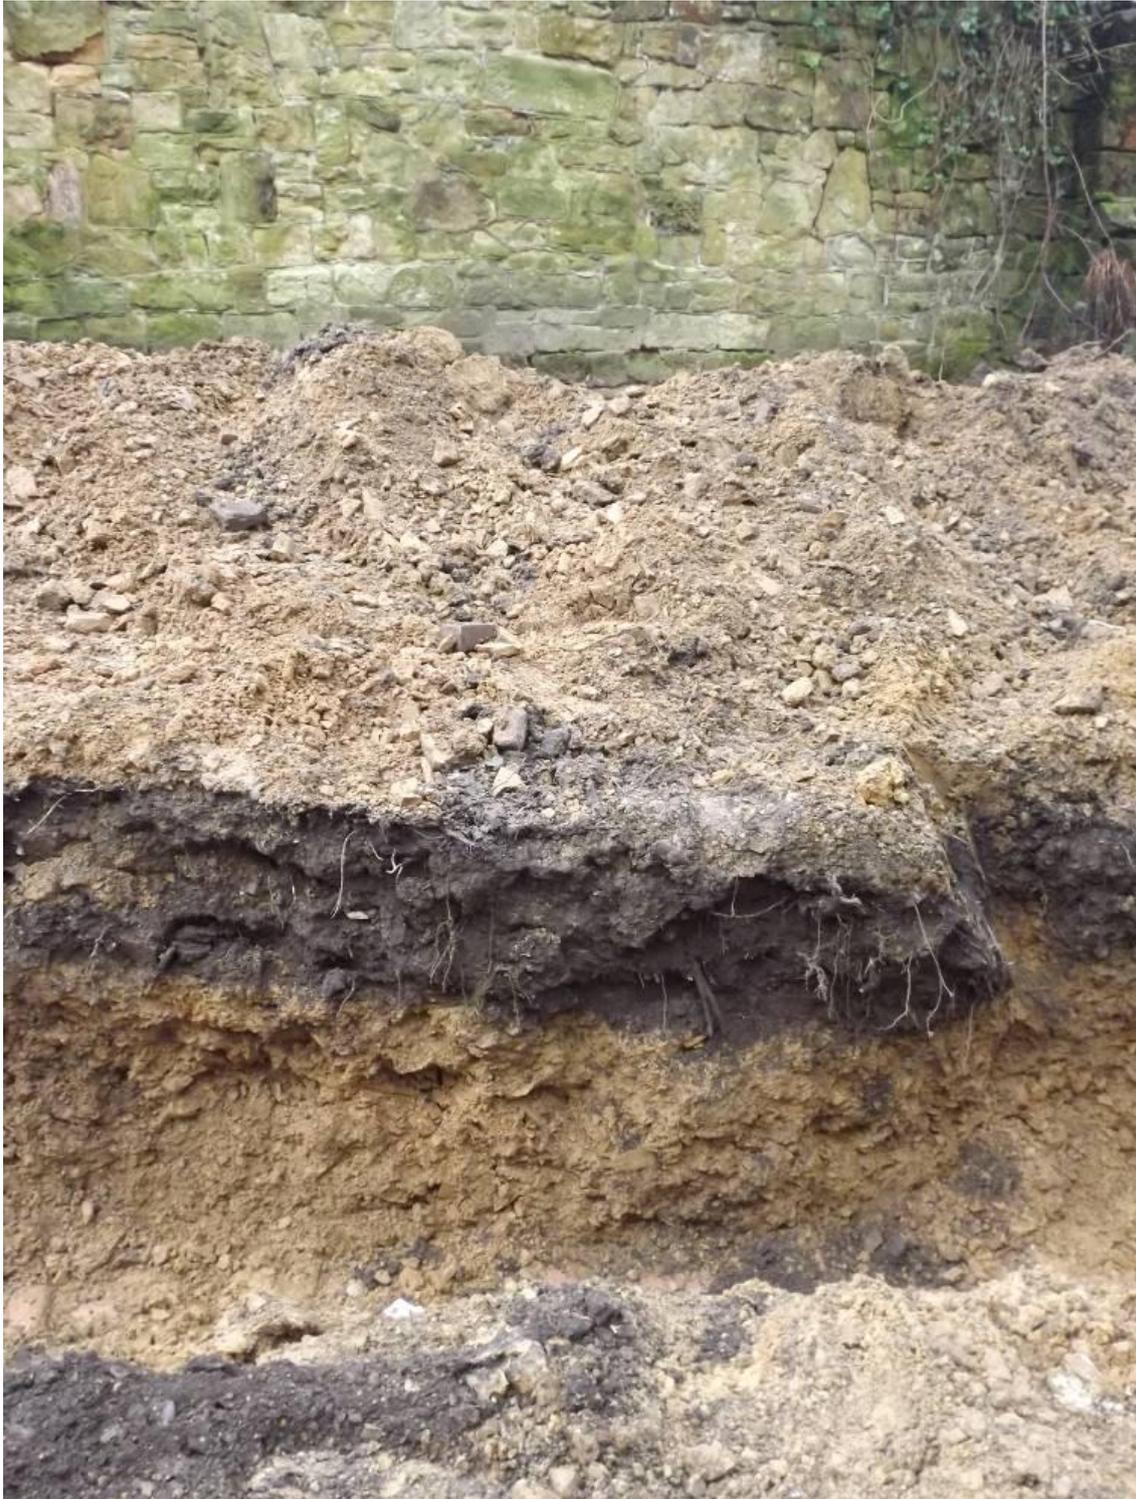
Plate 29. NE Section of mains sewer trench showing limited topsoil with previously disturbed sub-soil showing very sharp interface with topsoil and sub-soil.

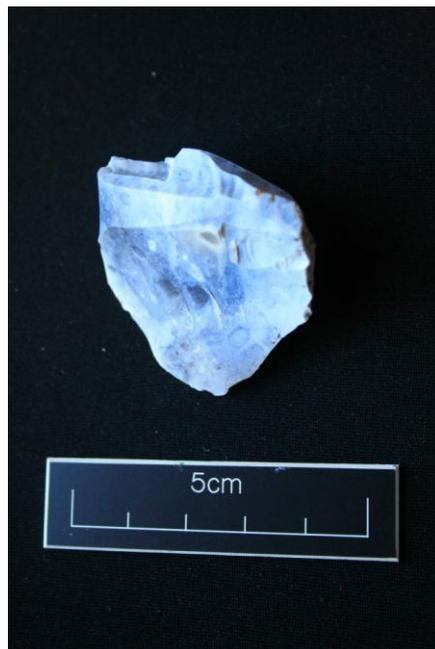
Plate 30. Mesolithic flint debitage from the main trench 8 topsoil context.
