A DESK-BASED ASSESSMENT FOR FIRLE STABLES,
FIRLE, EAST SUSSEX.

Archaeology Services Lewes

Project number: 146-18

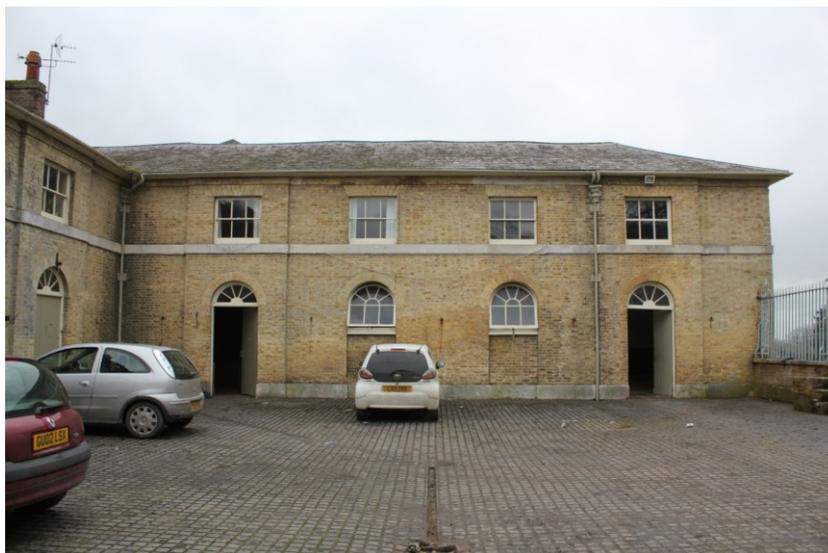
Plate 1. The projecting north-east wing of the stables.

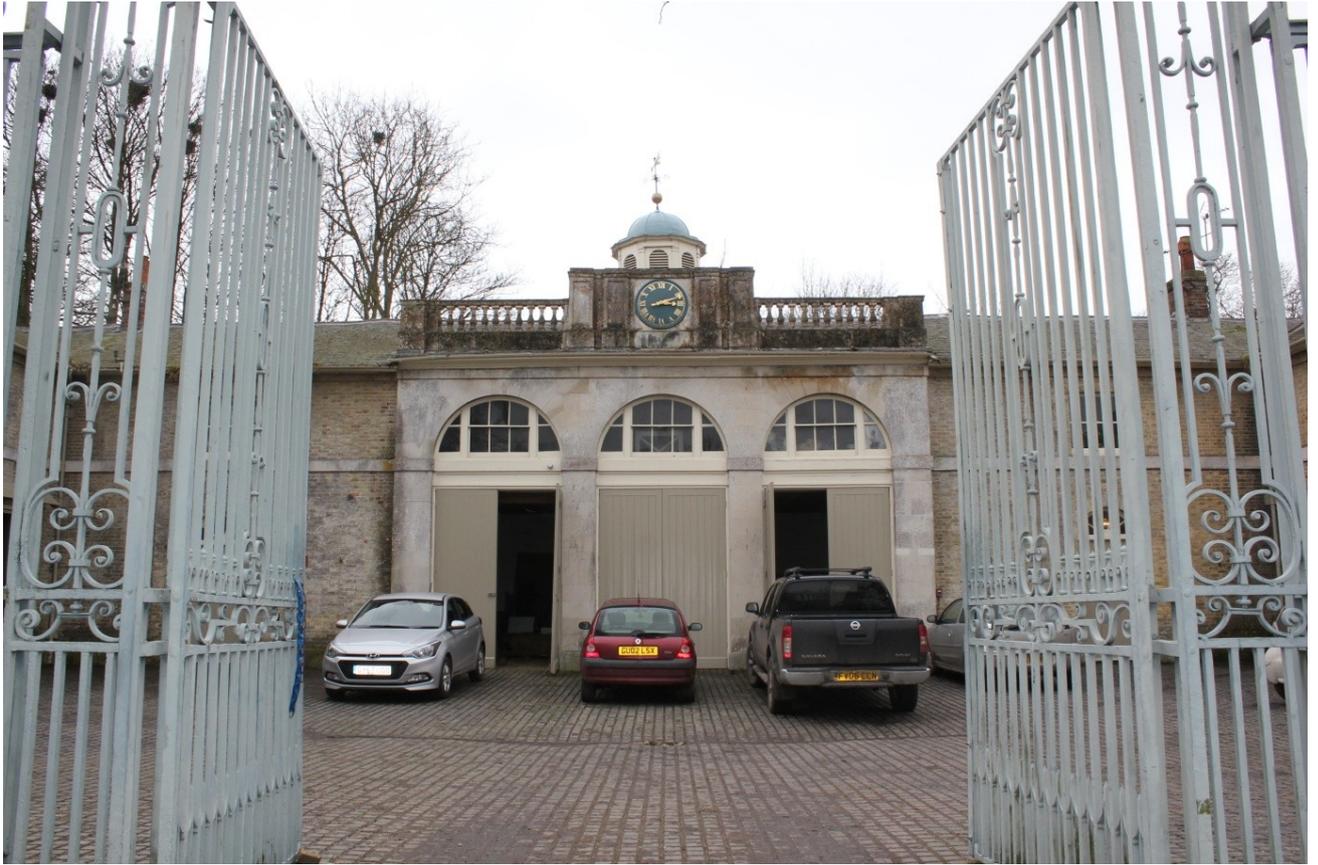
Plate 2. The former coach house in the central range of the stables.

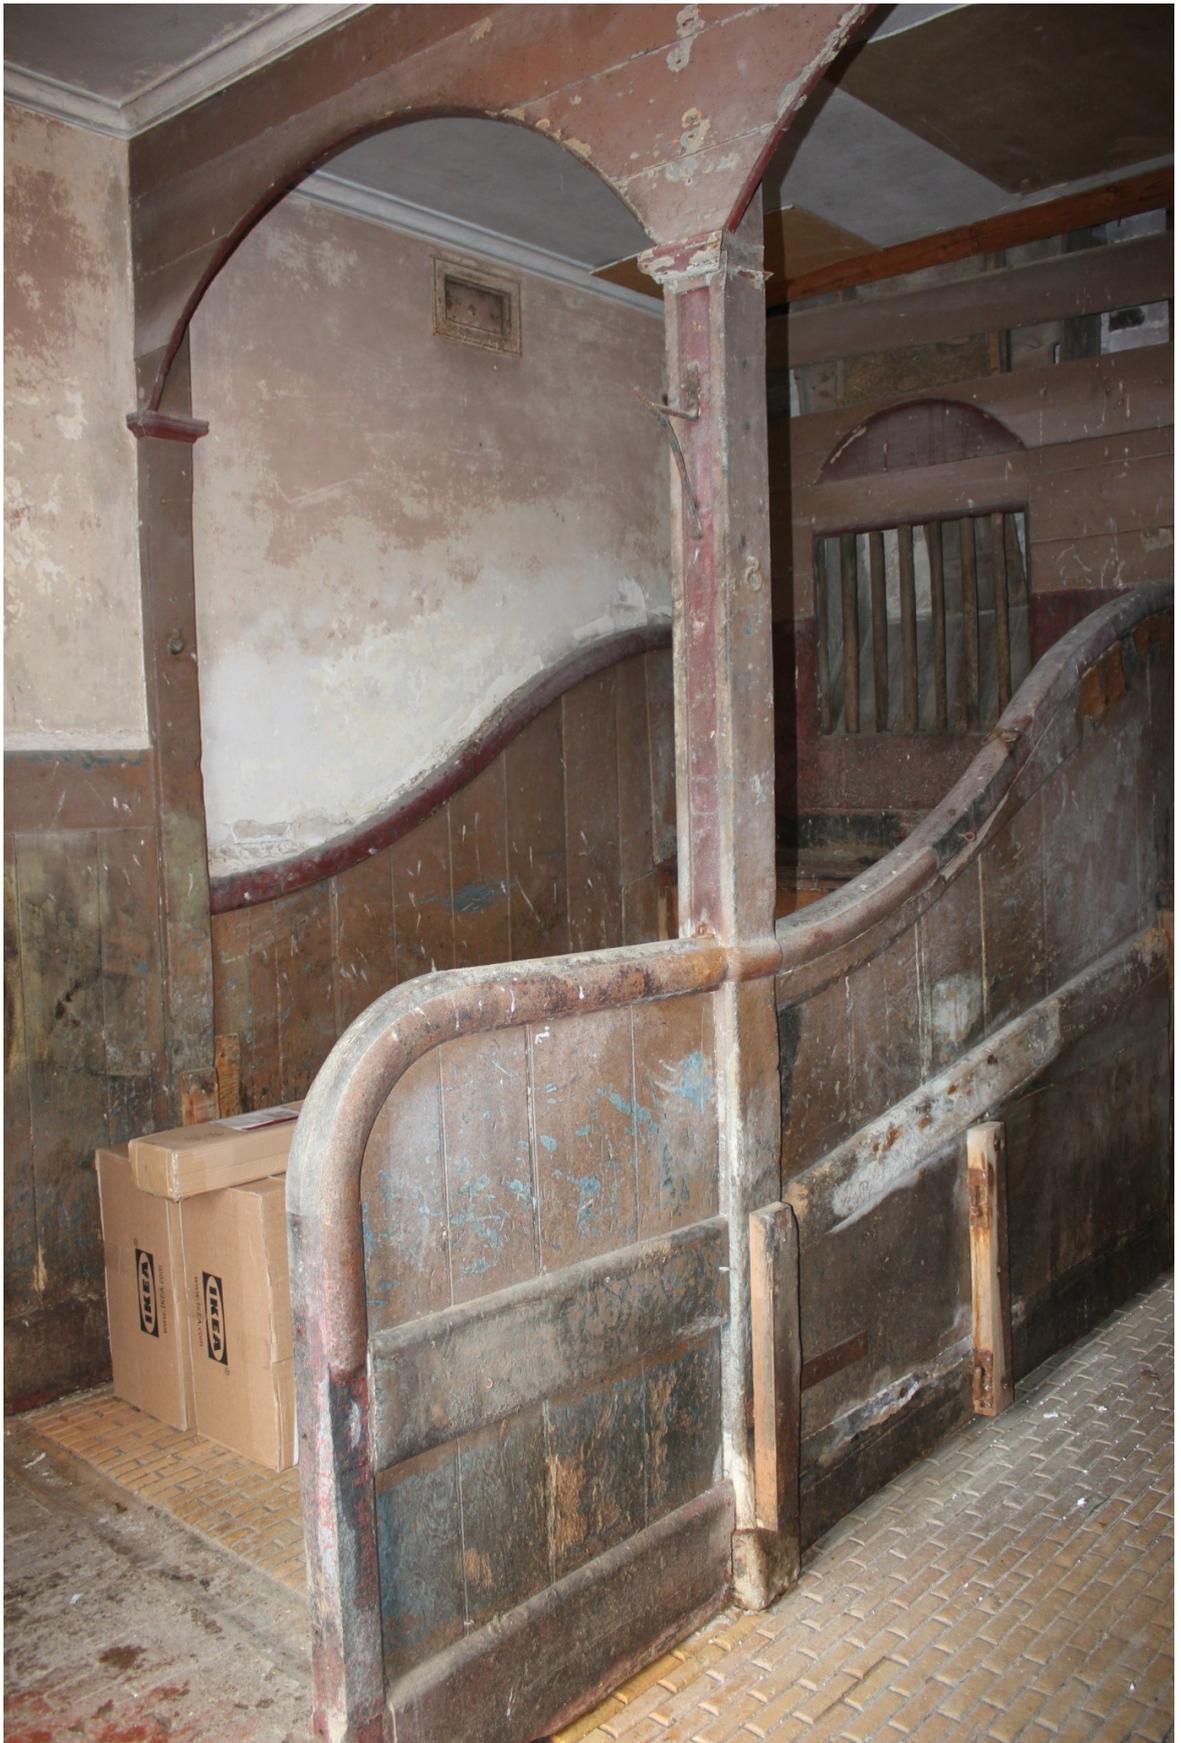
The north-east projecting wing is currently used for stabling alongside a modern engine room. The central range is used partly for residential accommodation and also as a garage/storage area. There is a door into the stable from the courtyard on the south-east side. The stable is in its original form, with tongue and groove panelled walls, part brick floor with some later ceramic 'cobbles' and in-built stalls providing space for two horses (Plate 3). A pedestrian door which would have led into the residential accommodation on the south-west side has been blocked from the rear, although the door is still *in situ* (Plate 4). A modern door has been inserted into the opposing wall which leads into the modern engine room for the estate.

Plate 3. The original stalls in the stables.

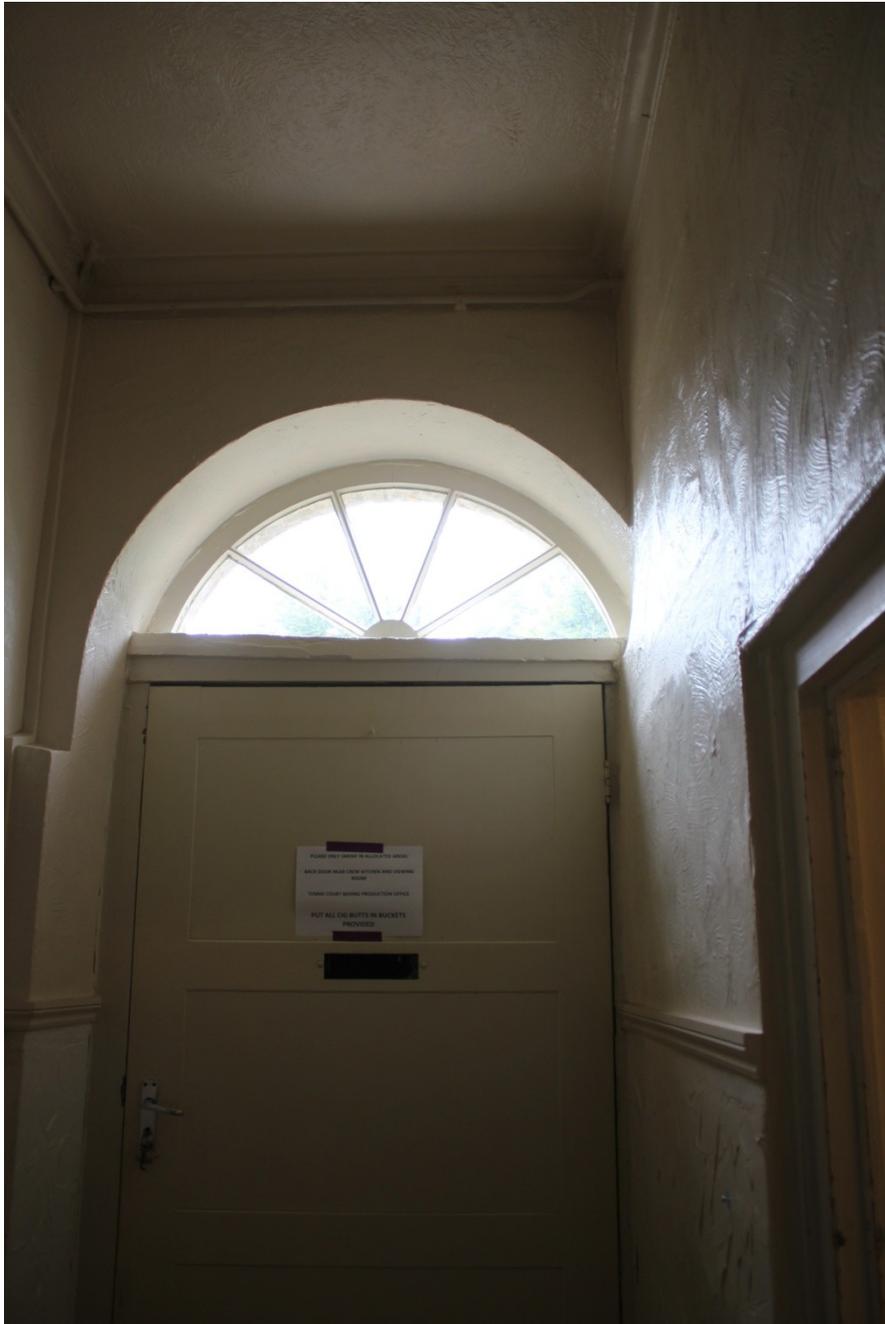
The flat in the north-west corner of the central range at ground-floor level consists of a kitchen, living room and L-shaped corridor leading to a flight of stairs to the first-floor accommodation. There are two doors giving access into the flat; one in the rear south-west facing elevation, which is a replacement door under an original segmental fanlight and frame (Plate 5) and one in the front, north-east facing elevation, which is discussed below.

Plate 5. The original rear pedestrian door into the residential annexe.

partitioned to the hallway and this steps out slightly at the rear door where it partly conceals the frame and the fanlight, so is likely to be a later addition (see right hand side of Plate 5). There is a blocked doorway between the kitchen and the hallway at the far north-east end of the corridor. In addition, there is a blocked window aperture (Plates 6 and 7) which would have looked out over the riding school in the north-west wall, which is now fitted with shelves. This is 1.53m above floor level, a with cut-and-rub soldier course over the blocked aperture; there are no jambs and the cill is wooden; this is all painted. The proposals are to open this aperture and remove the lower courses to provide a doorway from the wedding venue in the riding school to the new bathroom facilities here. This would involve the removal of the lower course of bricks (0.88m high), which was previously boarded, as evidenced by a row of corroded nails. It was noted that these bricks appeared 'sharper', with fewer layers of paint, probably due to the former panelling.

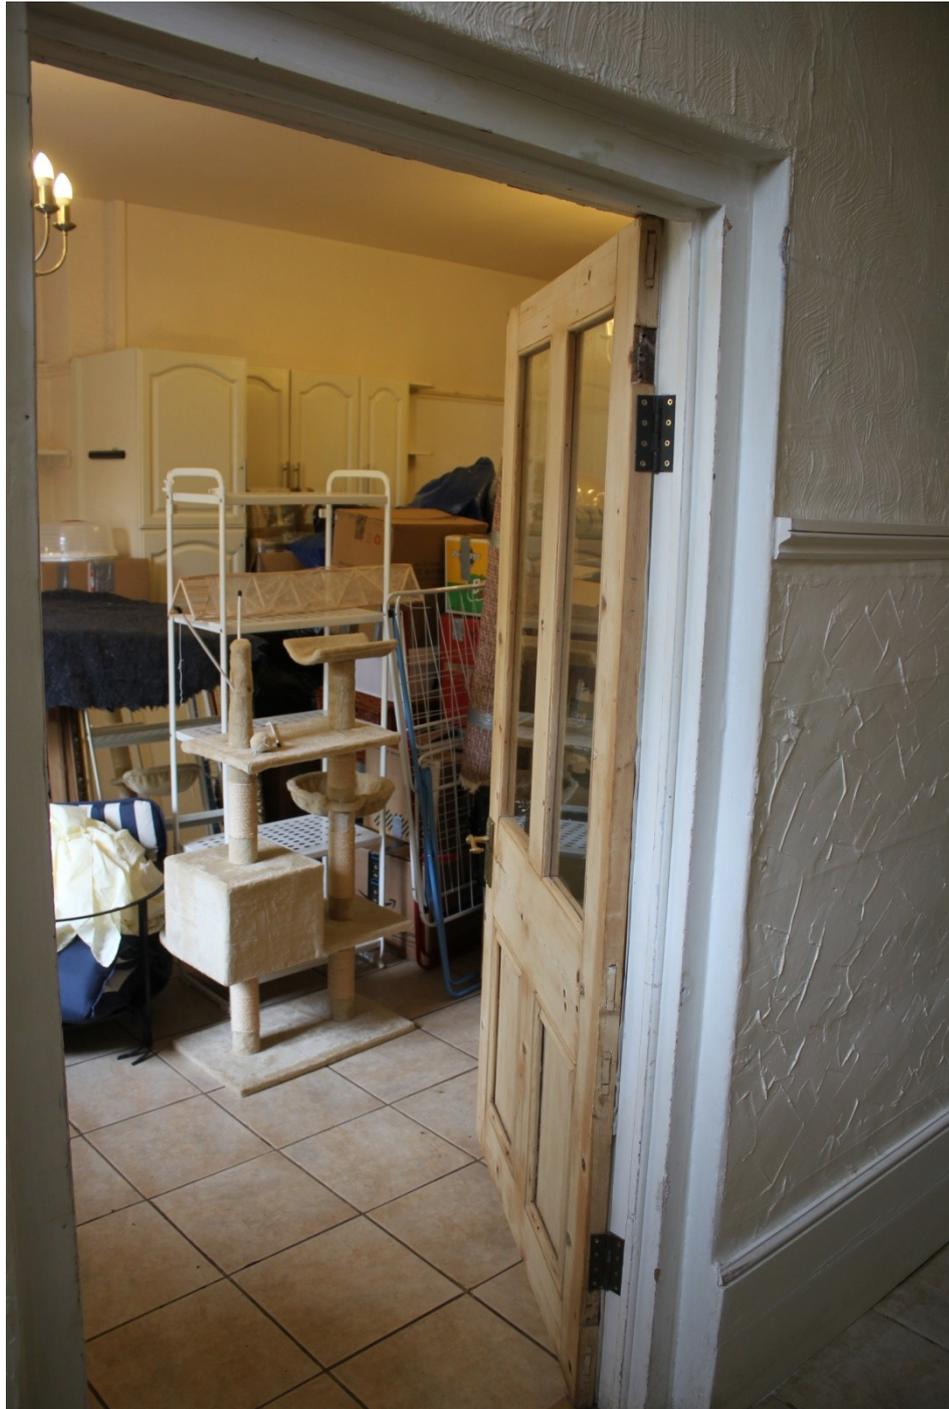
The north-west wall also has plastered panelling, but here it appears horizontally fixed (Plate 10). The architrave into the existing kitchen doorway is probably early 20th century (Plate 11).

Plate 11. Door into kitchen.

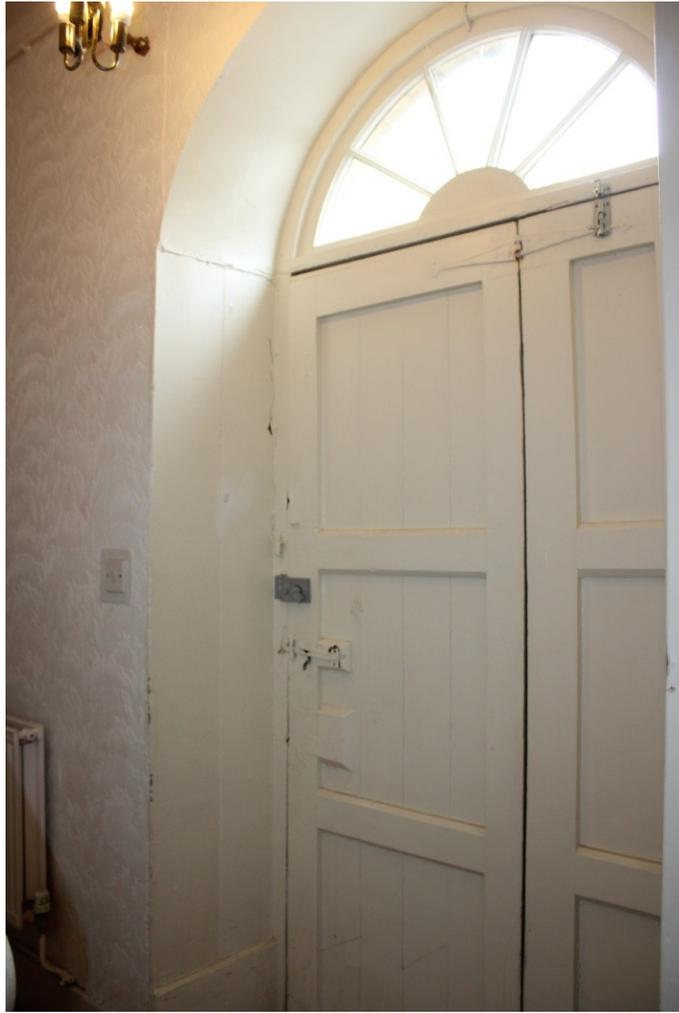
The hallway turns at right angles through what appears to be a later, knocked-through aperture leading into the central range. The tiled flooring continues, with papered walls, plastered ceiling and modern skirting and architrave throughout. The original door (Plates 12 and 13) leading in from the courtyard on the north-east side is original, with a similar segmental fanlight to that in the rear doorway and panelled reveals. The stairwell (Plate 14) leading to the first floor is located here and this is probably a mid-20th century replacement. It is carpeted, with closed stringers and panelling, and there is a door in the space below the stairwell.

Plate 12. The original pedestrian door into the residential annexe in the front wall.

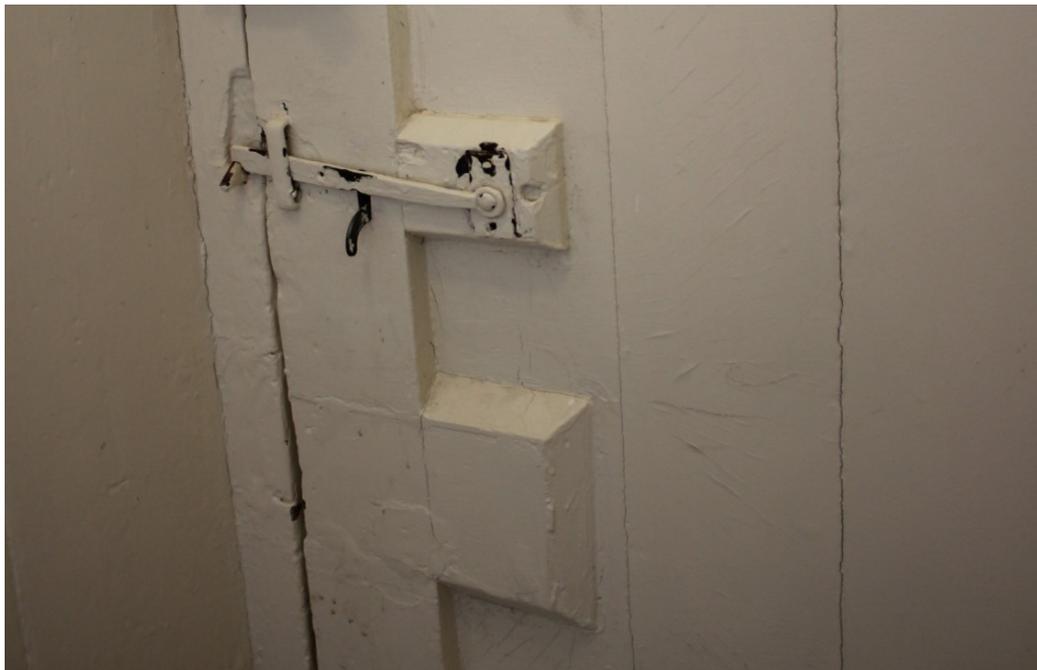
Plate 13. Detail of the door latch in the front entrance door.

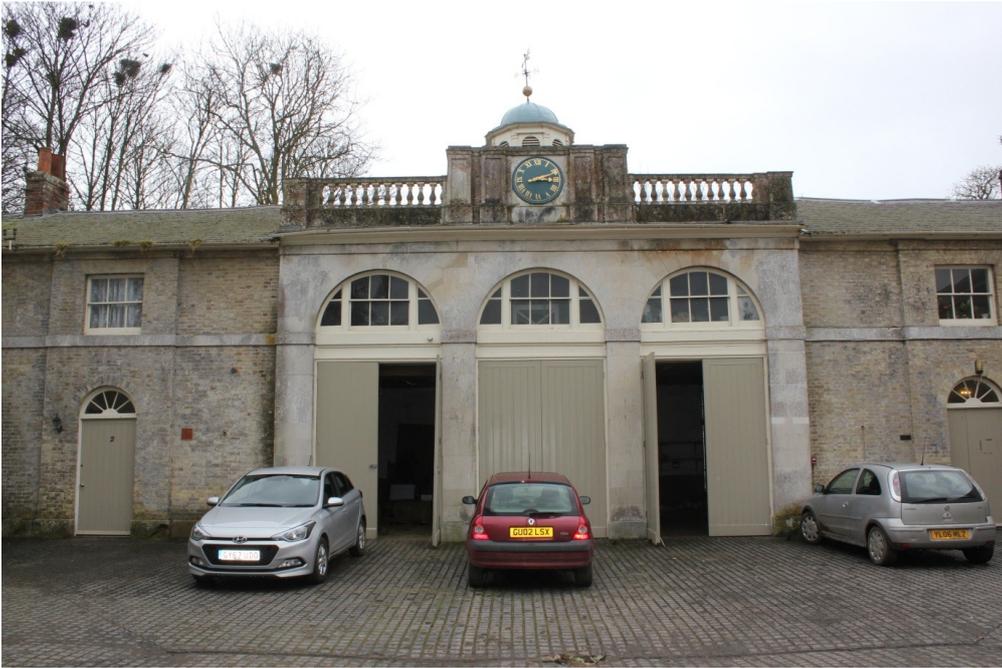
The former coach house is now a garage space in the central range (Plate 15) and is divided into three bays and has an original brick floor. There is a plastered wall on the north-west side, a partially painted brick wall to the south-west side and a plastered wall on the south-east side. The access into the space is through three, full height, double-width doors in the north-east side off the courtyard. In-between the doors are four brick piers with four projecting piers on the rear wall which support four cross- beams for the floor above.

Plate 15. The former coach house with clock room above and clock tower surmounting the roof.

- In addition, the ground floor garage will be converted into a bar and a new doorway is proposed for the north-west wall, giving access into the new toilet facilities beyond. This is in a highly significant area and if not approached in the right manner could cause substantial harm to the historic fabric. However, there is a possibility that the proposed doorway is actually re-instating an original door, although we cannot prove this without further investigation. As long as the floor remains intact,

and any new fittings are mindful of the historic fabric here, it is likely the proposal will cause less than substantial harm.

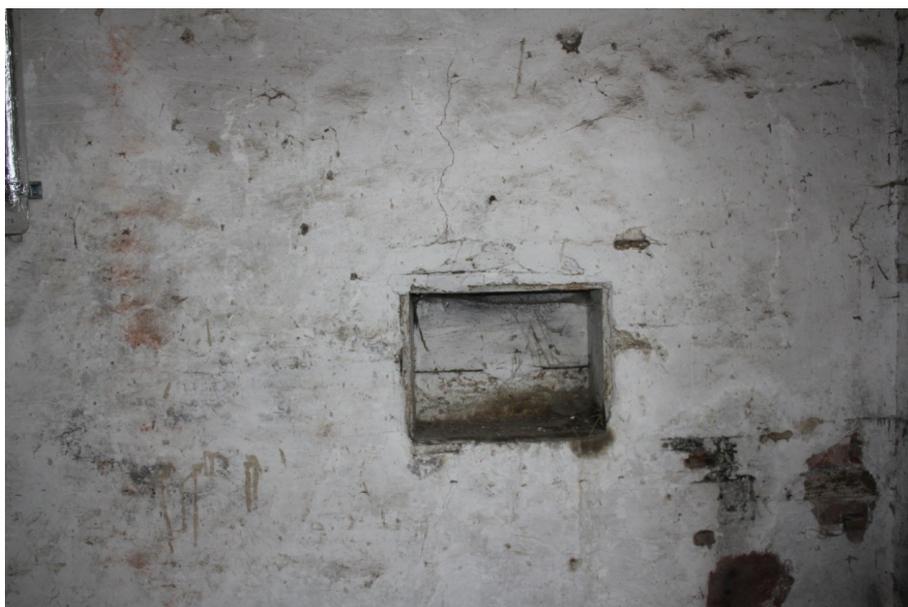
Plate 18. Niche in the north-west wall of the coach house.

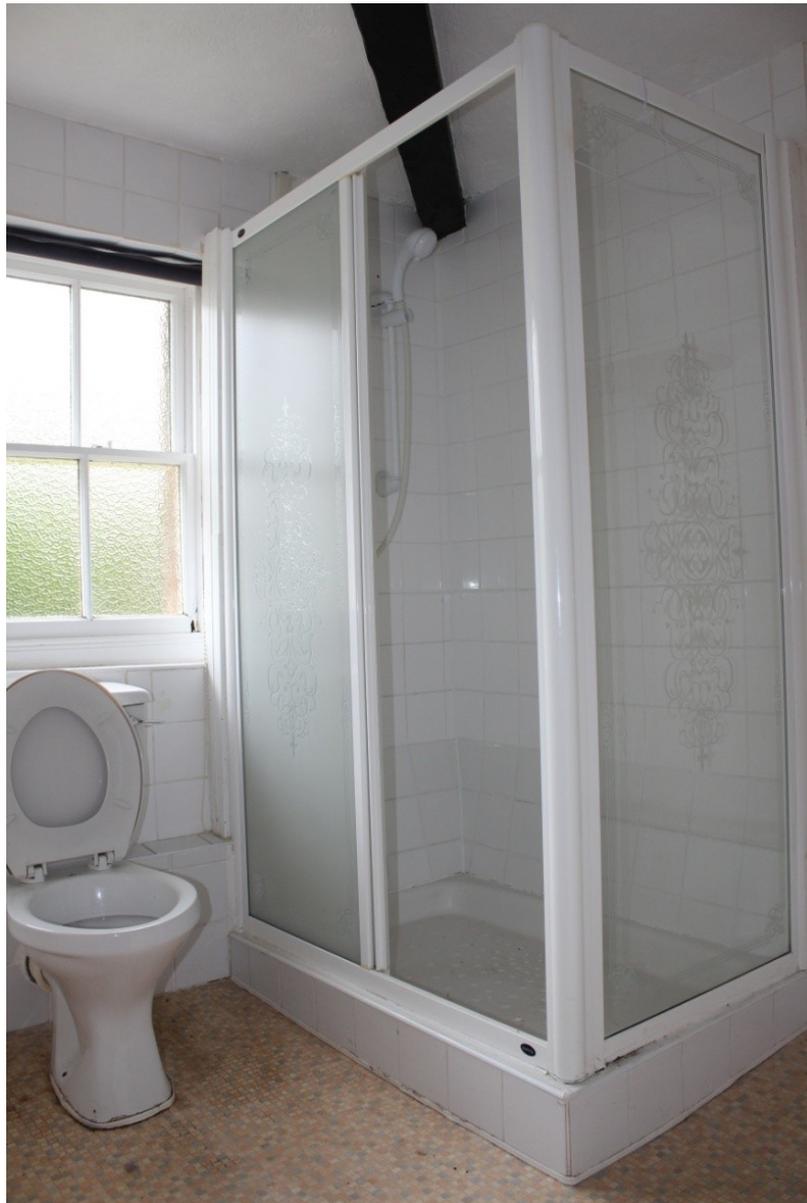
Plate 19. Diagonal, horizontal bracing in the ceiling at first floor level.

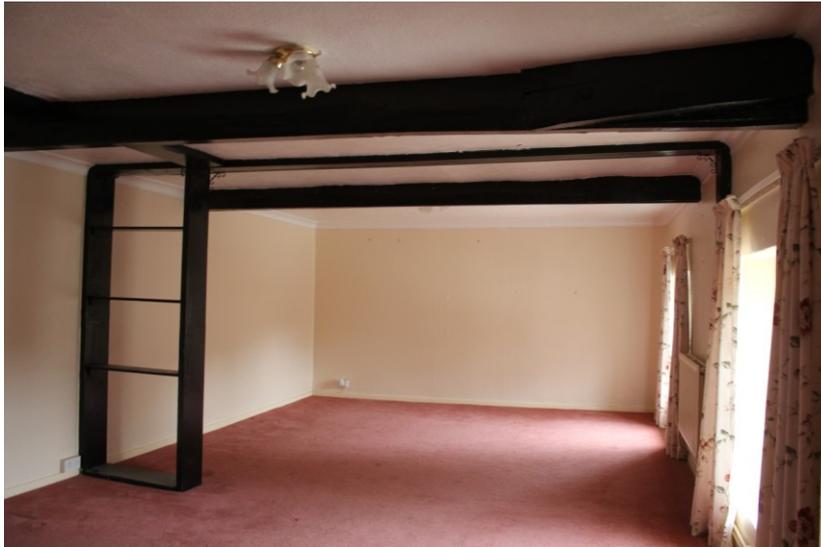
The stairs give access to a small hallway which opens to a small bathroom, two bedrooms, a lounge and a series of cupboard spaces off the hallway which house the boiler and provide storage. All rooms are modern, with carpeted/linoleum-covered floors, plastered ceilings, modern doors and papered walls throughout. The only original exposed features here are diagonal beams exposed in the ceilings of all rooms, which appear to be a form of horizontal bracing (Plate 19). There are also some further overhead cross-beams exposed in the cupboard space and the lounge (Plate 20). There is an opaque, sliding sash window in the bathroom which is a 20th century addition.

Plate 20. Diagonal brace and cross-beam in the first floor living room.

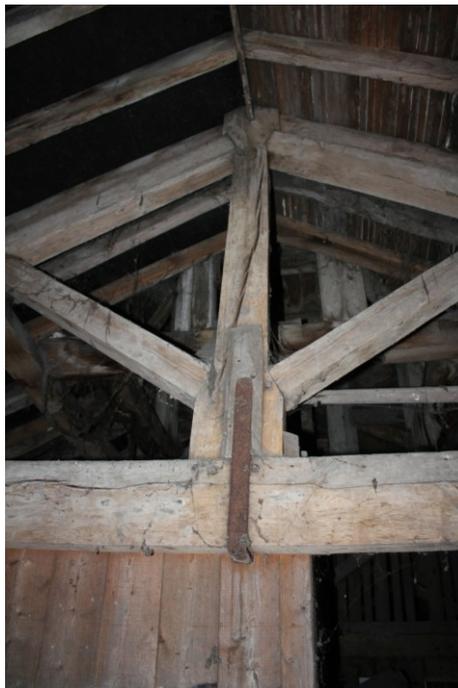
Plate 21. Kingpost truss.

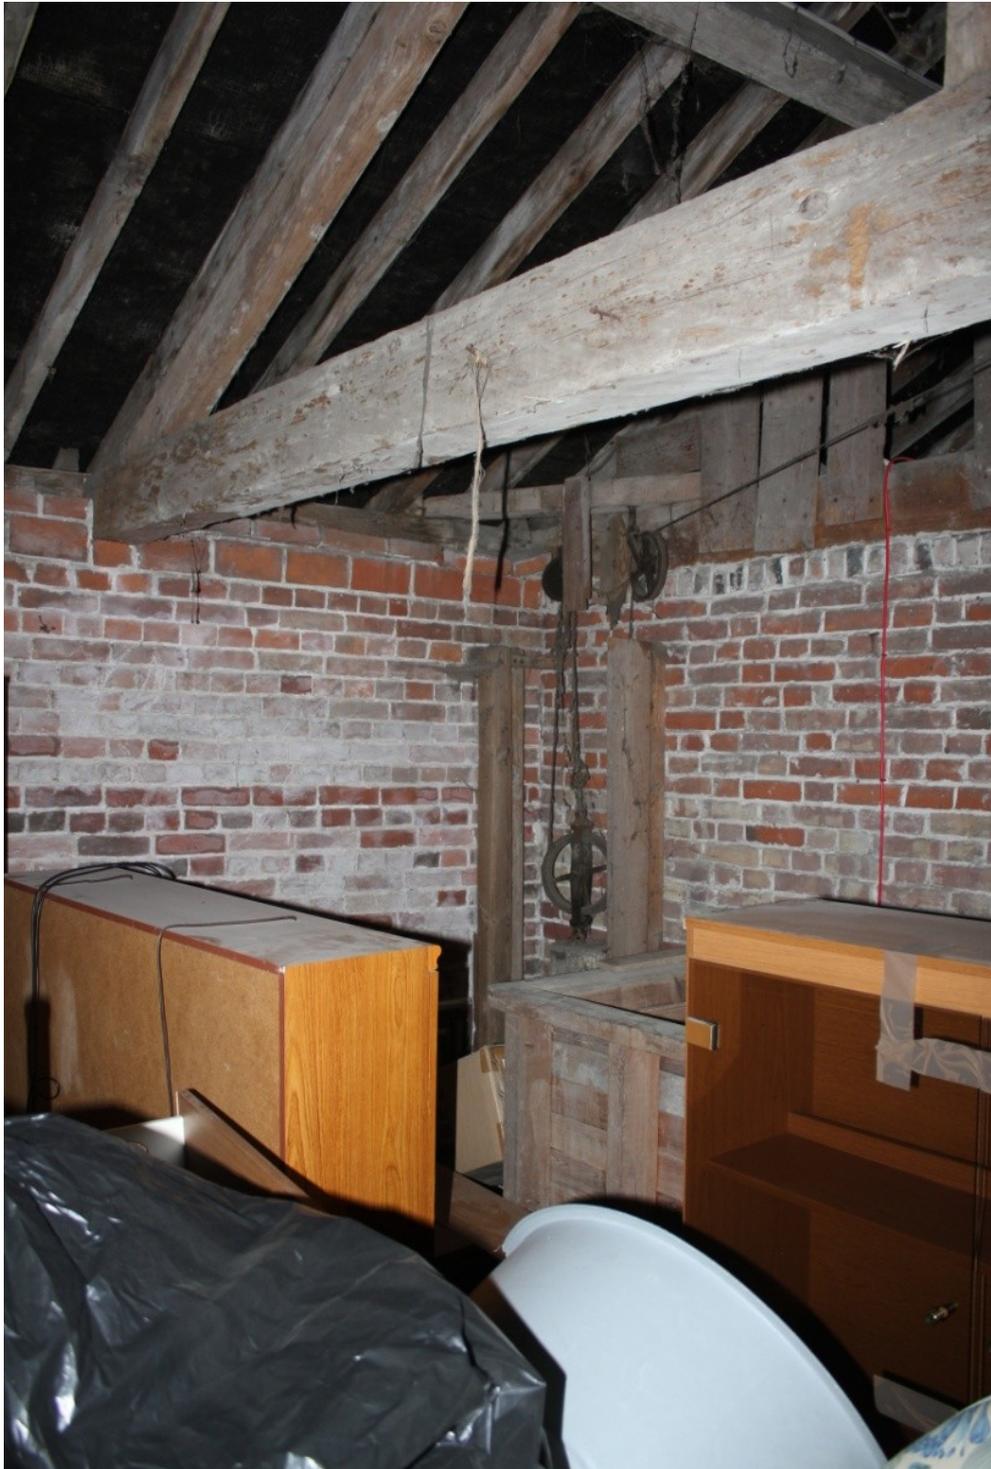
The first area on the north-west side houses one of the weights for the clock in the north-west corner, with a small space sub-divided in the area by means of a panelling with a thick handrail above, almost like an animal pen (Plate 22). The function of this is not known. It measures 2.82 long by 1.12m wide and is 0.91m high and lined with tin on the inside walls. The flooring in this area is softwood boards, 0.24m wide, and it is open to the roof.

Plate 22. Clock weight in the corner with boarded 'pen'.

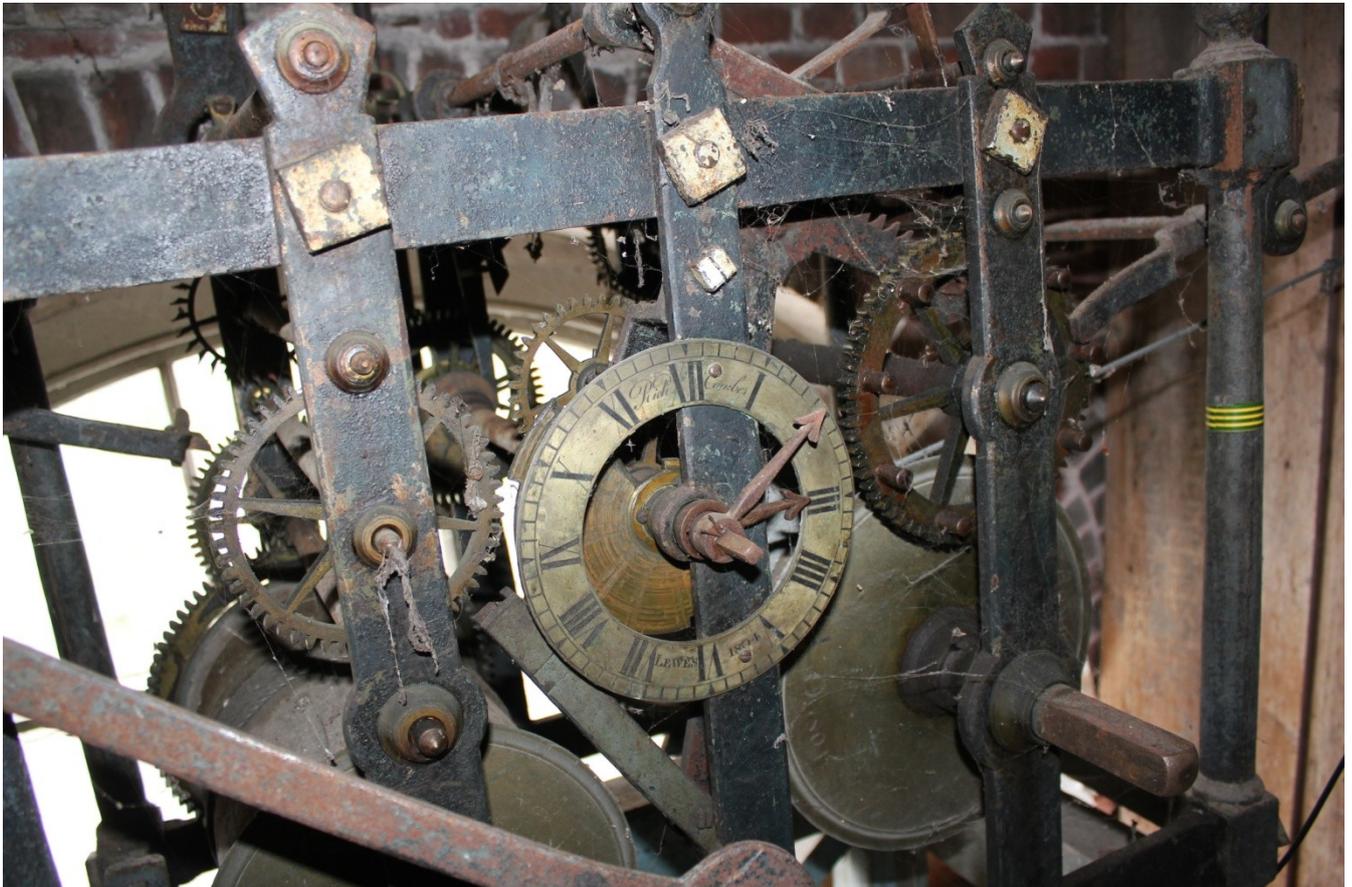
The second area provides a partitioned space where the clock mechanism is housed. The clock face internally is inscribed 'Rich Comber, Lewes 1804 (Plate 23). Richard Comber was the son of a barber from the Cliffe area of Lewes⁴, who died in 1817 and is buried in Saint Michael Church, High Street, Lewes. This space is divided by means of plank and stud partition walls to three sides (all pegged in place), with a central Diocletian window overlooking the courtyard on the north-east side. The flooring is softwood boards, 0.24m wide.

Plate 23. Internal clock face and mechanism.

- A new bridal suite is proposed within the existing clock room. This is in a highly significant area and if not approached in the right manner could cause substantial harm to the historic fabric. However, if approached with conservation ideals in mind, it could provide an excellent opportunity to draw on the contribution made by the heritage asset to the character of a place and could protect the facility for the future. However, it is to be recommended that the clock be fully restored, including the wooden panelling surrounding it, although we cannot comment further until proposals are drawn up in full.

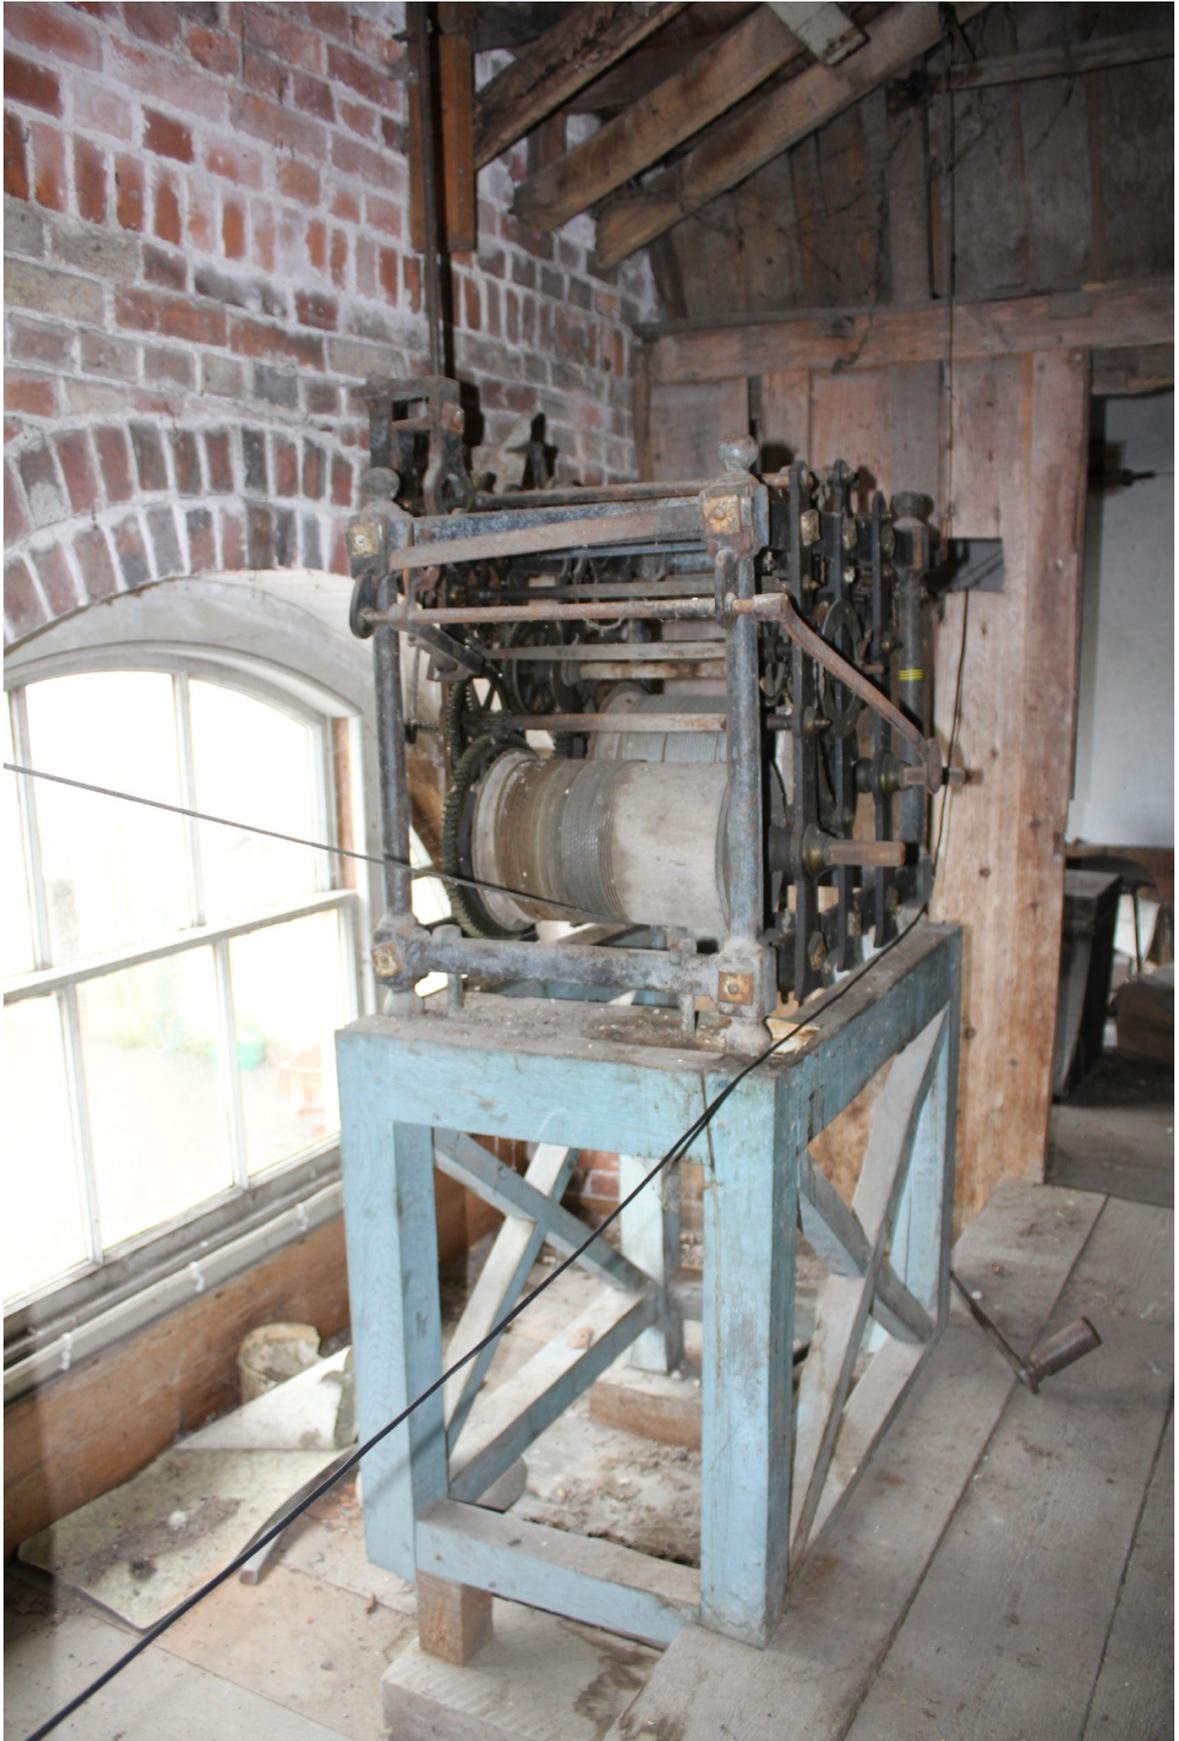
There are two narrow doors giving access into the area, via a short step up (0.26m) to a central platform where the clock sits (Plate 24). The doorway on the north-west side housed a re-used 17th-century, oak panelled door, which has since been removed but sits adjacent to the doorway (Plate 25).

Plate 24. Central window adjacent to the clock mechanism. Note the weight cable running off the left side.

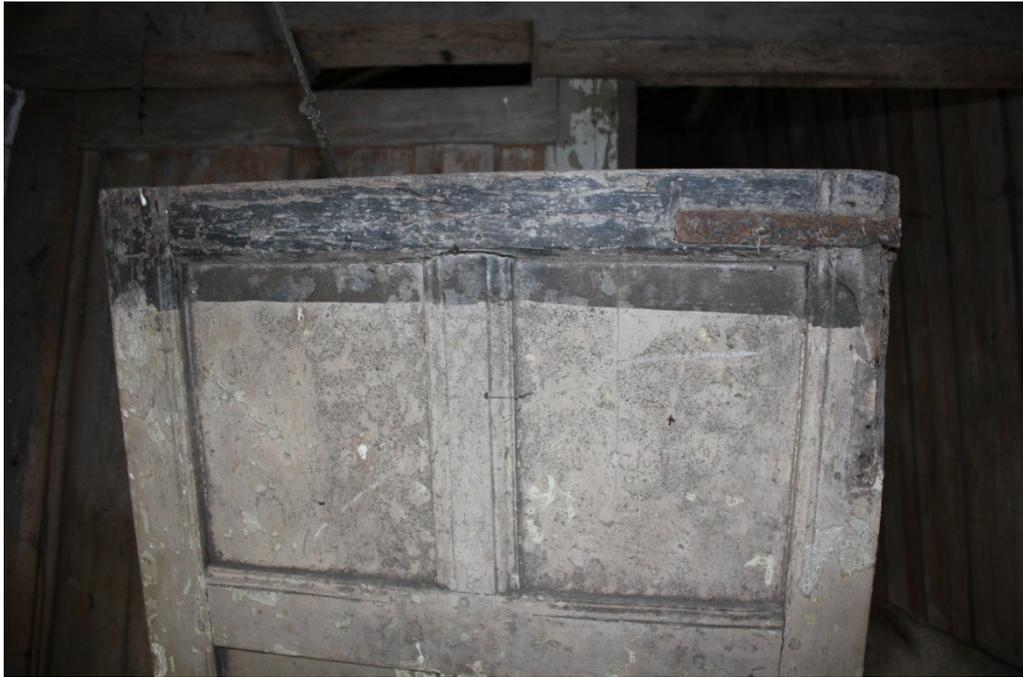
Plate 25. Re-used 17th-century panelled door.

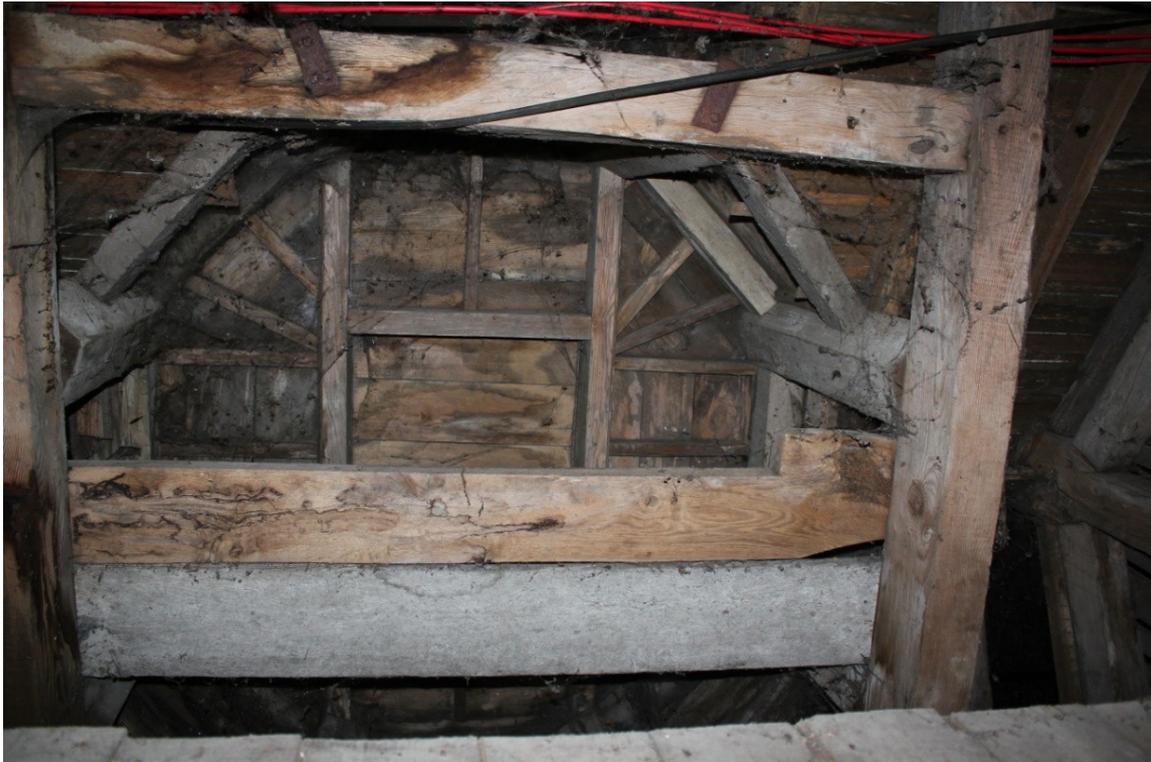
The pendulum no longer swings, and the octagonal bell tower overhead is centrally positioned (Plate 28).

Plate 28. Looking up at the base of the bell tower.

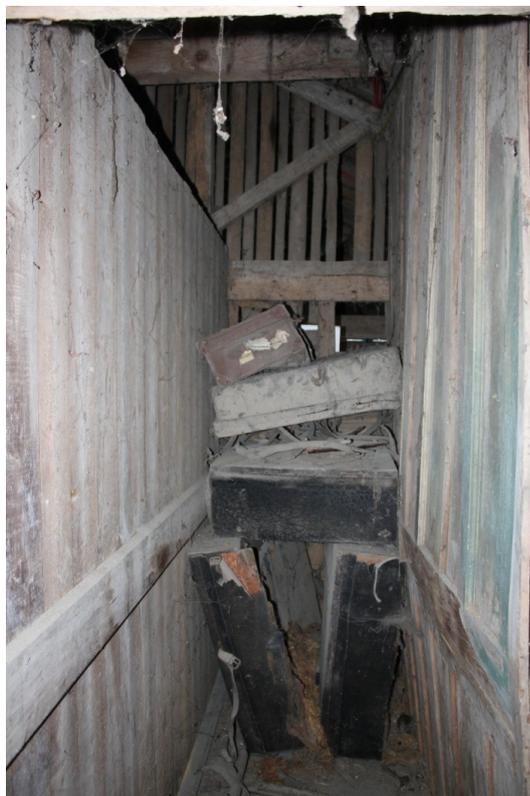
Behind the space partitioned off for the clock mechanism is a narrow storage area which is full of stored items and appears blocked on the north-west side, so this could not be investigated further (Plate 29).

Plate 29. Small storage area behind the clock room.

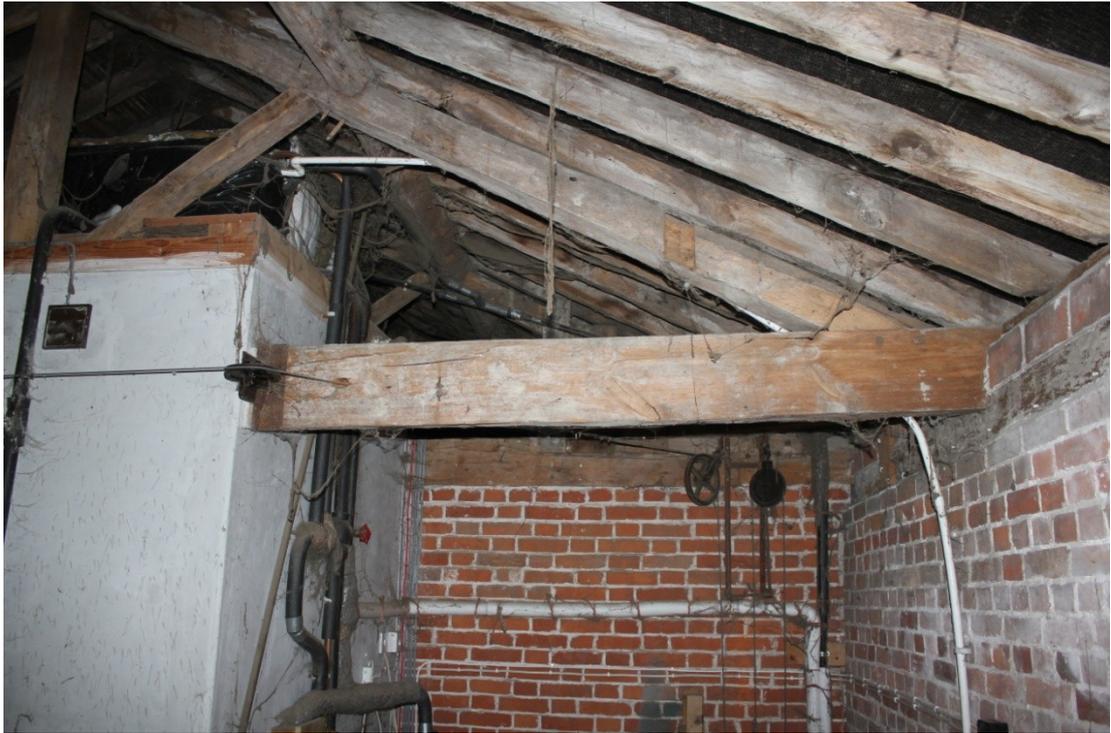
Plate 33. The second weight balance for the clock in the south-west corner.

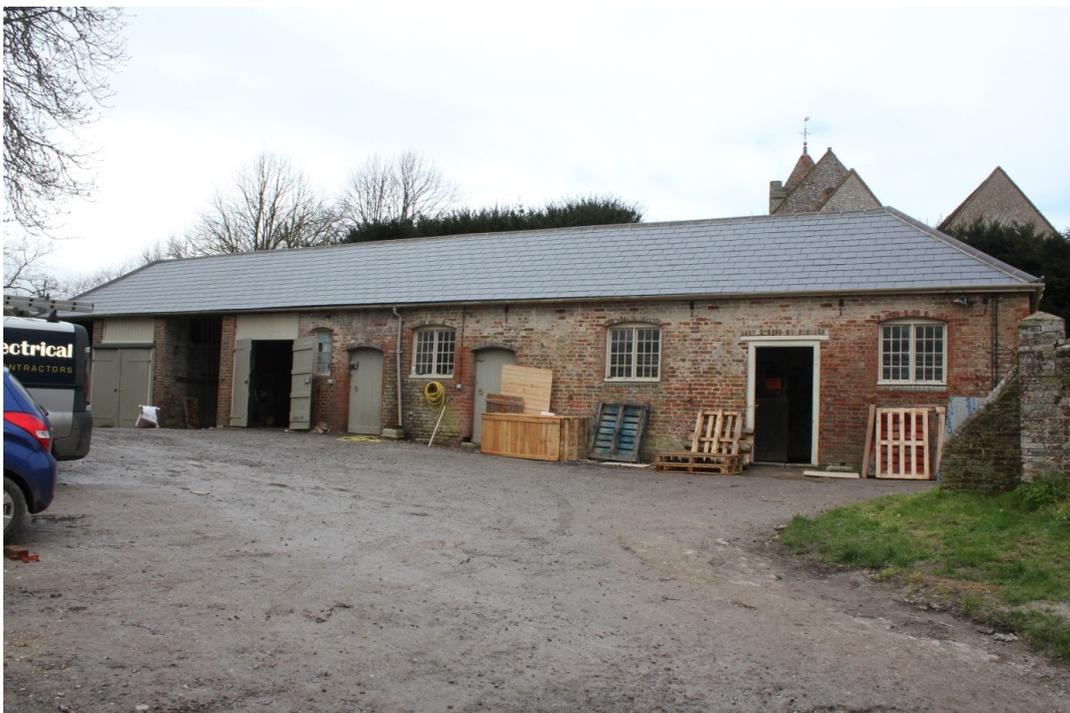
It is proposed that this building (Plate 34) is converted to provide a kitchen and storage for the wedding venue as part of Phase 2. Consequently, this will be considered under a separate application and is not discussed in full here, other than by means of a photographic survey.

Plate 34. The building proposed for conversion in Phase 2.

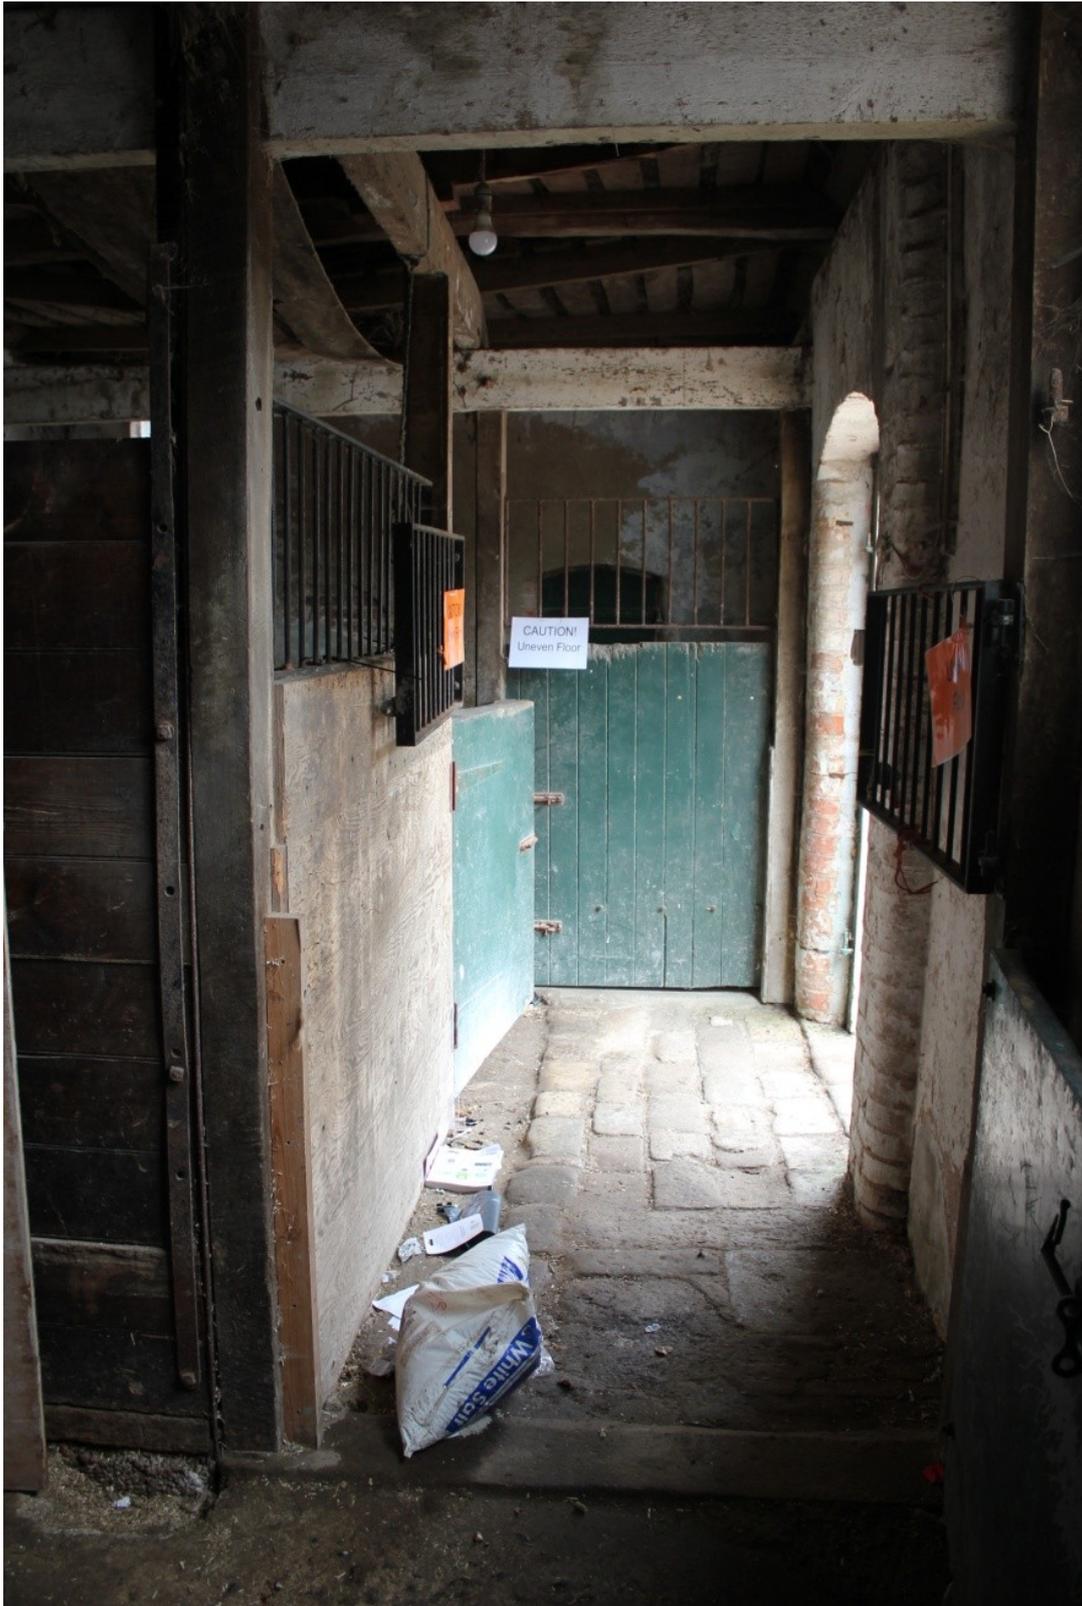
Plate 35. The stable in the outbuilding on the north-east side.

It is clear from the map regression exercise that this building has two phases, with a stable built first (Plate 35) and then four open-fronted storage bays (Plates 36 and 37) built at some point after 1843, two with double-width locking doors.
