A DESK-BASED ASSESSMENT FOR FIRLE STABLES,
FIRLE, EAST SUSSEX.

Archaeology Services Lewes

Project number: 146-18

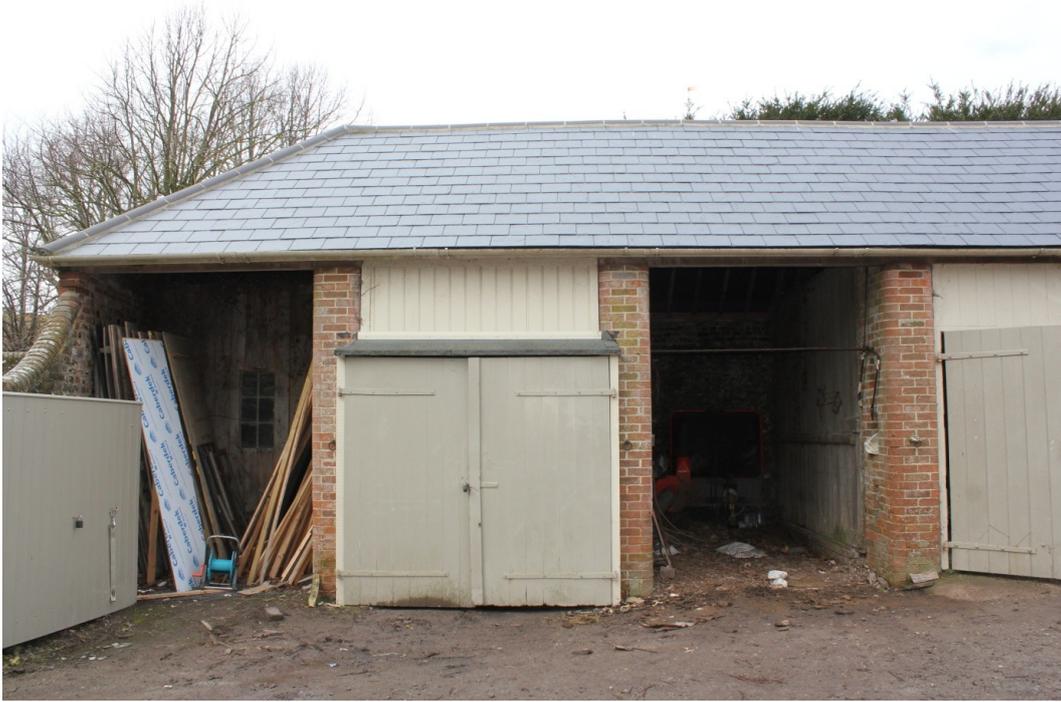
It is clear from the map regression exercise that this building has two phases, with a stable built first (Plate 35) and then four open-fronted storage bays (Plates 36 and 37) built at some point after 1843, two with double-width locking doors.

Plate 36. The open-fronted and lockable storage bays added to the outbuilding after 1843.

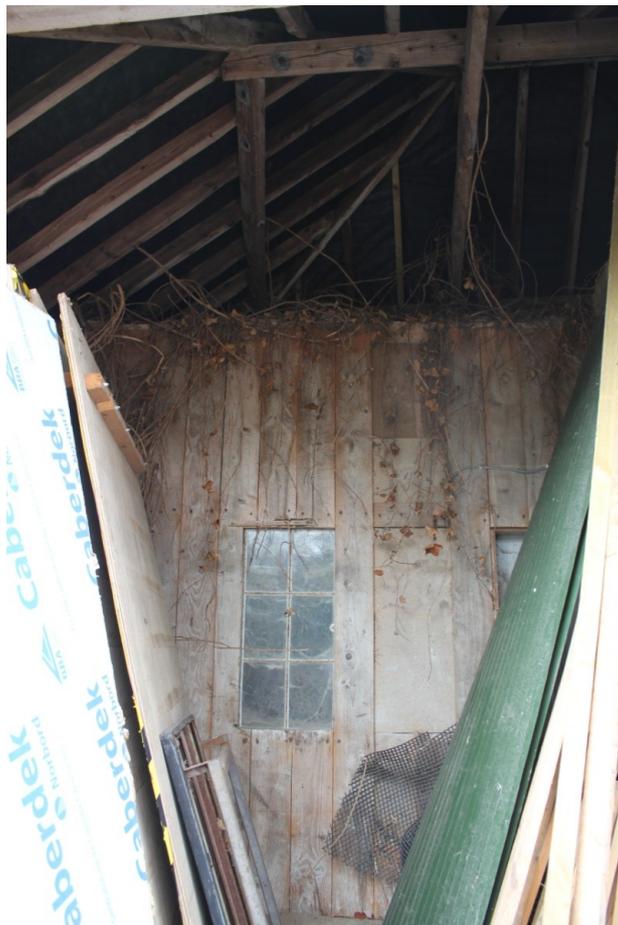
Plate 37. Small lockable room formed in the open storage bay of the outbuilding.

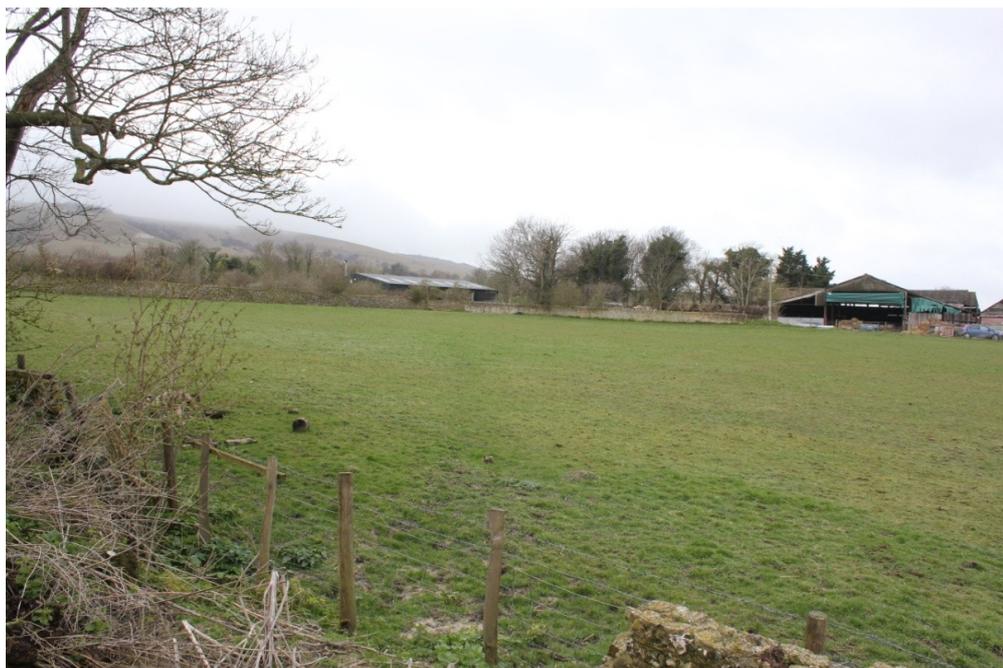
Plate 39. The southern part of the field for the proposed car park.

The more southerly part of the field shows no earthworks and is flat (Plate 39). Part of this area was previously excavated and monitored by ASL during the biomass development and several features and artefacts were found here. This included a possible Roman trackway at a depth of 0.80m and residual prehistoric pottery. However, the car park surface will be constructed with 'Grasscrete' with just 75mm of soil being stripped prior to laying plastic matting for the surface. Consequently, this will only impact on ploughsoil.
