Guidance for Historic Buildings

Guide No. 5. Condition surveys

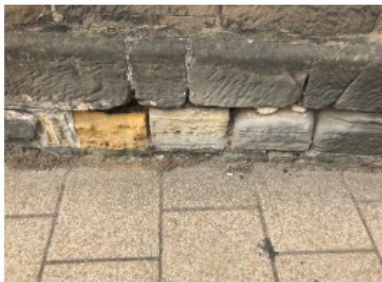
<p>By far the most significant issue from a structural point of view, is the amount of erosion suffered by areas of the masonry, particularly the sandstone blocks. This was referred to within my 2006 report and has not been addressed since that time. There is no doubt that erosion has progressed during the last 13 years.</p>

<p>Stone erosion to North East elevation at low-level</p>

Fig.10. Example of a Structural Engineer's Condition Survey (Bunney 2019).

Often there may be some degree of overlap between the Architect, the Structural Engineer and the Archaeologist. A Structural Engineer's report (Fig.10) will be less likely to discover historic phasing and background, focussing on the defects seen. This is often achieved through visual inspection with the Architect, with a resulting written report similar in format to the Architect's.
